International Property Inspection

Property Inspection Report

123445 Sample St., Sample, CO 12121
Inspection prepared for: Sample Report
Date of Inspection: 11-6-2013

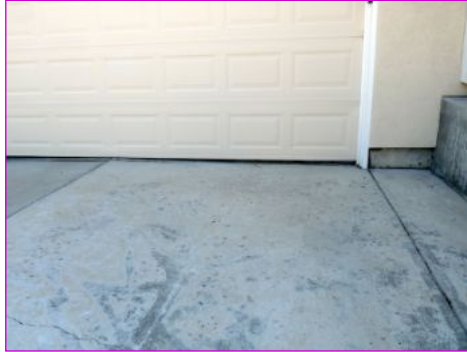
1. Driveway Condition

- Moderate settling visible in the driveway at the time of the inspection appeared to be due to inadequate compaction at the time of original construction. Most settling takes place in the first few years after original construction, after which settling stops in the effected area.

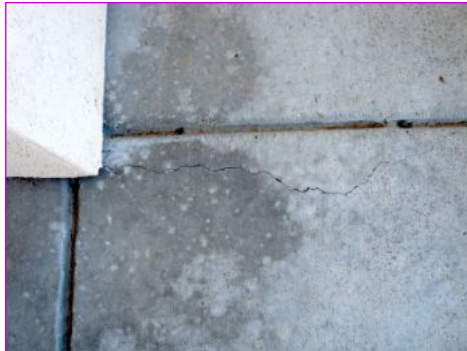
2. Walkways

- Home walkways were constructed of poured concrete.
- At the time of the inspection, the walkways had areas of moderate settling visible. This condition is typically the result of poor compaction practices during original construction. As time passes, settling continues until soil beneath the affected area reaches equal density with the surrounding soil and the affected portions of the walkway become stable. Chances that settling will continue are low.
- The concrete walkways exhibited shrinkage cracks. Shrinkage cracks commonly occur as newly-placed concrete dries, especially at high-stress areas like corners. Shrinkage cracks are surface cracks that are not a structural concern.

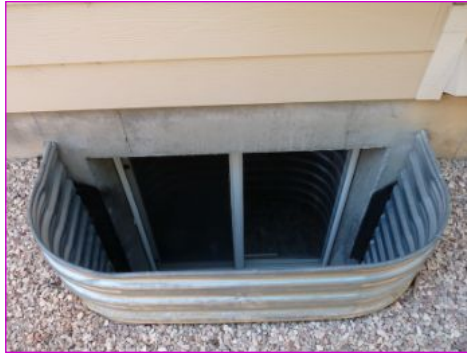
3. Window Wells

- One or more window wells lacked covers at the time of the inspection. This condition can be hazardous to small children and may trap pests such as skunks. The inspector recommends installation of window well covers.

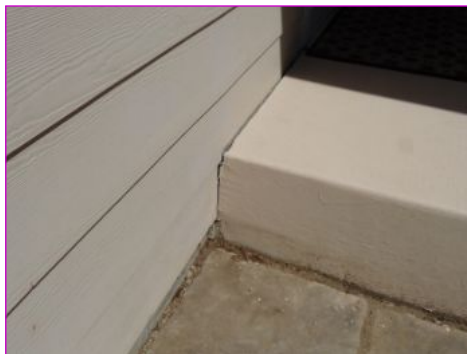
- Siding had concrete poured against it. Moisture will be trapped at such areas. Siding will dry more slowly and deteriorate more quickly than siding exposed to free air flow. Deteriorated siding will be difficult to replace.

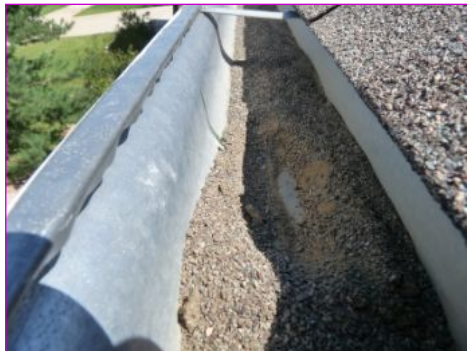
- The Inspector observed few deficiencies when inspecting the gutters. Any exceptions will be listed in this report.
- Granules from the asphalt shingles were accumulated in the gutters. This condition is common as loose granules that are not embedded in the asphalt covering shingles are washed loose by runoff from rain. This is not a defective condition, but is common and expected, however the granules trap sediment, which hardens and prevents fully functional drainage of the gutters. This condition may hasten corrosion. The Inspector recommends thorough cleaning of the gutters.

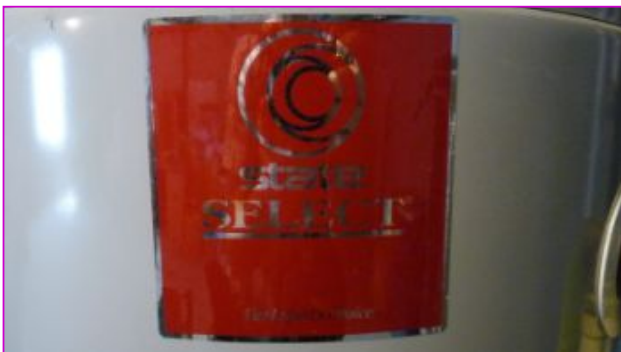
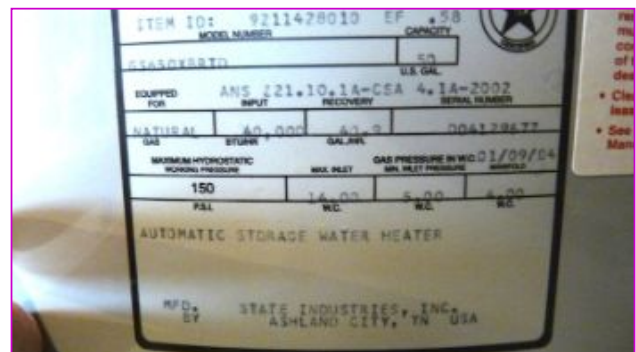
- The water heater was manufactured by State Industries
- Water heater capacity was 50 gallons.
- The photo shows the data plate of the water heater.
- The date of manufacture for this water heater appeared to be 2000.

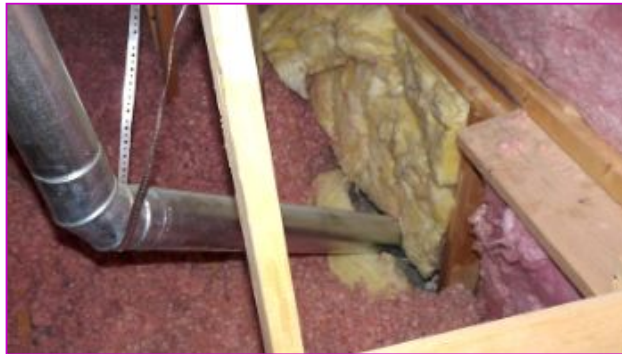
- The combustion exhaust flue for this furnace had improper clearance from combustibile materials. This type of vent requires 1-inch minimum clearance. This condition is a potential fire hazard and should be corrected by a qualified contractor.

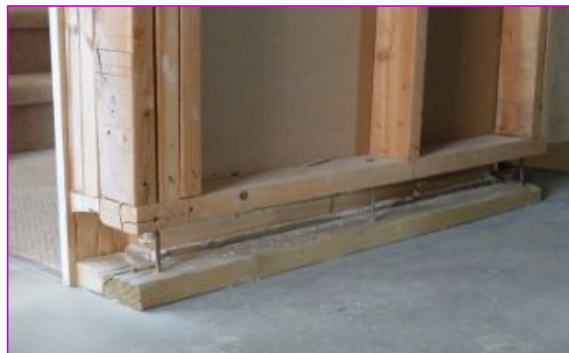
• Wall framing visible in the basement showed the use of methods designed to accommodate soil heaving in areas known to contain expansive soils. This method involves leaving a gap at the bottom of the wall to prevent damage from heaving of the floor slab. It's called "floating" the wall. The home was located in an area known to have expansive soil. Expansive soils are soils which expand with changes in soil moisture content. With the addition of moisture, some expansive soils increase to many times their original volume, creating heaving and settling forces that can easily damage home foundations.
