# **J. ARONSTEIN**

## **HAZARDOUS FPE CIRCUIT BREAKERS** **AND PANELS**

*(Updated as of May 25, 2007)*

*Information for Inspectors and Homeowners*

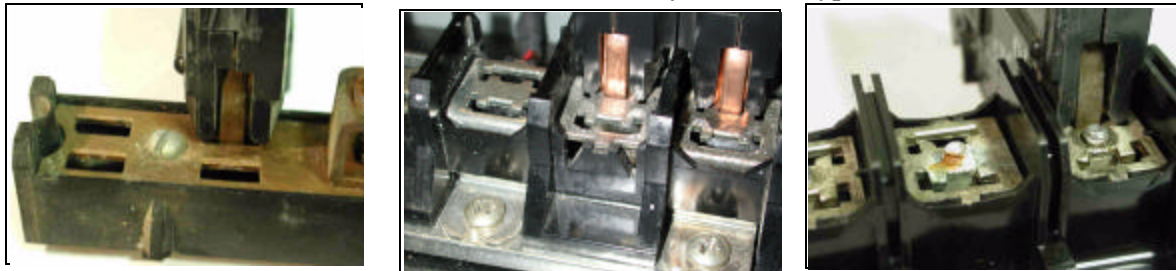
**FIGURE 2 - THREE DIFFERENT FPE STAB-LOK® SOCKET DESIGNS**

- A. Copper buss bar with punched openings.**
- B. "Z" clip, clamped to bussbar with 10-32 screw.**
- C. Stab socket on a post, attached with an 8-32 steel screw.**

Of the three types illustrated, the one shown in Figure 2-C is known to have a high probability of deteriorating and overheating of the stab socket structures when subjected to significant current flow. Each individual stab socket plate is connected to its bussbar via a post (spacer), and the assembly is held together by an 8-32 steel screw. FPE panels with this construction are prone to overheating failure. The seven panels of the present study that showed evidence of serious overheating were constructed this way. One example is shown in Figure 3.

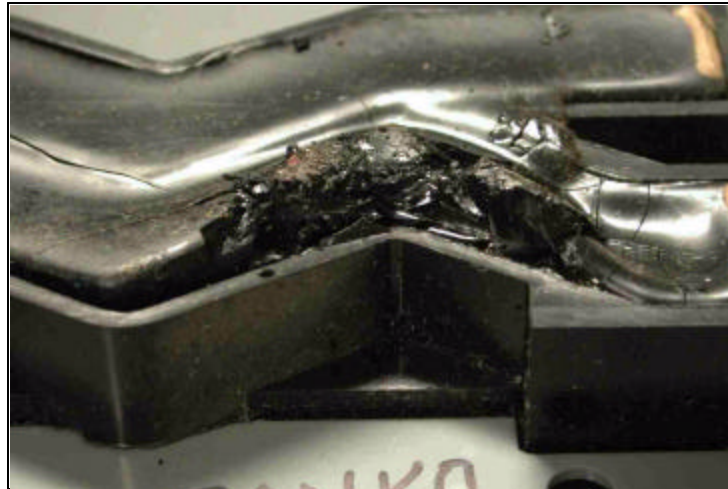
**FIGURE 3 - OVERHEATING AT THE CONTACT BETWEEN THE BUSSBAR AND THE STAB SOCKET ASSEMBLY CAUSED THIS DAMAGE TO THE INSULATION.**

(This view is of the backside of the panel. The damage cannot not be seen unless the panel is taken out of the enclosure.)

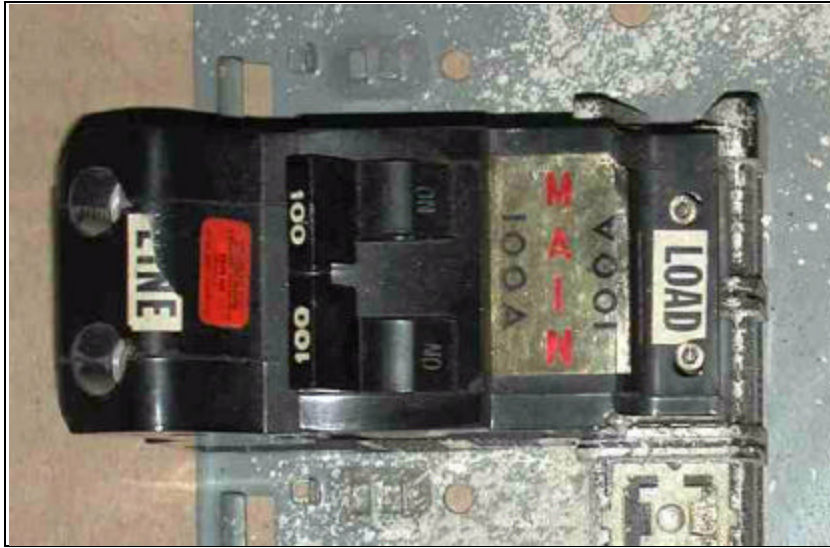
Some FPE Stab-Lok® panels have 100-amp main breakers that feed into the bussbars through the same plate and post system. In this design, the two main breaker output terminals do not have the stab type contact. Instead, each one is screwed down to a plate the same size as the stab socket plate, but which has a threaded hole in it instead of the stab openings. As with the plate and post assembly, the screws clamping the main breaker terminals are size 8-32, which is absurdly small for clamping the terminals of a 100-amp main breaker.

**FIGURE 6 - FPE 100-AMP MAIN BREAKER CONNECTS TO THE BUSBARS THROUGH THE PLATE & POST CONFIGURATION, USING ONE SOCKET-HEAD 8-32 SCREW AT EACH TERMINAL TO ATTACH TO THE CONTACT PLATE.**

**(The heads of the 8-32 terminal clamping screws are seen above and below the "LOAD" label.)**

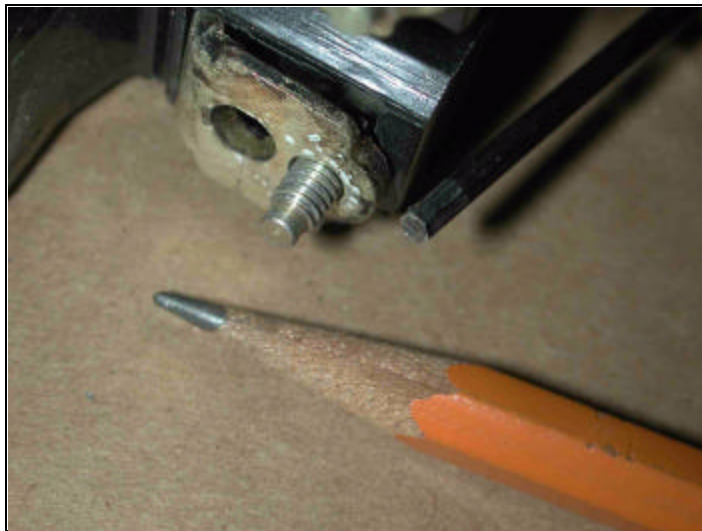
To put the diameter of the 8-32 screw in perspective, it is the same size as used on common receptacles for connecting #14 or #12 copper wire (for 15- and 20-amp circuits), and has a diameter of only about 5/32". An FPE panel and main breaker of this type is shown in Figure 6. The main breaker's output terminal mounting screws and the tiny Allen-wrench that fits them are shown in Figure 7.

**FIGURE 7 - ONE LOAD-SIDE CONTACT AND ITS 8-32 CLAMPING SCREW, ON THE FPE 100-AMP MAIN BREAKER OF FIG. 6. THE SCREW-HEAD TAKES A 3/32" ALLEN WRENCH, WHICH IS ONLY SLIGHTLY LARGER THAN THE LEAD OF THE #2 PENCIL.**

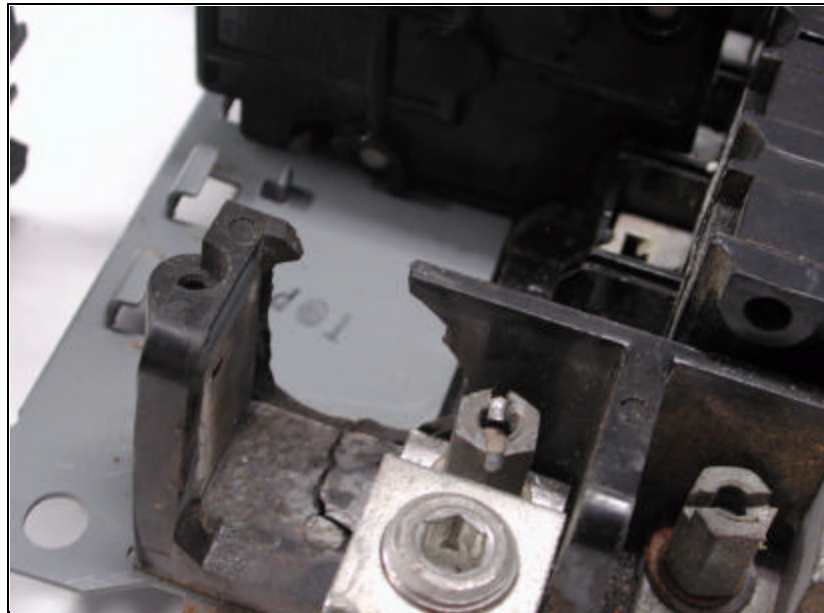
**FIGURE 10** - THE DAMAGE TO THE INSULATING STRUCTURE OF THE PANEL (FIG. 8) IS MORE CLEARLY VISIBLE WITH THE BREAKER REMOVED.

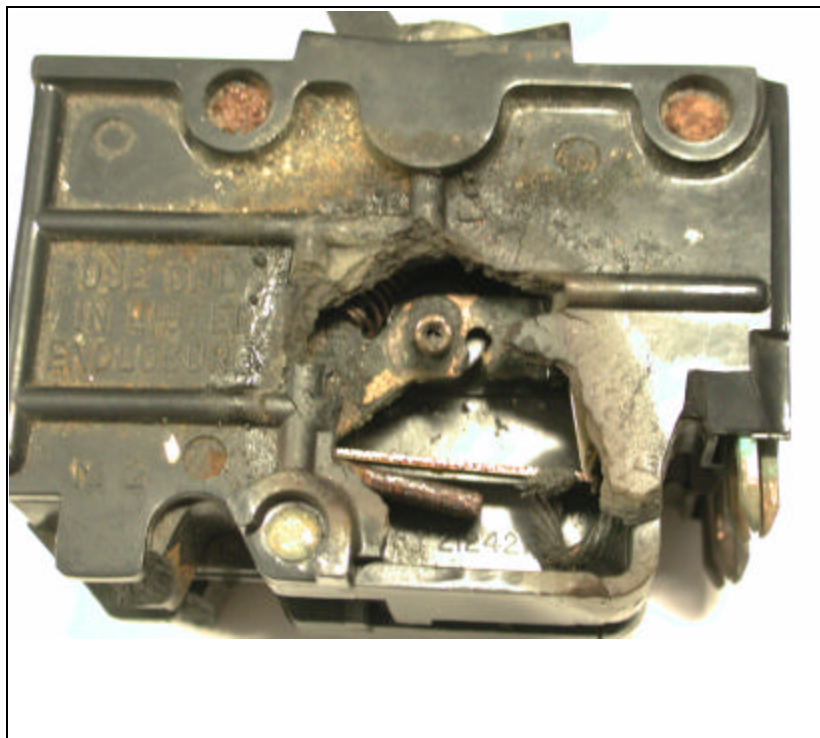
**FIGURE 11** - THE FAILED FPE STAB-LOK® DRYER BREAKER (UPPER RIGHT, FIG. 8)

The damage to the breaker, from some previous short circuit or failure event, is exactly as had been demonstrated in the tests done for CPSC.<sup>2,3,4</sup> Those tests demonstrated that, when an FPE breaker jammed and the current exceeded about 300% of the breaker's rating, the side of the breaker disintegrated and/or ignited from the heat being generated within the breaker. This is due to resistive heating of the breaker's internal current-carrying components, mainly the bimetal element and the flexible copper braid that connects to it. This is not an arcing failure, although the damage to the insulating materials of the breaker and panel sets the stage for an arcing fault to occur.

There are additional problems in this panel. Overheating damage occurred to the insulation on the backside of the panel. Further, in addition to the dryer breaker that failed (jammed) in the home, two other two-pole breakers from this same panel failed in the lab testing. All this in a panel that looked OK from the front!
