Confidential Inspection Report

LOCATED AT:
2408 Benedict Cyn. Rd.
Los Angeles, California 90046

INSPECTED ON:
Tuesday, March 22, 2016

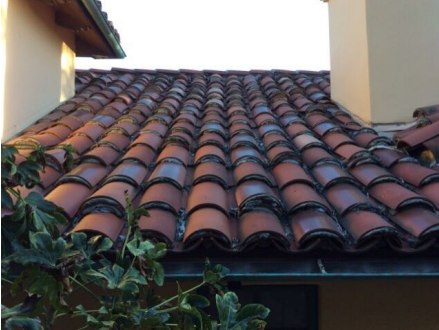
26: - There are many individual cracked, chipped and displaced tiles along in the field. Several missing tiles is also observed. The number of affected tiles is small, but felt underlayment is exposed and we recommend repair to prevent its deterioration.

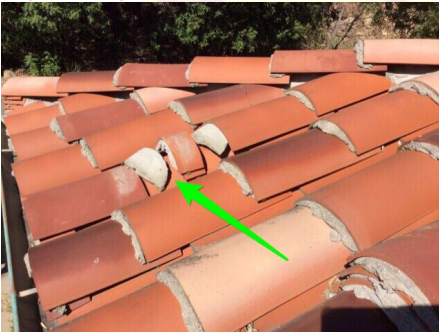
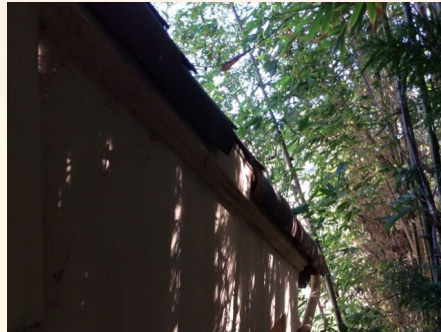
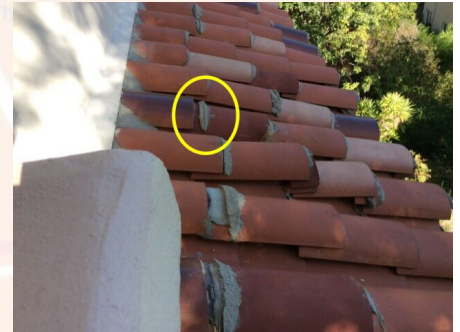
27: - There are a significant number of loose and missing tiles on the ridge and throughout the field.

28: - The condition(s) and/or configuration noted above demands attention for the long term viability of the roofing surface. For necessary preventive maintenance, we recommend the advice and services of a licensed roofing contractor.

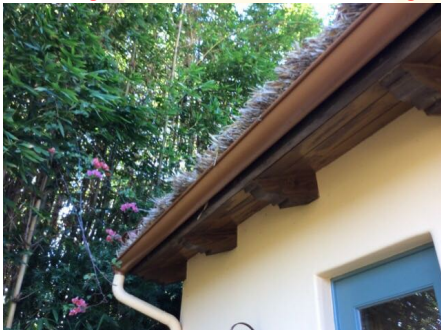
44: - Sections of the gutters are laden with debris. We recommend all debris be removed to ensure proper drainage. The condition of the gutters can be better assessed at that time.

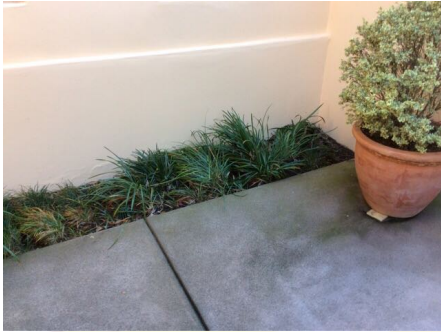
52: - It is our opinion that the existing surface drainage system at the north patio and planters is either insufficient or defective. As evidence of water intrusion is absurd at the adjacent subterranean walls and subfloor areas. Consult the owner regarding the circumstances. We recommend that repair or upgrades to the drainage system be undertaken. Enclosing of the soil filled planters at the north grounds with concrete should be considered.

53: - The drainage system should be checked for debris and cleaned regularly to ensure proper operation during heavy weather.

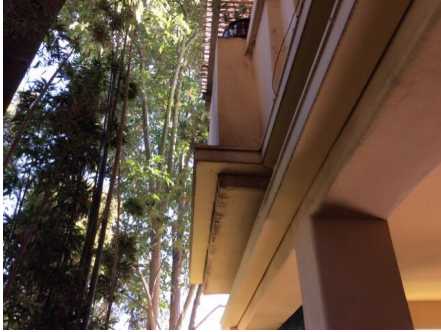
56: - The stucco exterior is in satisfactory condition, with a few minor cracks. These hairline cracks are typical and no action is indicated. They can be patched and sealed in the course of routine maintenance.

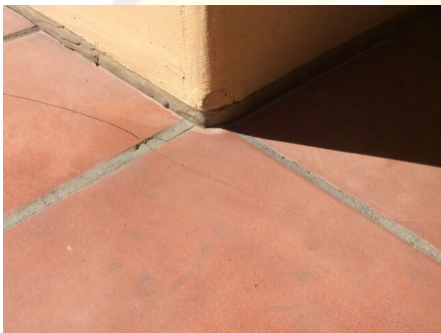
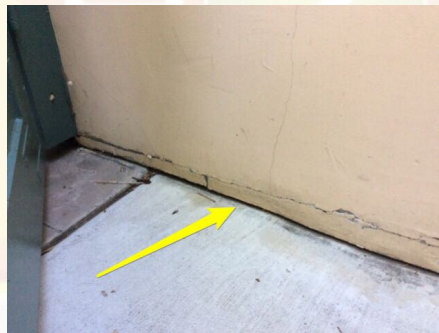
59: - The weep screed has been damaged and/or obstructed at the walls. The added caulking and stucco obstructs drainage. We recommend repair, reinstallation and/or replacement in accordance with present standards.

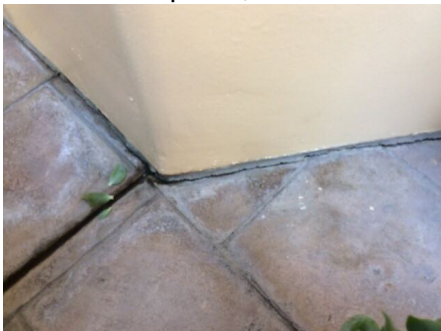
61: - Obvious repairs and/or modifications have been made to the weep screed at the stucco walls. The owner may have information about the original conditions, the repair or remodeling work, and any permits that were required, obtained and completed.

62: - For attention to the condition(s) noted above, and/or cost estimates, if necessary, we recommend the advice and services of a licensed plastering contractor.

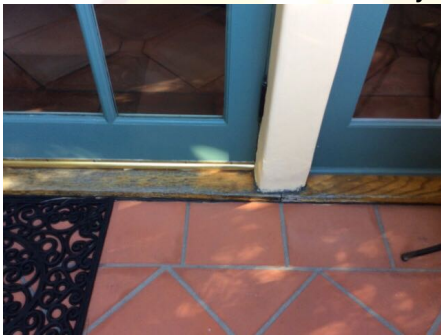
67: - The exterior doors are generally in serviceable condition but the finish is worn on several doors and thresholds. We recommend they be refinished for a better appearance and to maximize their service life.

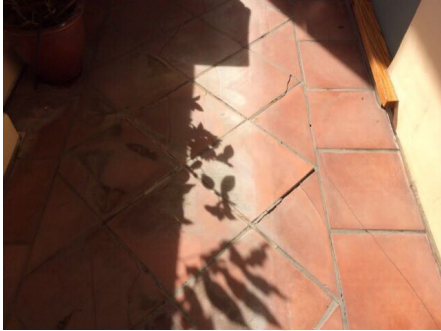
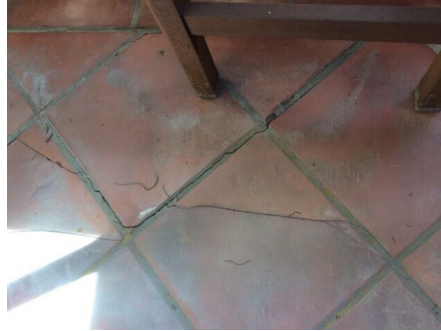
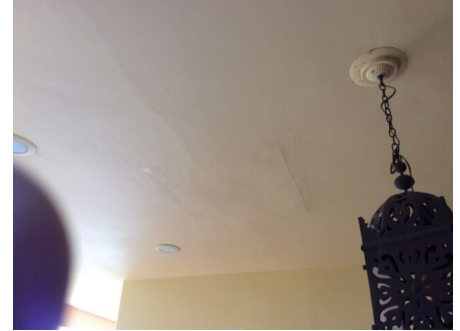
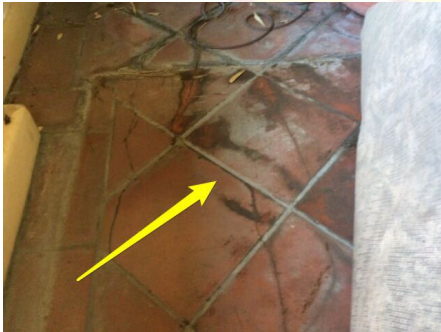
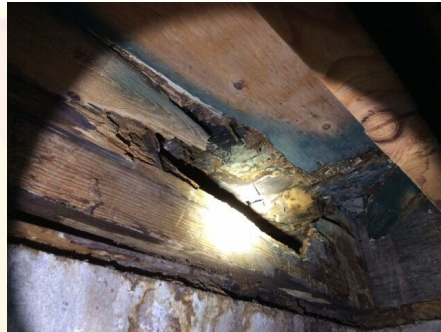
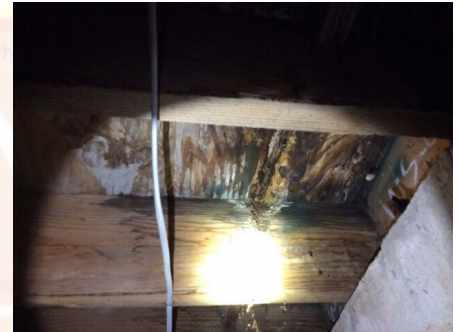
71: - Numerous cracks, loose and displaced tiles are noted at the master bedroom and southeast decks. The moisture membrane and/or flashing appear to have failed. Water damaged is present at the support structure below. We recommend all damaged material be replaced, and the leak must be eliminated. The surfaces below the area rugs is not viewed completely. The need for a significant repair and or replacement of the deck surfaces should be assumed.

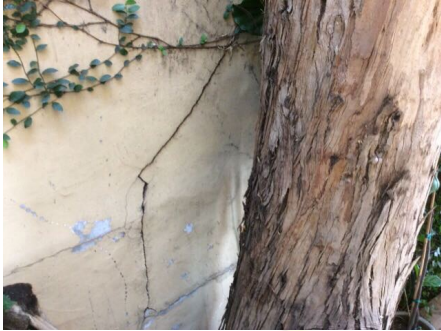
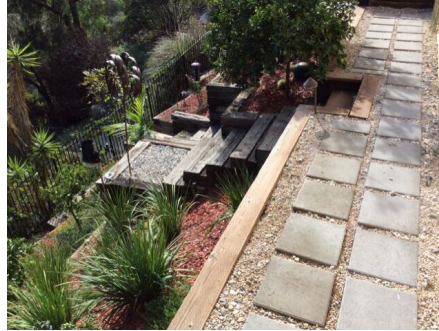
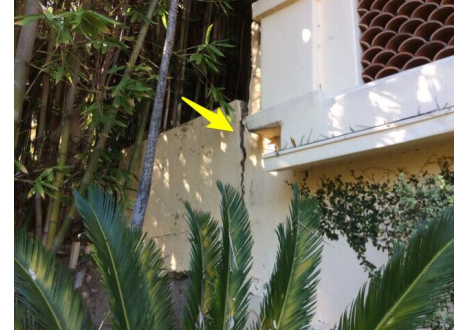
76: - The walls, fences and gates are not within the scope of the inspection. However some comments are given as a courtesy and for a better understanding of the property. The wood walls at the slope are non-conforming. Check permits. The lack of guard rails at the walls and overlooks presents a fall hazard. The west and east wall is cracked and displaced. The source and or significance is not determined. Further review of the walls, fences and gates by a qualified expert is recommended.

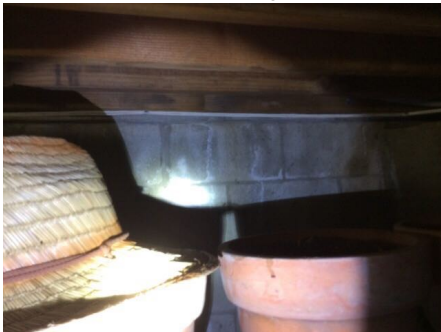
89: - Efflorescence is observed at the foundation concrete denoting moisture penetration. This whitish, fuzzy material is a 'salt' deposit left when moisture in the foundation evaporates on the inside of the foundation.

90: - This indicates an occasional surplus of moisture on the outside of the foundation. Steps could be taken to improve the exterior drainage but no other action is indicated at this time.

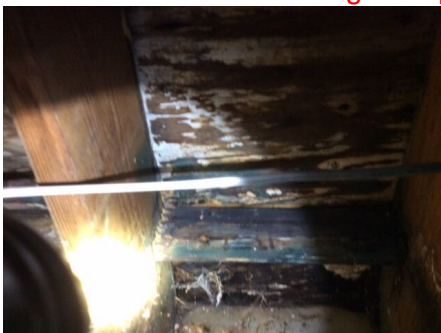
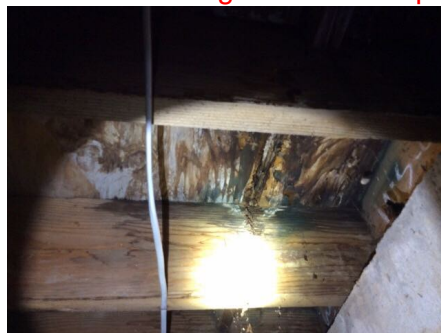
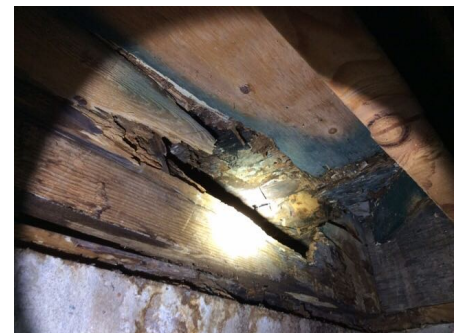
92: - The subfloor beneath the balcony/decks is in a poor state and needs significant repair and replacements. The deck surfaces leak. Water staining, damage and degraded framing is observed. We recommend the subflooring be repaired and all damaged material replaced.

93: - Because damage may extend into the inaccessible framing and associated members, the extent of concealed damage will not be known until repairs are in progress.

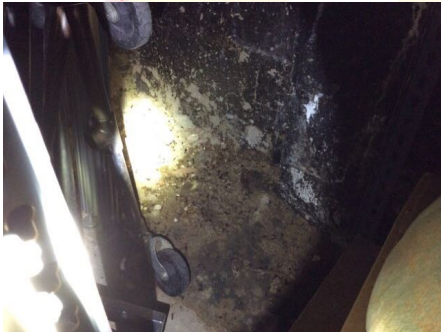
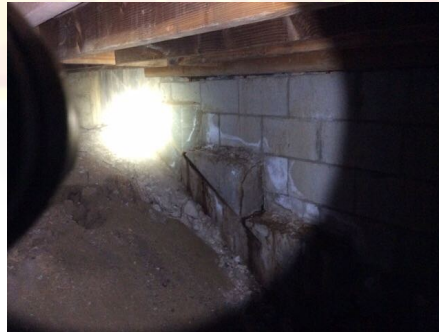
97: - There is evidence of moisture entry and periodic accumulation of water in the crawl space. Minor pockets of water are not unusual. In most cases, minor water entry is not a concern provided the crawl space has adequate clearance and venting.

98: - The soil at some areas was damp at the time of this inspection. With the lack of recent rainfall, this condition is most likely a result of over-watering of the landscaping.

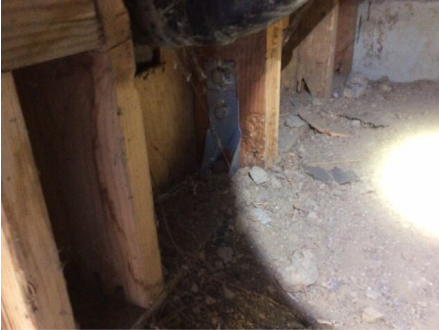
101: - There is earth-to-wood contact at several areas. This condition is conducive to wood destroying organism activity.

102: - We recommend a minimum clearances be maintained between soil and the bottom of the wood line. Any damaged or deteriorated material discovered in the course of this work should be replaced or removed.

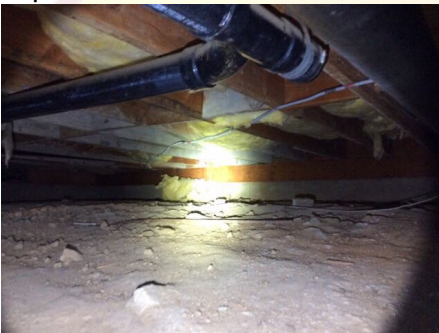
104: - There are fiberglass batts that have fallen out of place. We recommend this material be secured back in place.

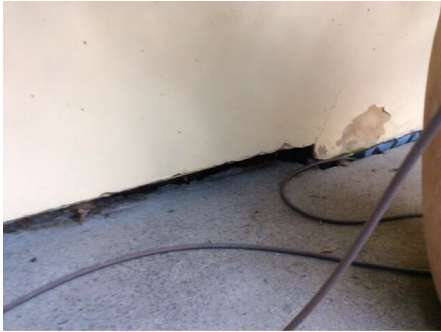
111: - **The gap at the lower area of the east wall should be sealed to prevent intrusion of water and rodents.**

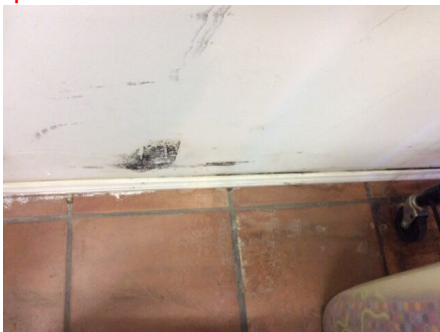
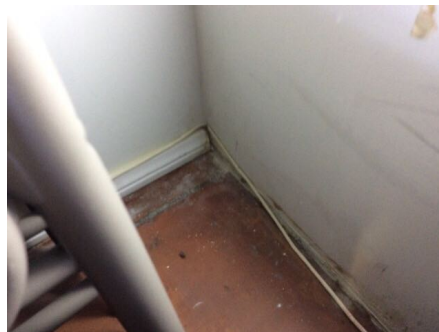
140: - Water stains and suspect mold have built up on the exposed subterranean wall surfaces within the downstairs utility closet. The source of the moisture is not determined. The owner should be consulted regarding past water intrusion issues. A mold expert should be consulted at this time for a further examination and recommendations as we are not qualified in this field. We recommend these surfaces be cleaned and chemically treated to remove the growth. Further examination of the walls and site drainage by qualified technicians is recommended.

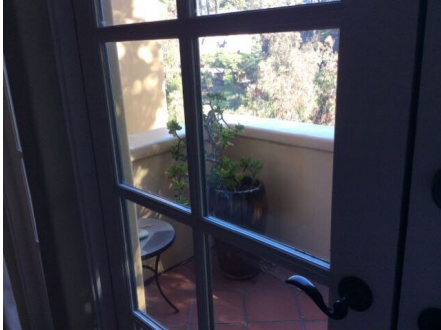
145: - There is condensation between the panes of glass of several double panes at the doors. This indicates a failed seal. We recommend the lens assemblies be replaced, which is the only method for correcting this deficiency.

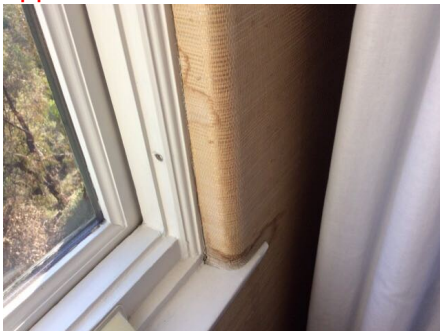
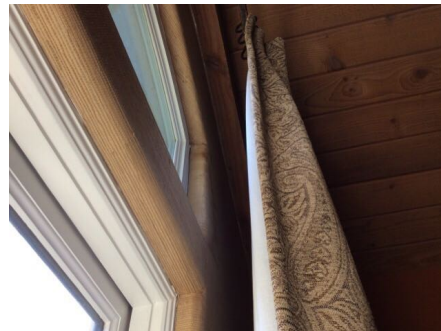
162: - We noted water staining and minor surface damage at the south wall and window. The source of the moisture should be identified and corrected, and the surface prepared and refinished to restore its appearance.

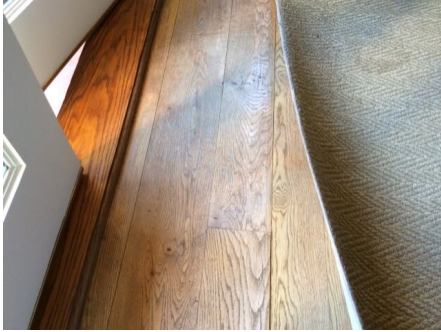
174: - Cosmetic damage and discoloration is noted at the wood floor. The flooring below the area rug is not viewed completely.

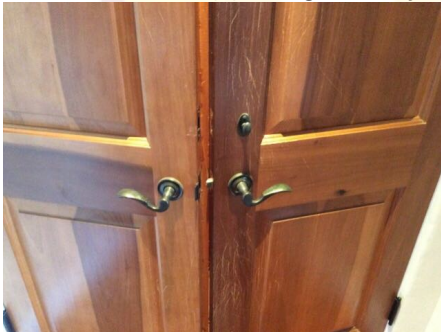
192: - The door(s) are generally serviceable. Pet damage is noted at the entry doors.

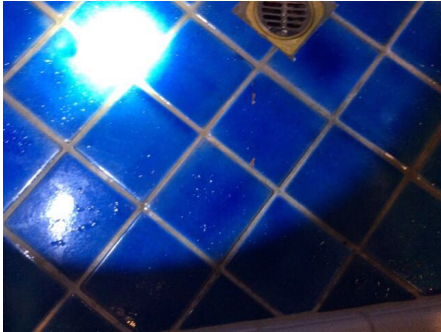
225: - Hairline cracks and the need for repairs are noted at the shower stall, as the cracked edges are sharp.

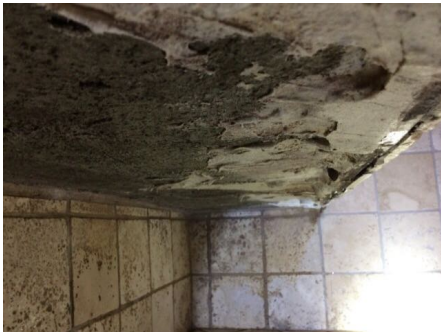
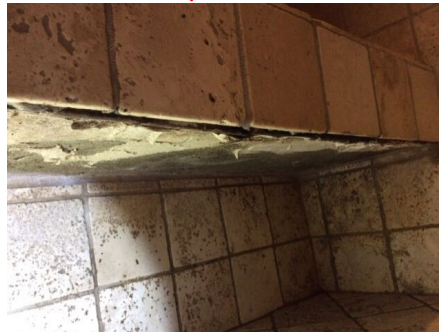
253: - The bottom side of the shower bench should be sealed completely to prevent water intrusion and or damage. The area below the bench is discolored. A mold expert should be consulted for a further examination and recommendations as we are not qualified in this field.

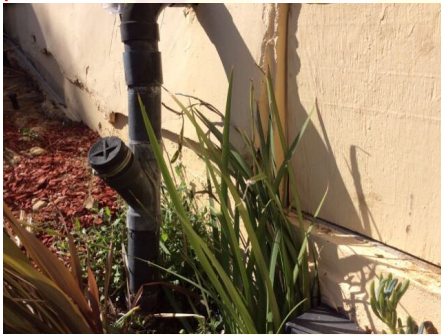
278: - The exposed ABS plastic drain lines at the south wall and slope area is displaced, cracked and leaking. We recommend that these lines be repaired or replaced. ABS plastic drain lines are typically not approved for exterior use. The exposed drain lines should be replaced with cast iron materials or be protected from the elements.

279: - Based on conditions and unconcealed piping, we recommend a full camera review of the main line and waste piping system at this time by a qualified expert.

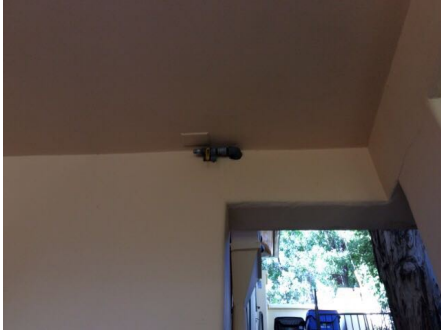
284: - There is an uncapped gas valve at the southeast patio . If it remains unused, we recommend it be capped to reduce the chance of gas leakage.

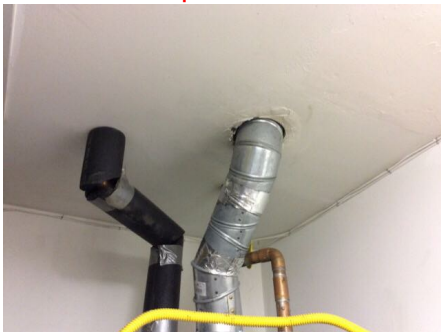
297: - The water heater vent is installed too close to a combustible surface. We recommend that approved clearance be provided. One inch clearance is standard.

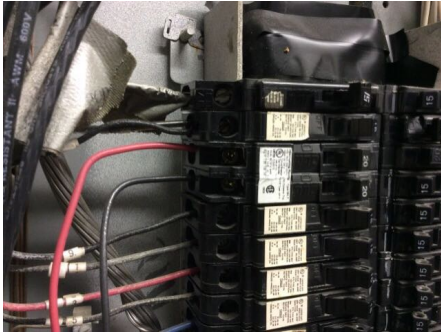
317: - Multiple wires are installed on individual terminals. This 'double lugging' is not permitted because positive connection for all wires is not assured. We recommend reconfiguration of the circuitry so that each wire connects to only one terminal.

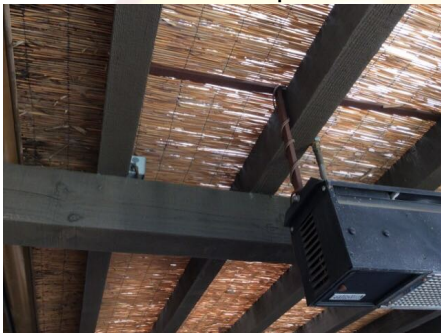
319: - We found exposed wiring in several areas. Even if insulated, we recommend all wiring be encased in a conduit or otherwise protected in accordance with accepted practice.

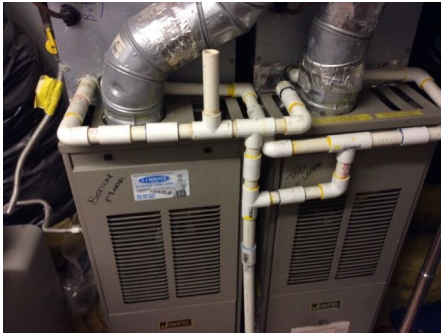
355: - The condensate drain systems should be serviced at this time as they are not configured properly. The primary and secondary drains are joined which is substandard. A secondary condensate drain line assembly or shut off switch which is standard should be provided.
