January 2019 Interim Revision July 2020 Page 1 of 13

INSPECTION AND MAINTENANCE OF ROOF ASSEMBLIES

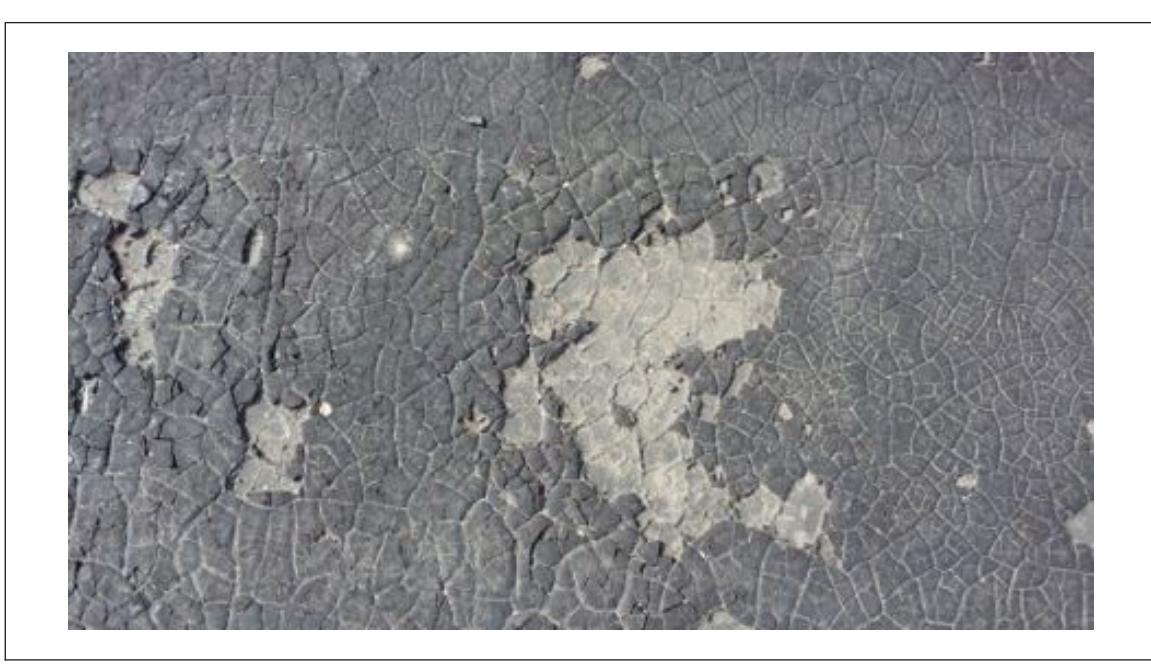
Fig. 1.1-1 Hail damage to 20-year-old "alligatored" built-up roof

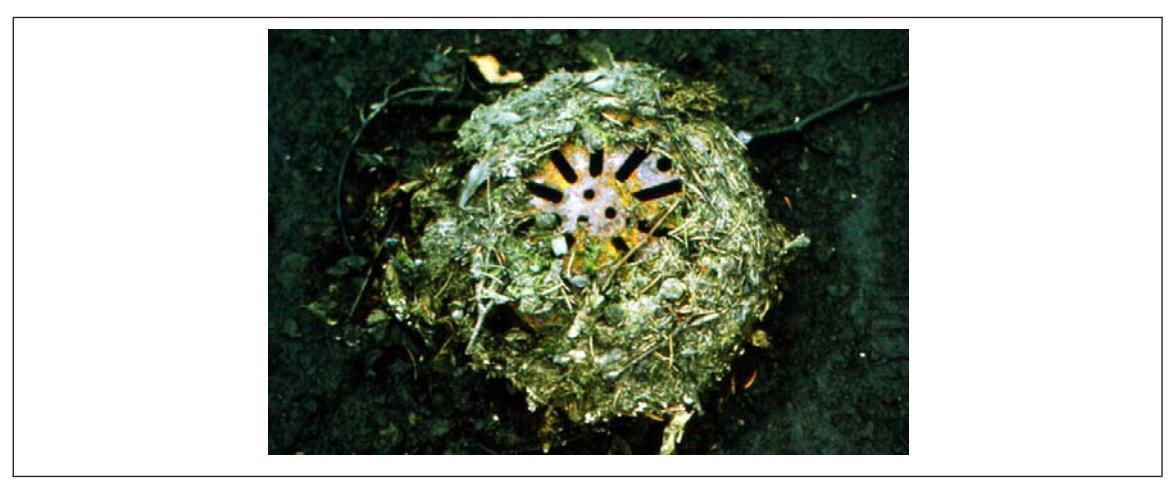
Fig. 3.1-1. Debris blocking roof drain

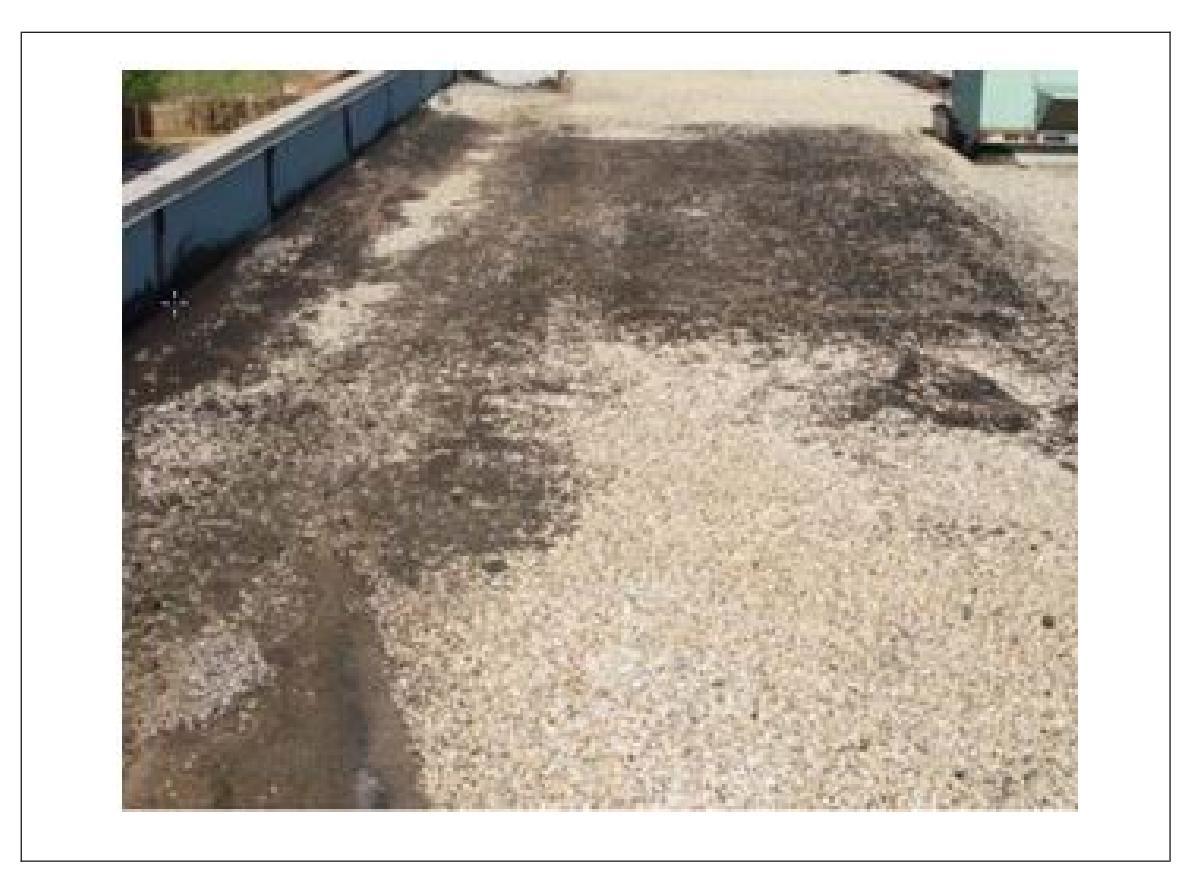
Fig. 3.1-9. Built-up roof with discolored area where water ponds (note exposed roof areas missing gravel)

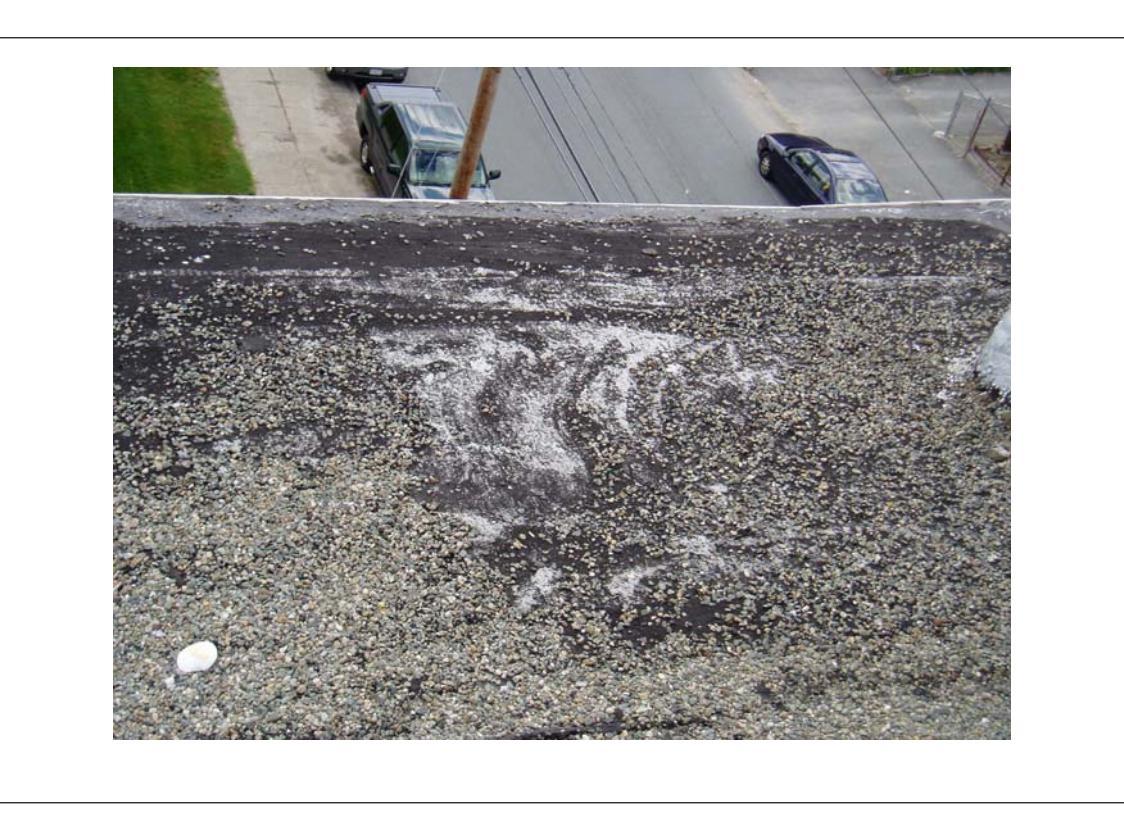
Fig. 3.1-10. Scrim showing where gravel is missing

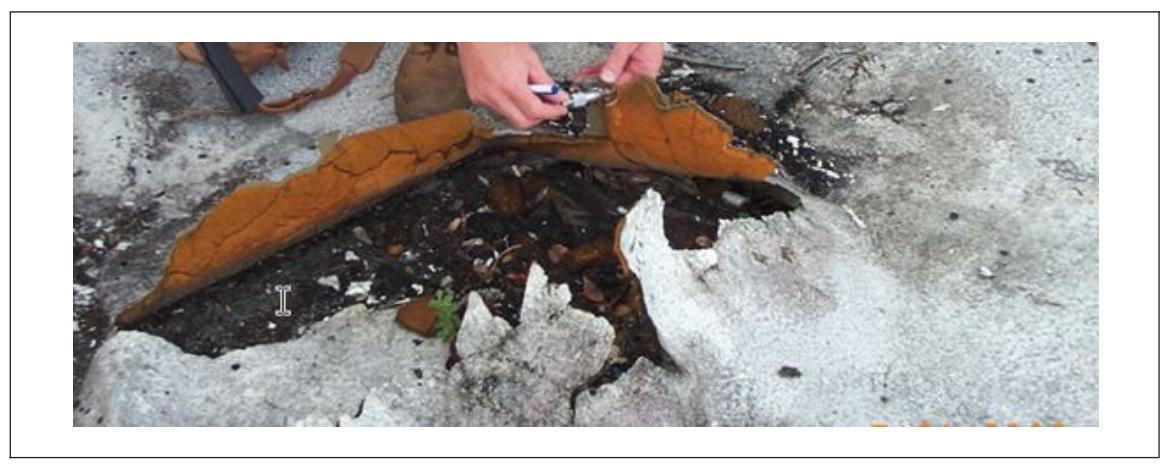
Fig. 3.1-11. Spray polyurethane foam flaking and delaminating

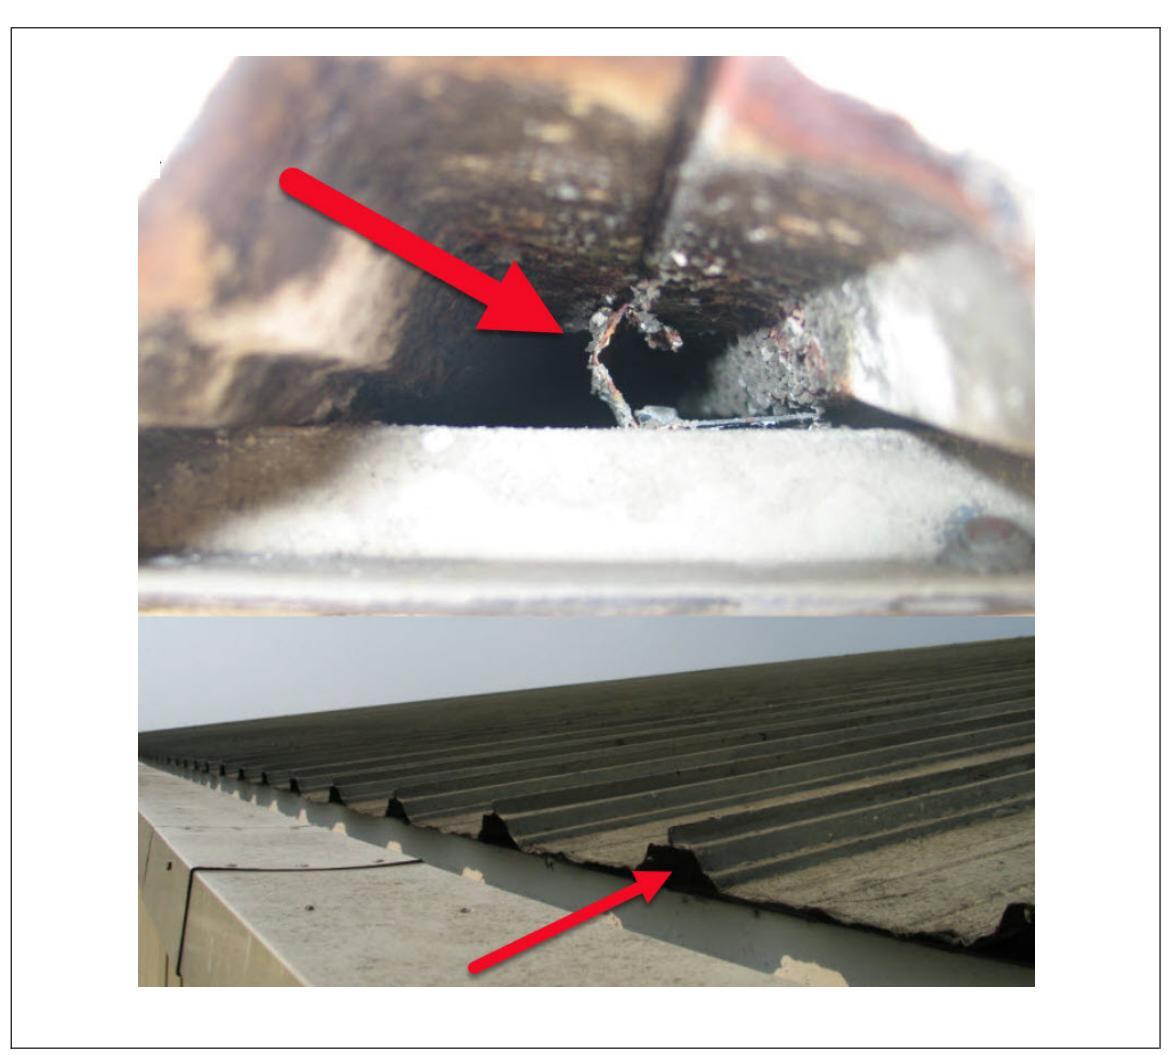
Fig. 3.1-12. Corroded and deformed roof clip on standing seam roof in coastal area
