# **J. ARONSTEIN**

## **HAZARDOUS FPE CIRCUIT BREAKERS** **AND PANELS**

*(Updated as of May 25, 2007)*

*Information for Inspectors and Homeowners*

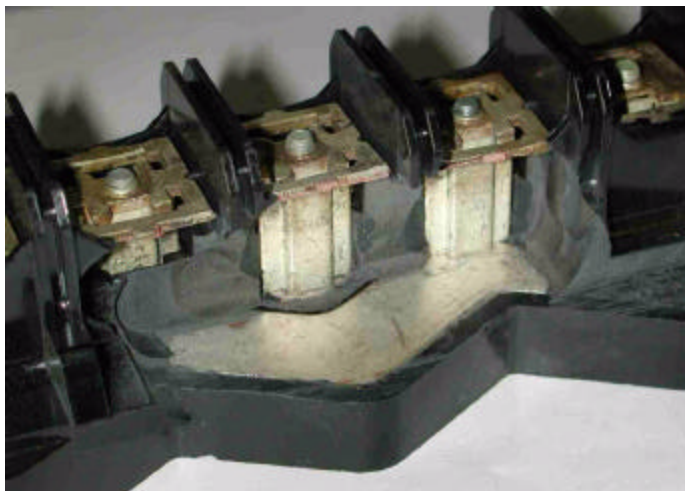
**A. Cutaway - Bussbar, Post, and Stab Socket Plate.**

A more serious failure of this type has been documented.<sup>1</sup> In that instance, the failure had been severe enough to ignite a smoldering fire on the plastic insulating material. The fundamental weakness in this design is the use of a single, relatively flimsy 8-32 screw to hold a structure together that can feed up to four half-width breakers with a total "ampacity" (rated circuit capacity) up to about 160 Amps. Figure 4 shows how the stab socket plate and post are attached to the bussbar.

**FIGURE 4 - CONDUCTING PATH FROM BUSSBAR TO STAB SOCKET**
