# FAÇADE CONDITIONS

An Illustrated Glossary  
of Visual Symptoms

**Edited by Dan Eschenasy, PE**  
Chief Structural Engineer  
NYC Department of Buildings

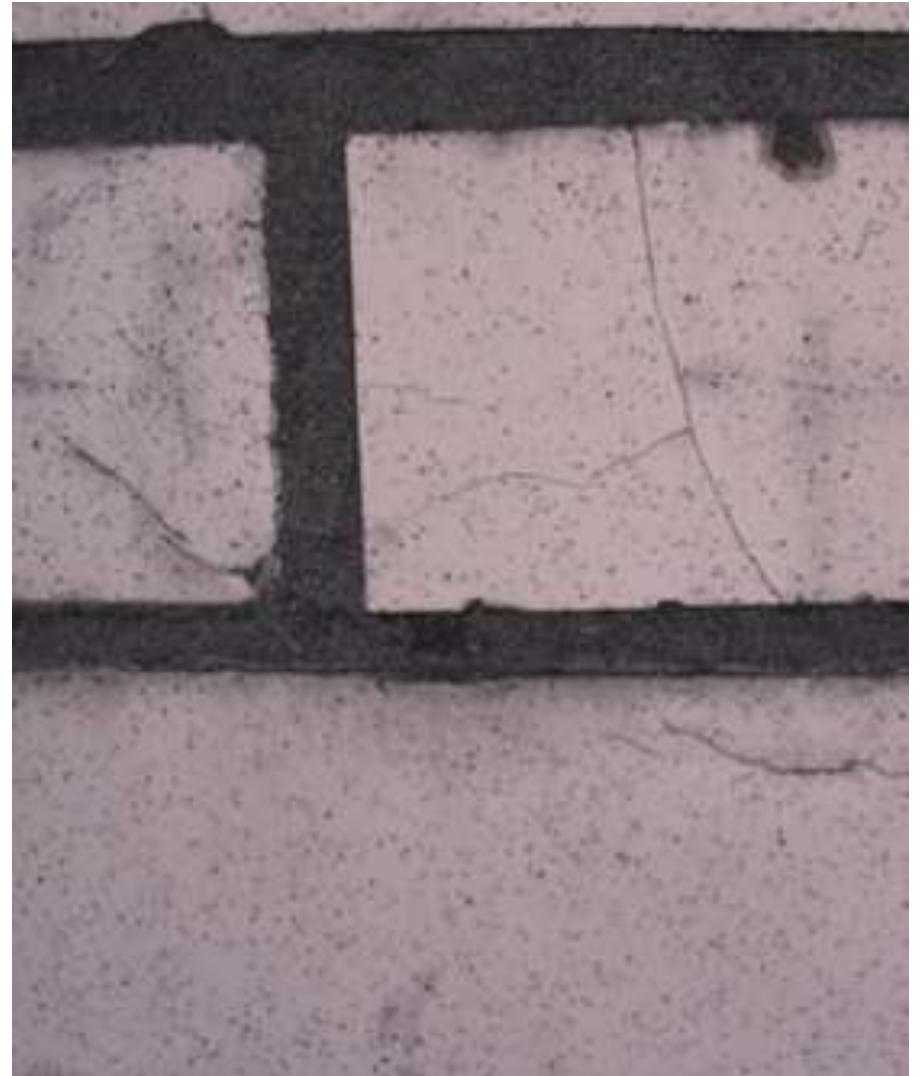
## 3.1.2 Cracks in Brick Surface

Cracks in brick surface that do not continue in mortar. Some spalling.

Freeze/thaw. Ice lensing. Usually in glazed brick. Constrained ceramic expansion. Brick with high saturation rate.

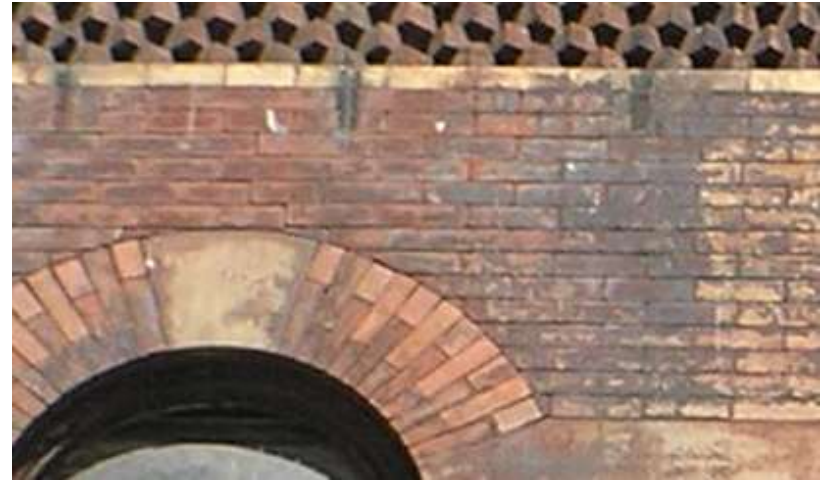
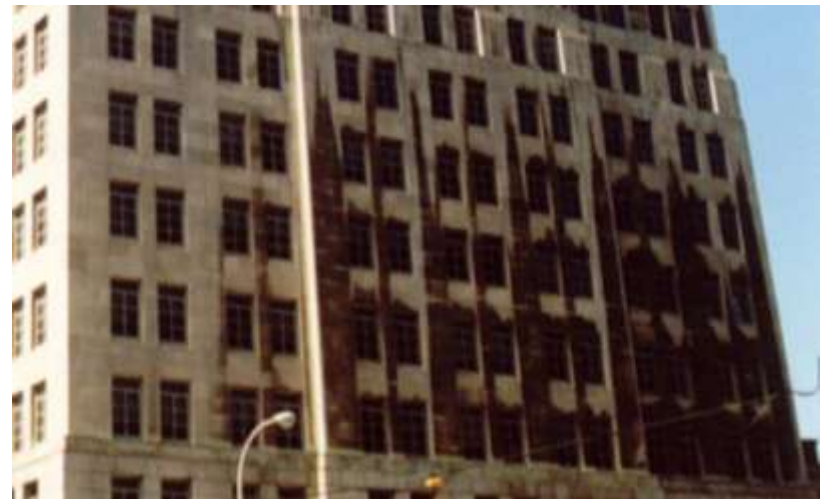
# 3.1.4 Erosion/Pitting/Abrasion of Brick Face

Poor quality of brick. Previous cleaning by sandblasting or improper cleaning.

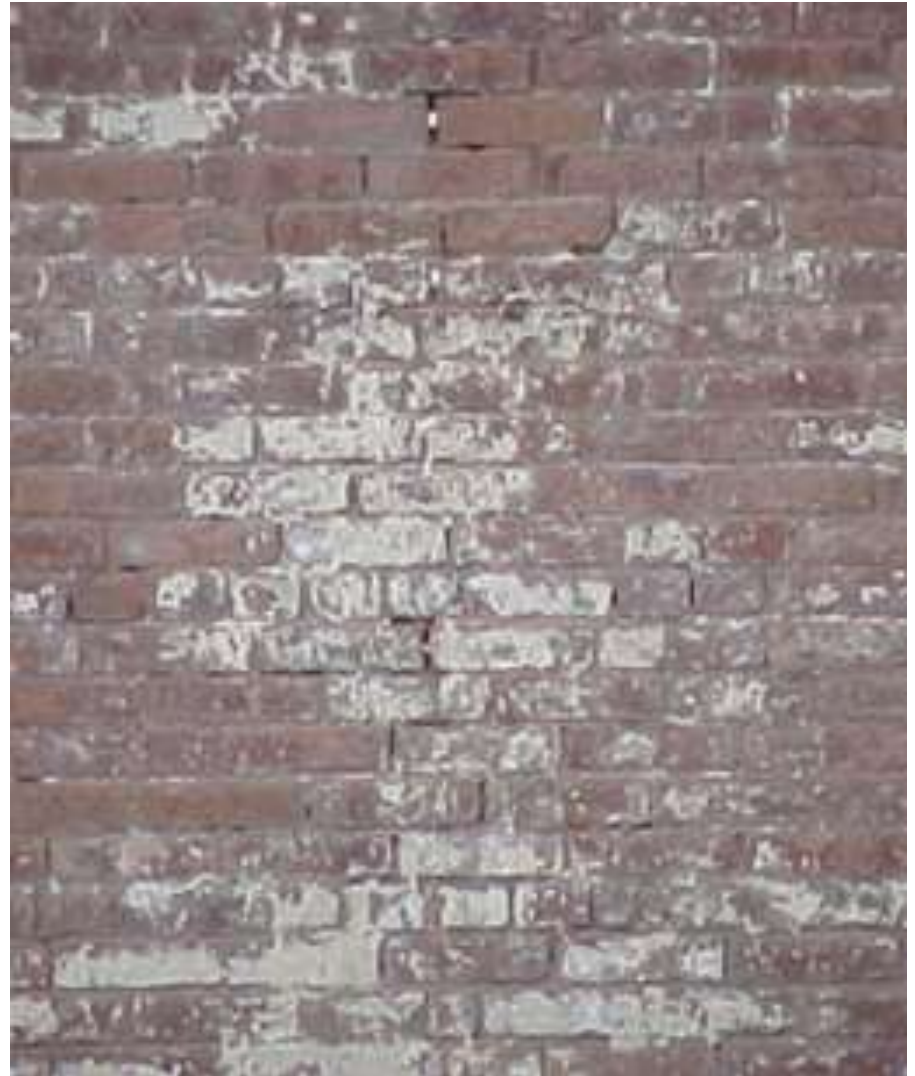
# 3.1.7 Cryptoefflorescence Spall

Migration of water thru porous brick. Soluble salts that are deposited in the mass of the brick. Cryptoefflorescence (subflorescence) increases volume from crystallization adding pressure on the brick internal structure or on the brick skin.

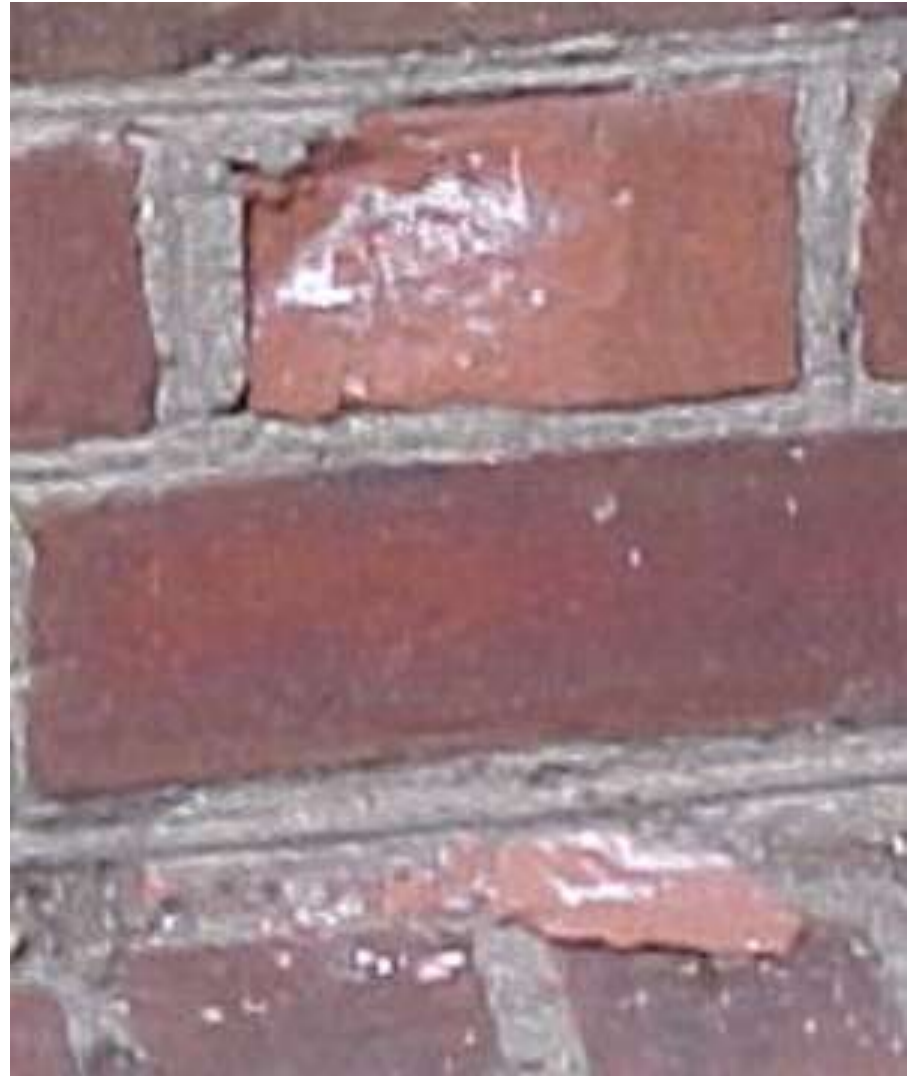
# 3.1.8 Brick Spalling/Delaminating

More common in glazed brick and coated brick where migration of water out of the brick unit is severely blocked by lack of permeability of outer layer. Freeze/thaw of entrapped water.

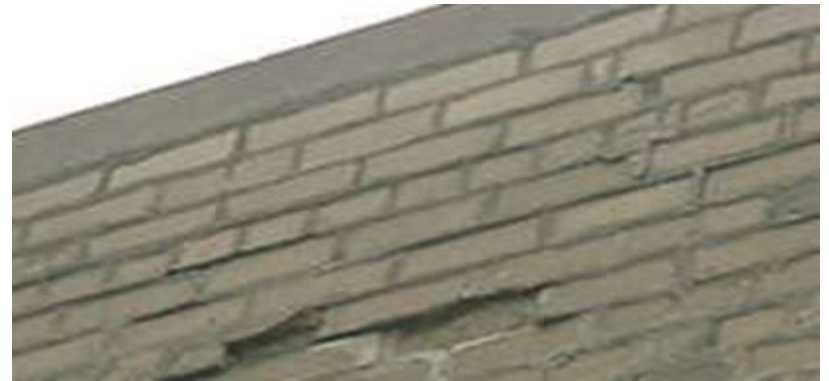
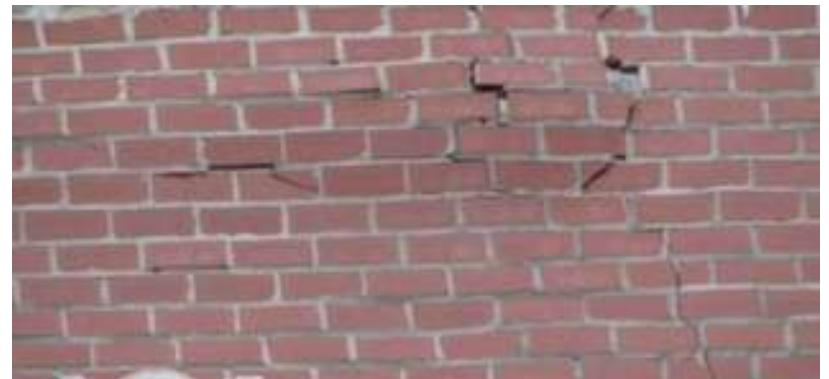
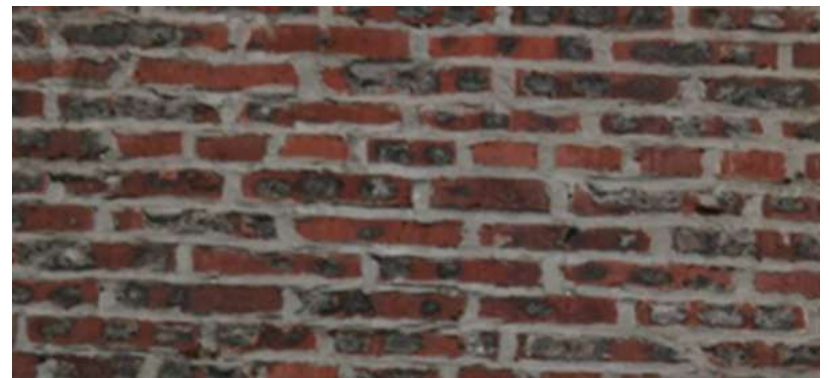
# 3.1.9 Brick Chipping/Spalling

Occurs when the brick face is under uneven local compression. (e.g. strength of pointing mortar highly exceeds strength of brick, expansion/shortening of adjoining metal, etc.). Constrained expansion of brick.

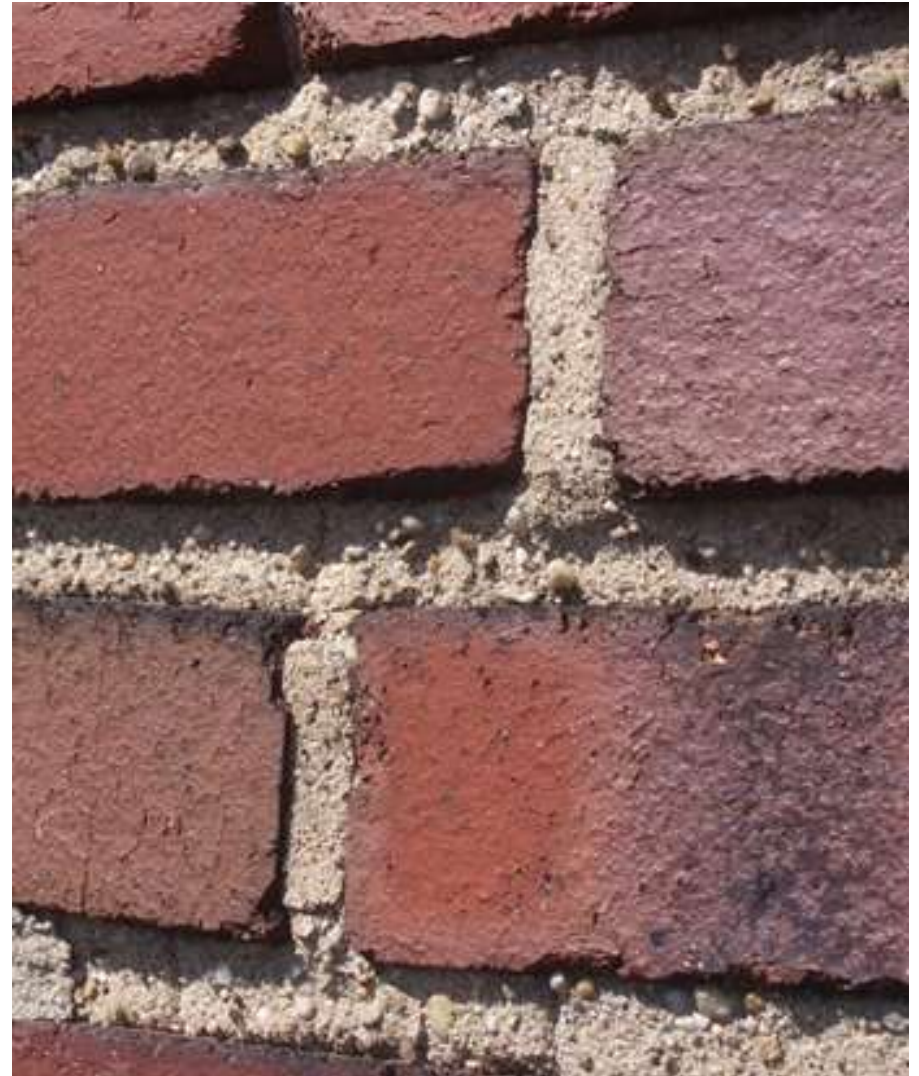
# 3.1.15 Open/Eroded Mortar Joint

Erosion due to wind or frost cycles.  
Disaggregating of lime component of the binder.

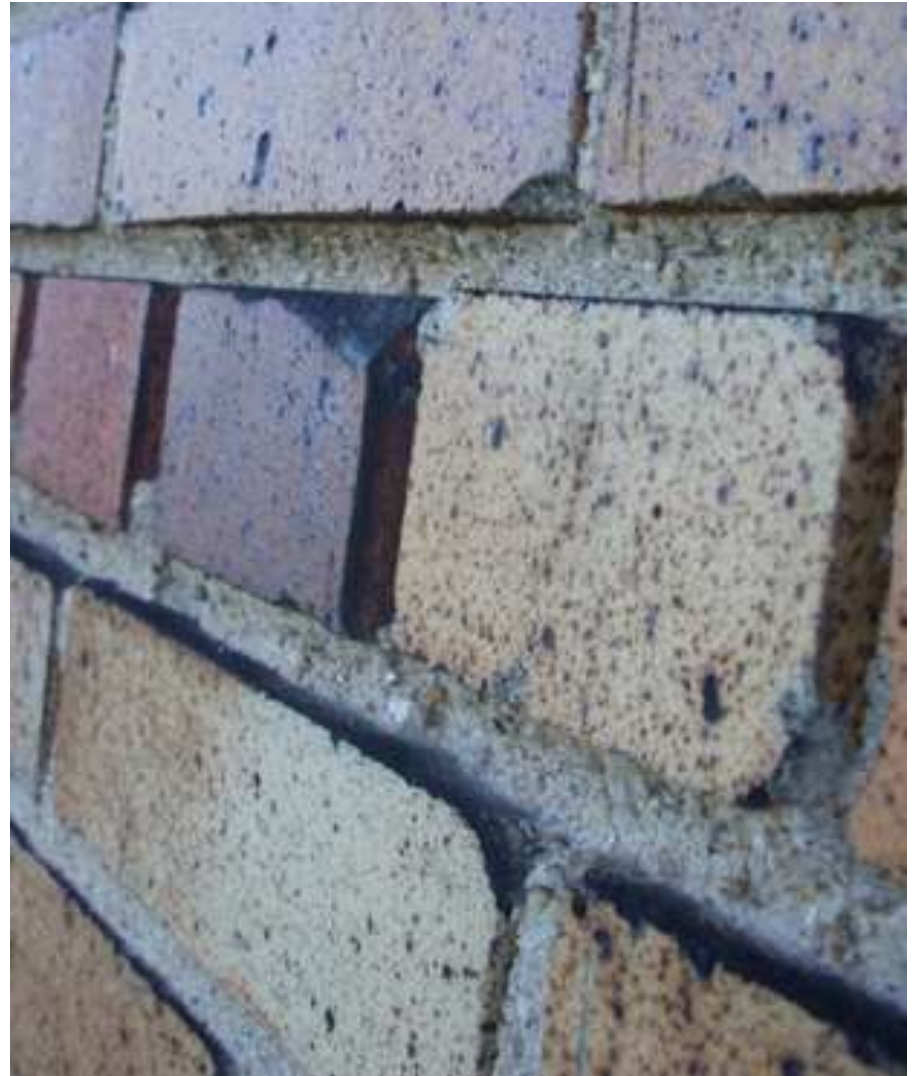
# 3.1.16 Disintegrating Joint Mortar

When mortar loses its binding function masonry is held in place only by gravity forces and friction. Friction is highly dependent on the level of humidity and the weight of elements above.

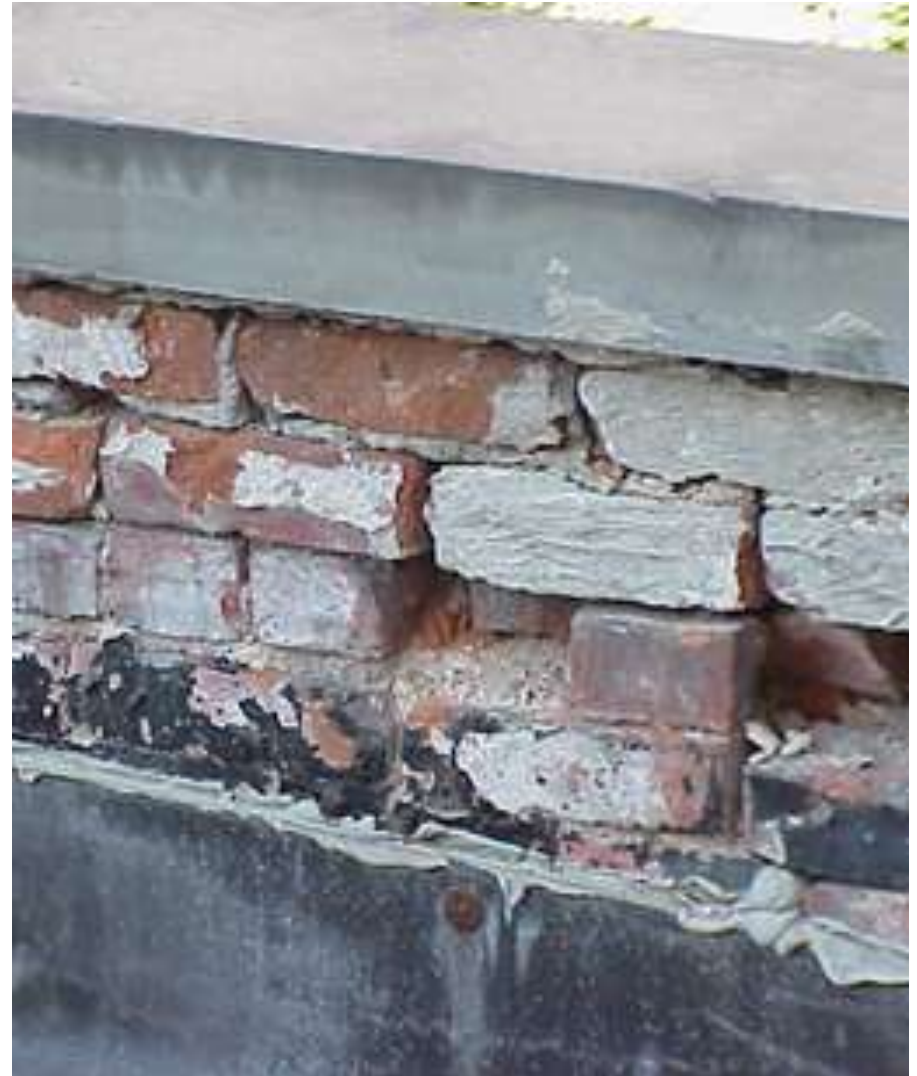
# 3.1.17 Missing Mortar From Joint

See also 3.1.16 Joint Mortar Disintegration. In some cases (extremely rare in building façade) stone might be placed dry, that is, without a mortar bed.

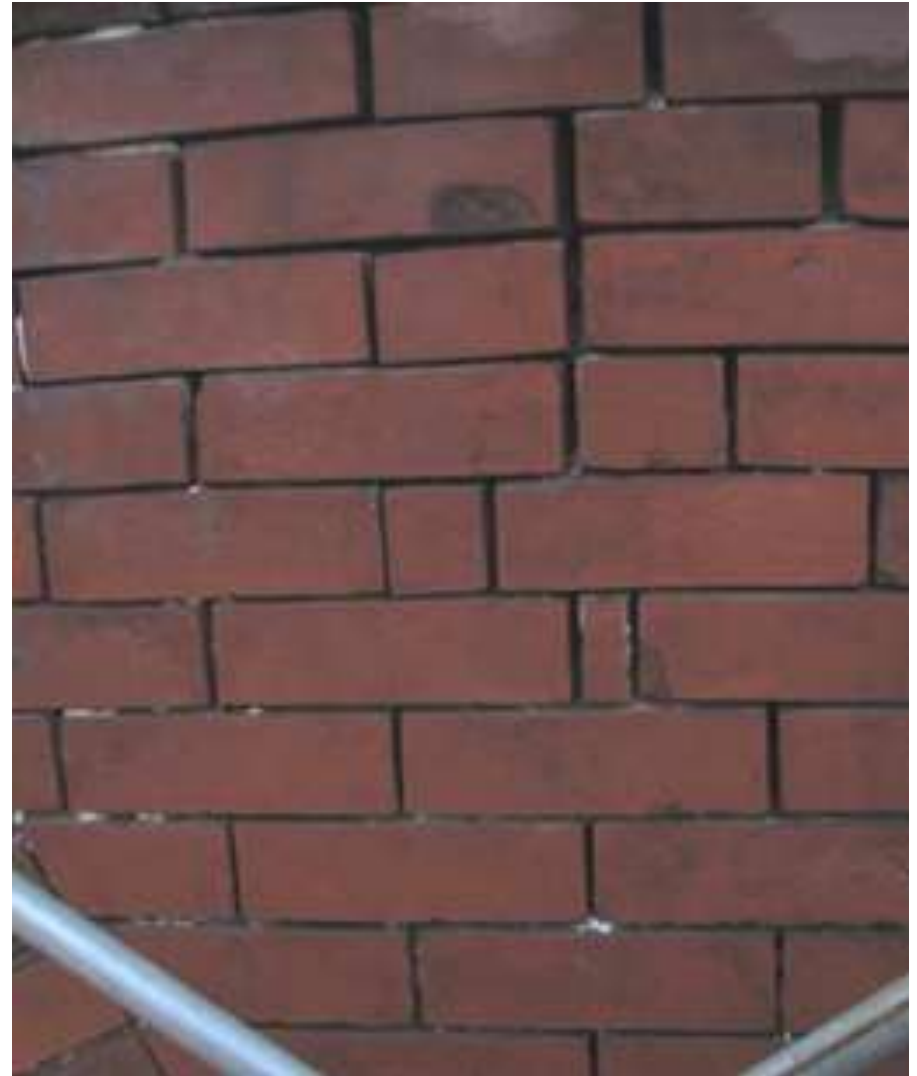
# 3.1.18 Debonding of Masonry Units

Improper initial construction (e.g. lack of wetting the brick, lack of compatibility brick/mortar). Separation occurs under minimal stresses.

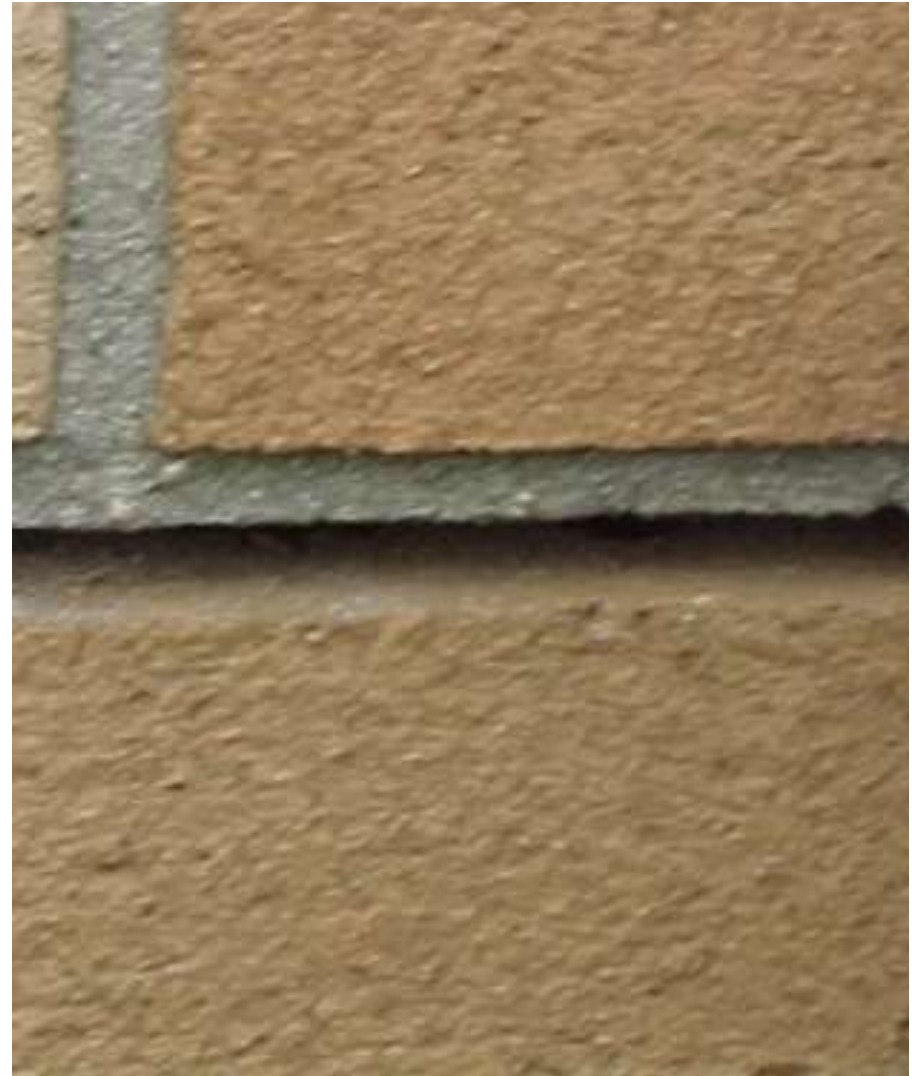
# 3.1.19 Mortar in Joint Reduced to Sand

Disintegration of mortar as a result of multiple freeze thaw cycles.

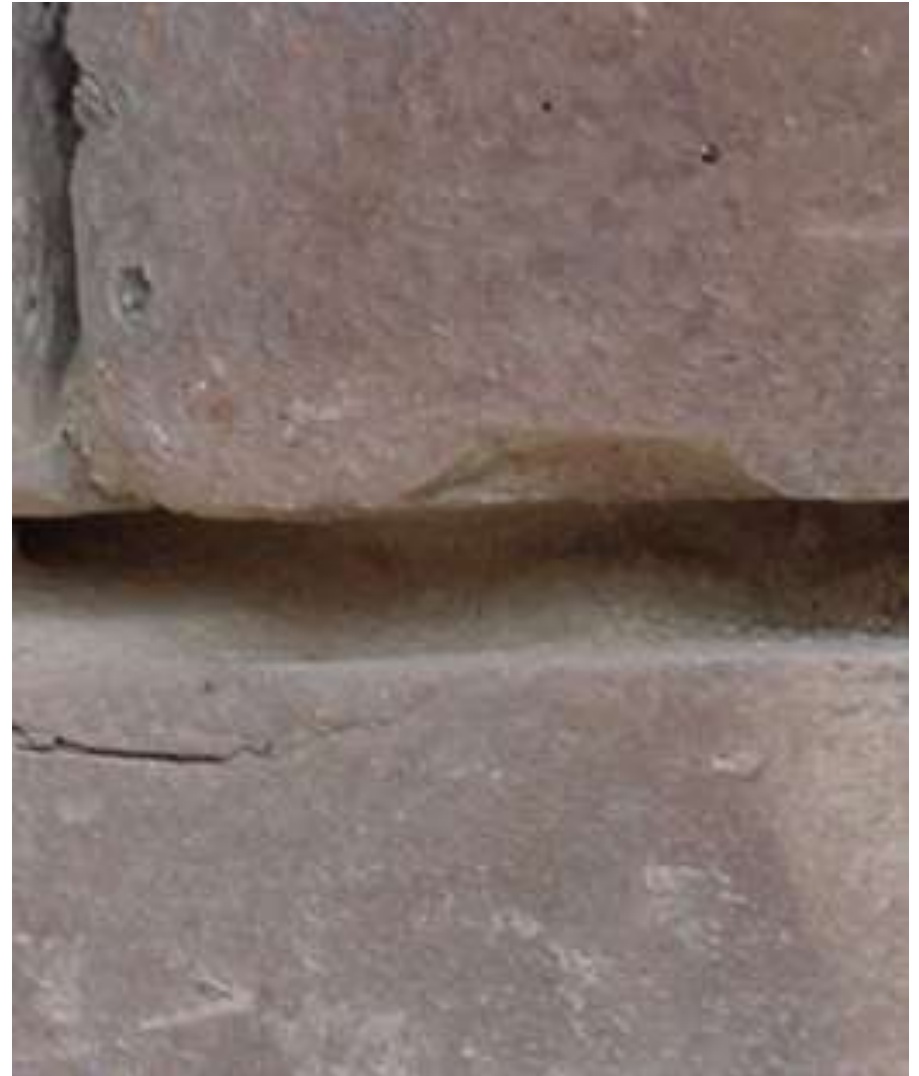
## 3.1.20 Loose/Detached Brick

Decomposition of lime binder in mortar over large periods of neglect. Cracking/debonding of mortar followed by successive cycles of icing/thawing.

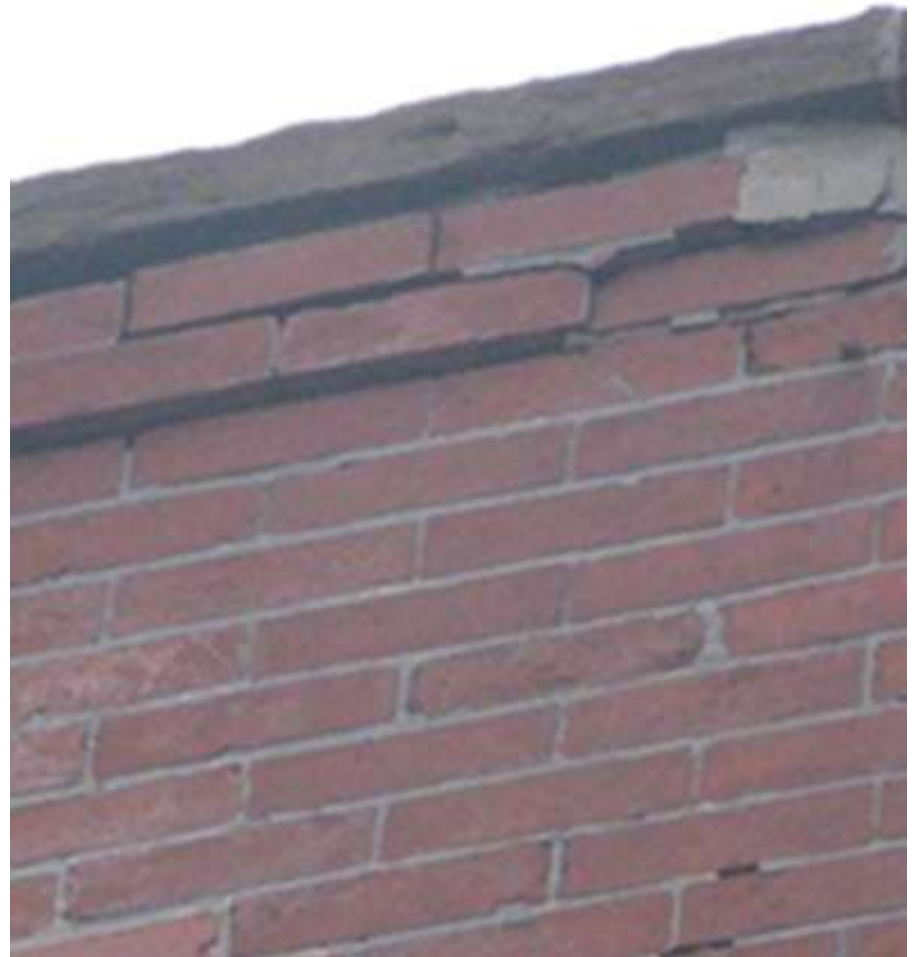
# 3.1.21 Improper Joint Repair (Pointing)

Lack of compatibility of existing and  
repair mortar, lack of sufficient depth  
of repointing.

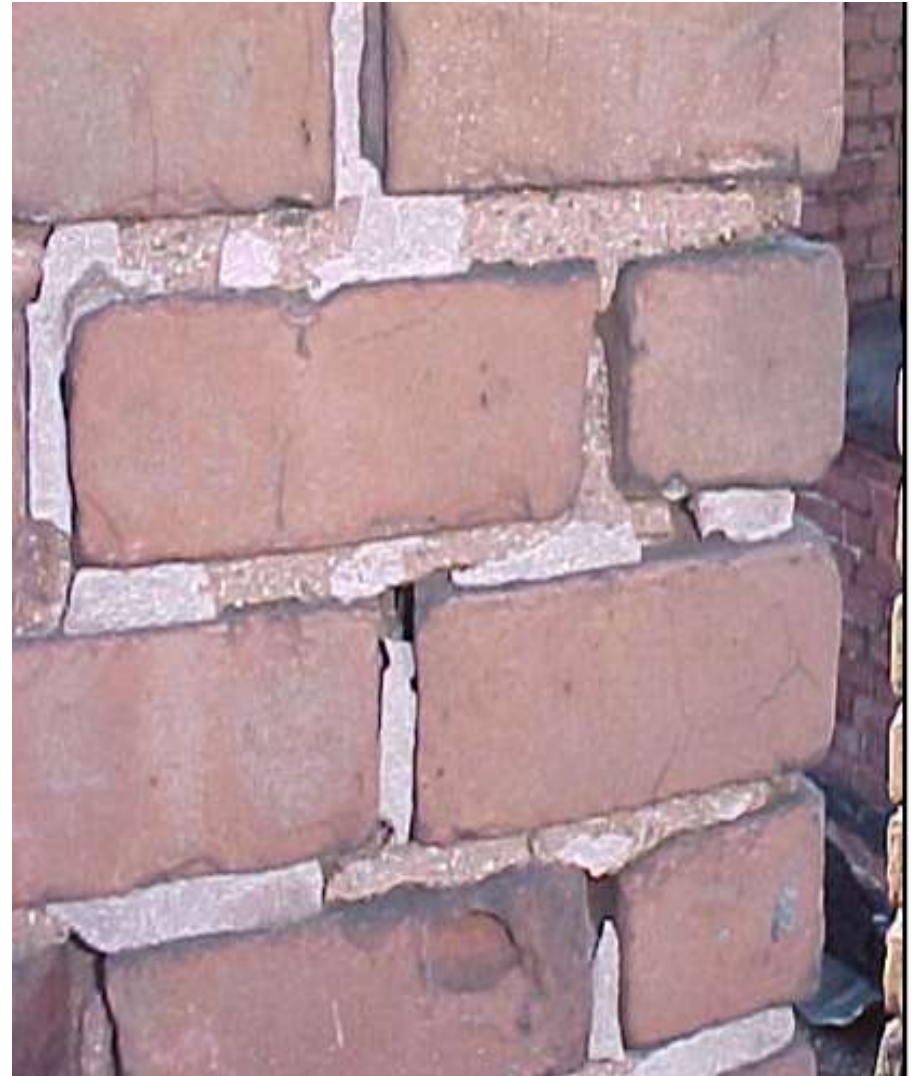
## 3.1.22 Lime Run

Soluble calcium carbonate deposits.  
Formation of lime run requires large quantities of water passing thru the crack or opening.

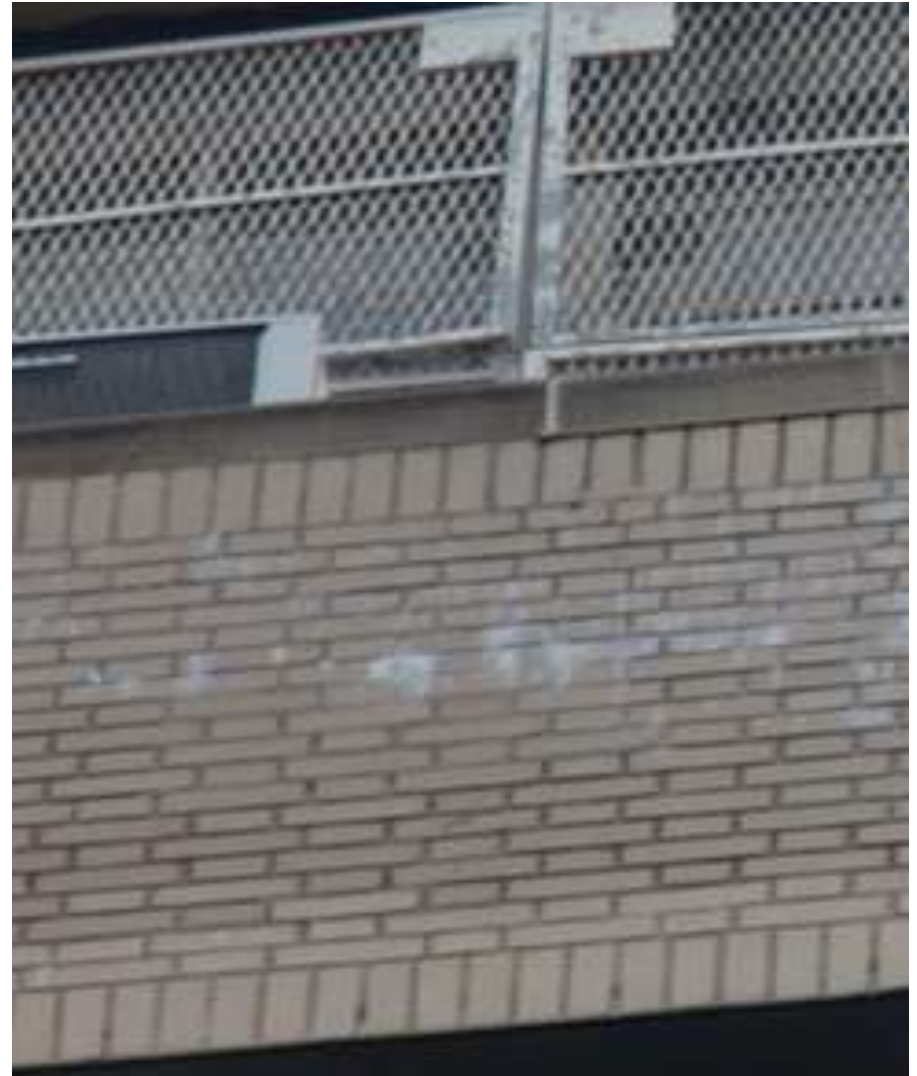
# 3.1.23 Eroded/Missing Mortar in Stone Joint

Acceleration of deterioration due to water ingress.

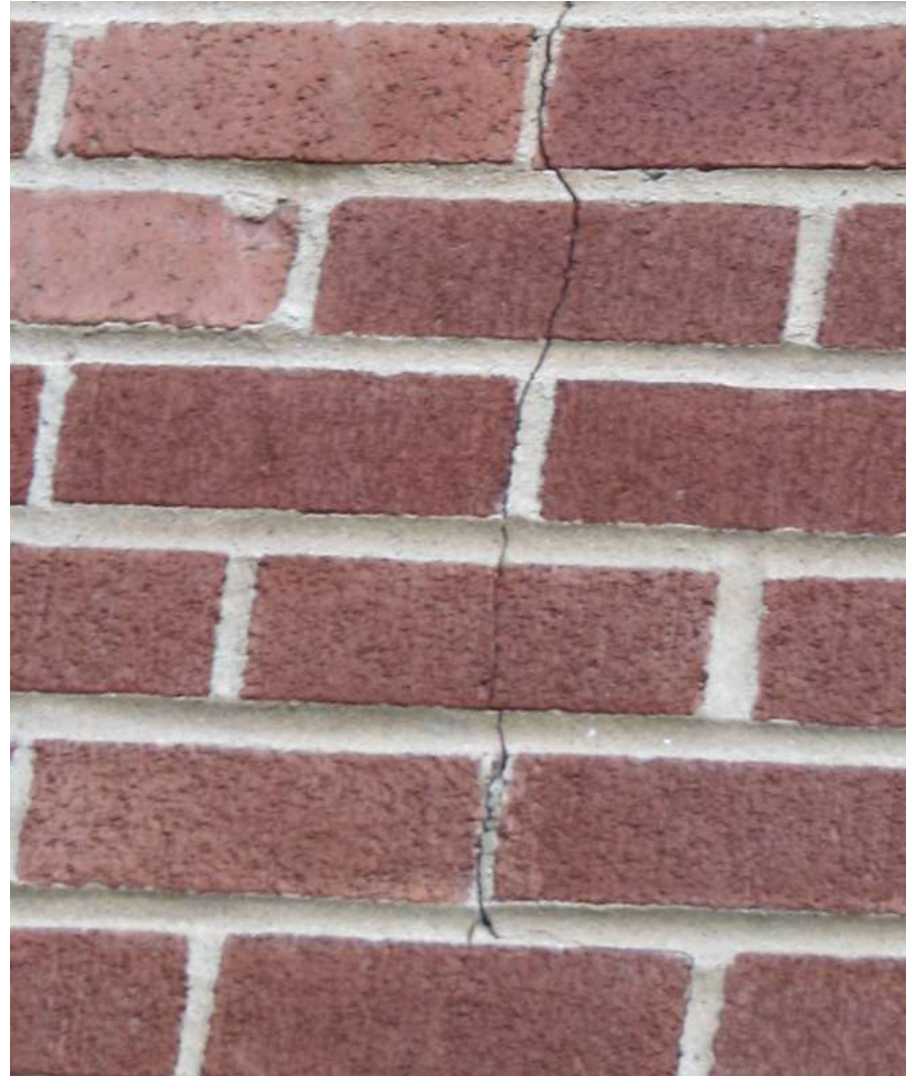
## 3.1.25.b Slight Vertical Crack in Masonry

Cracks are always the result of stresses in masonry that exceed resistance of brick or mortar or both. See various type of wall construction for specifics.

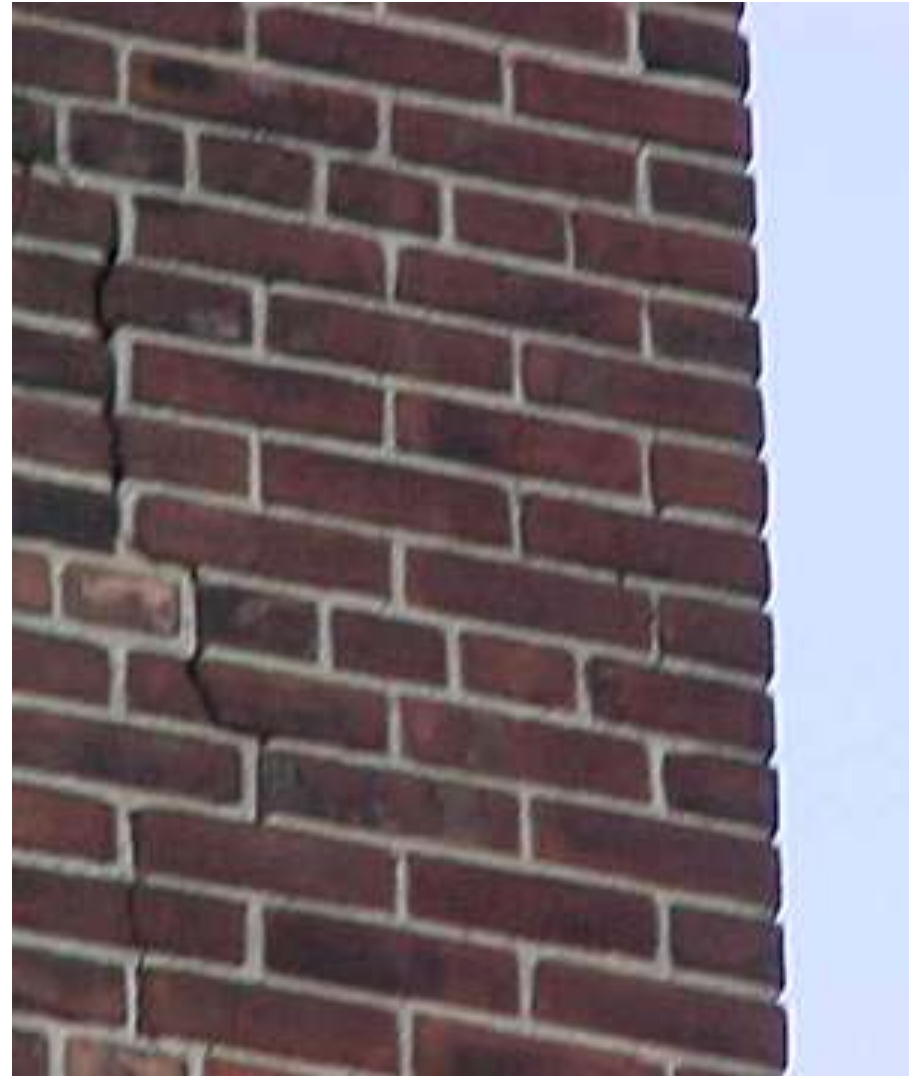
# 3.1.25.c Large Vertical Crack in Masonry

See various type of façade systems for specifics.

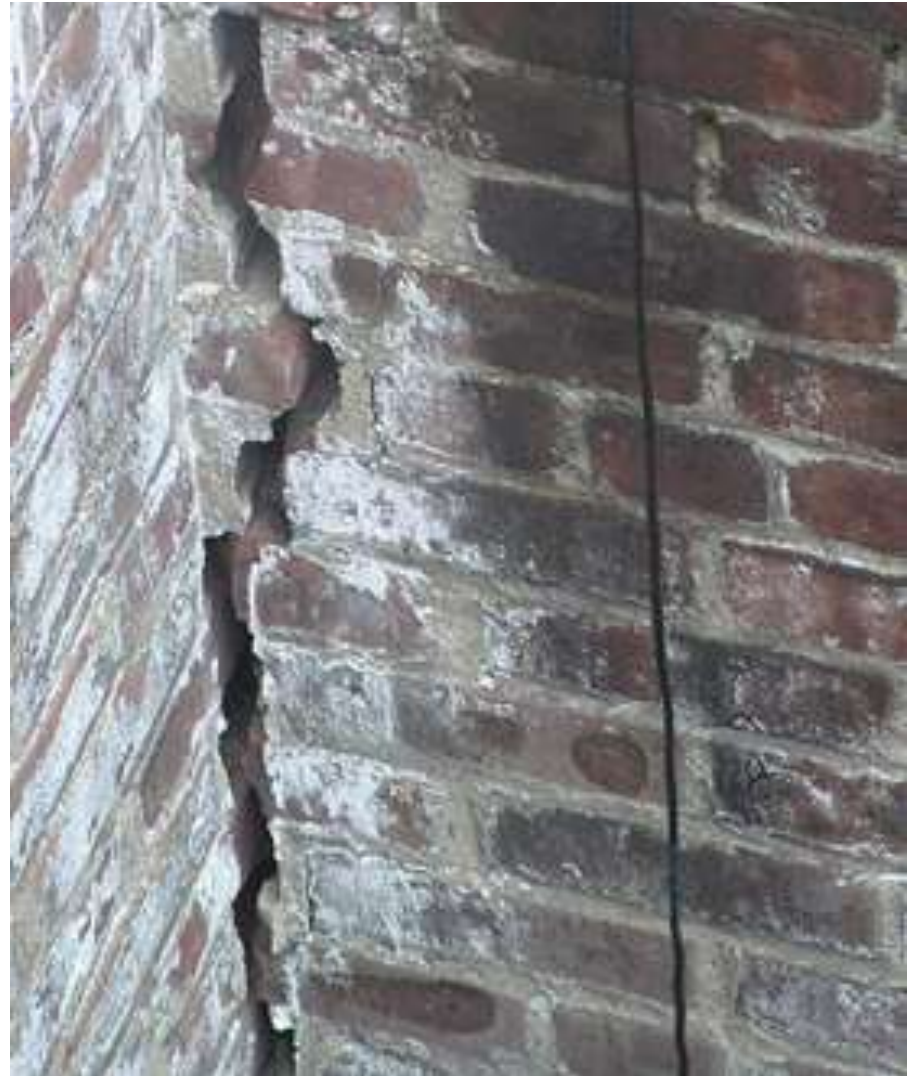
# 3.1.25.d Crack in Masonry Unit Only

Might represent an incipient condition at the surface of the masonry unit due to composition of brick. Significant difference between properties of brick and mortar.

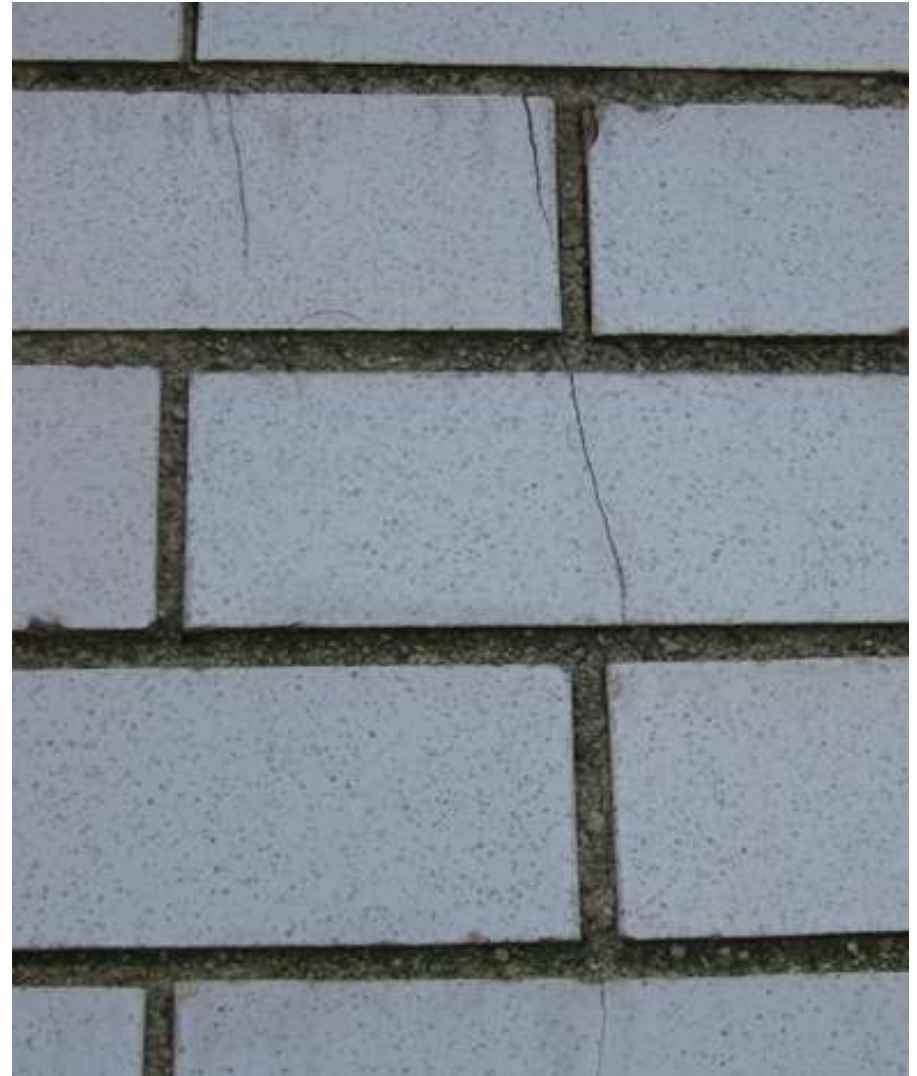
# 3.1.26.a Longitudinal Crack – Joint Only

The bond between the unit and the mortar is usually the weakest component of brick masonry. Horizontal cracking or debonding is usually the result of failure under tensile stresses.

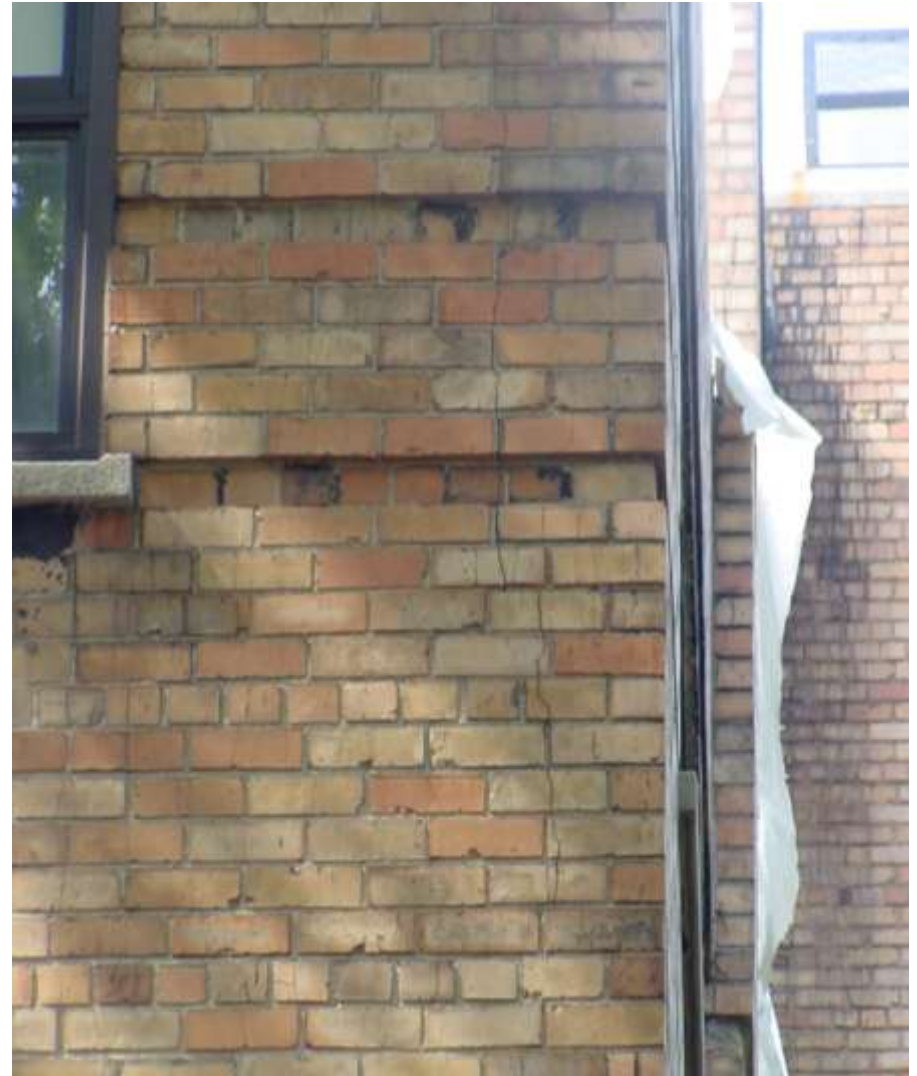
# 3.1.26.c Stepped Crack in Masonry Joints

Cracks are always the result of stresses in masonry that exceed resistance of brick or mortar or both. See various type of wall construction for specifics.

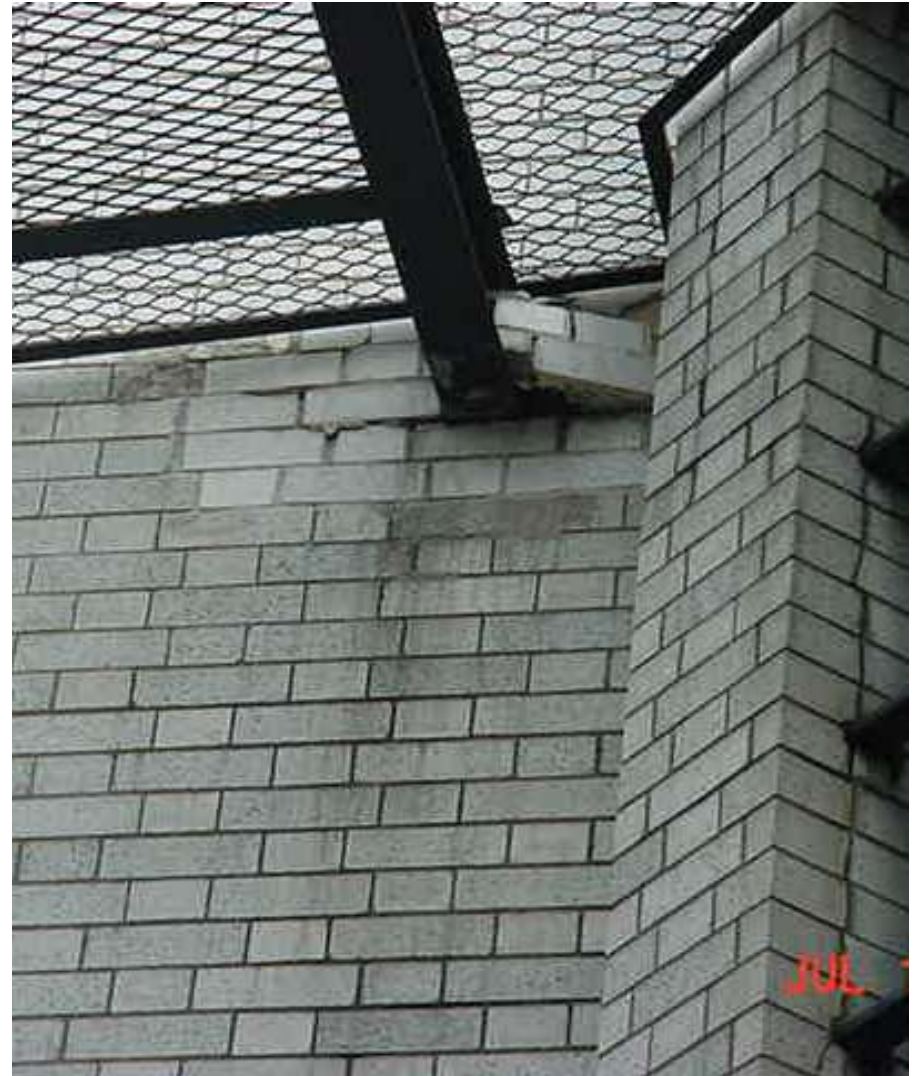
# 3.1.29 Loose Masonry

Unattached chunks of masonry. Masonry areas separated by cracks all around.

***Probable Causes/Deficiencies:***

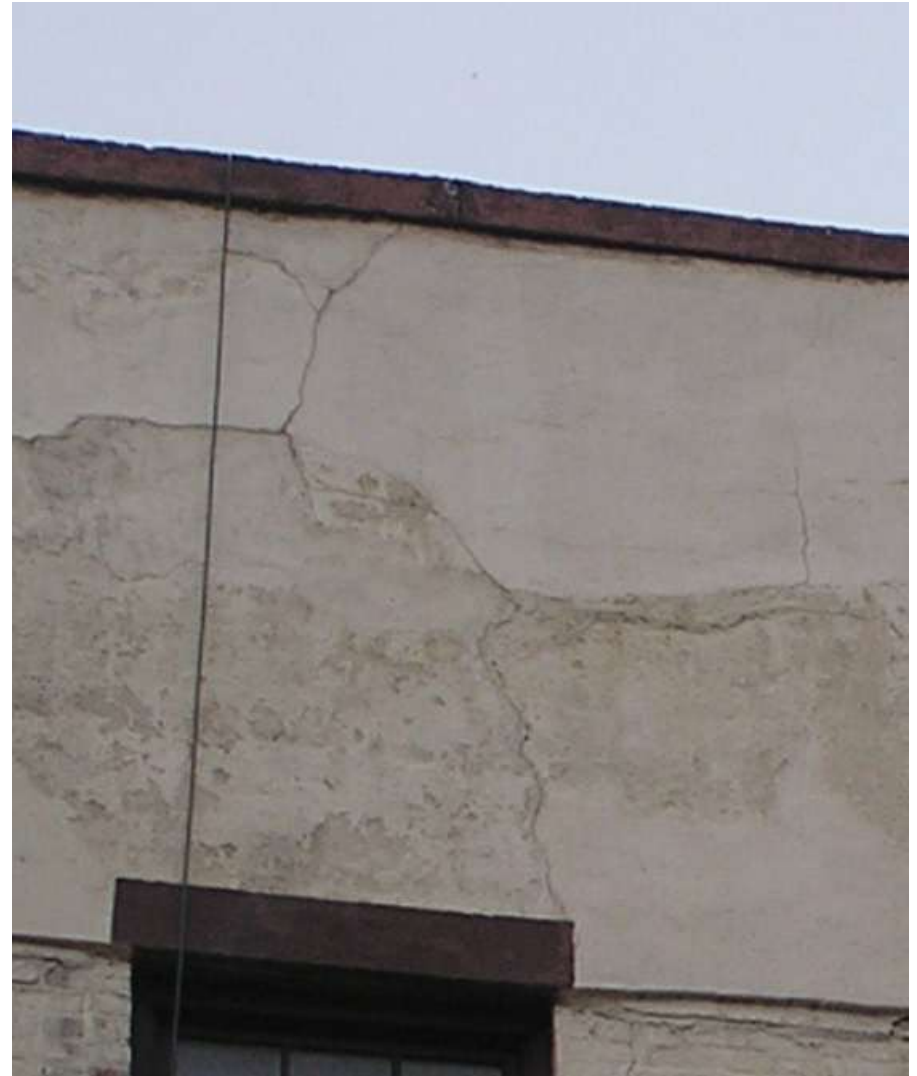
# 3.1.30 Crack in Stucco over Masonry

Size and direction of crack. Thickness of stucco layer. Presence of bulges. Condition of back-up masonry.

Check masonry condition/problems. Differential thermal movement and elasticity of stucco versus underlying masonry. Stucco cracks might reflect cracks in supporting masonry.

Relationship to crack in base material. Without removing the stucco it is difficult to determine if it had developed only in the rendering or it mirrors a crack in the base masonry.

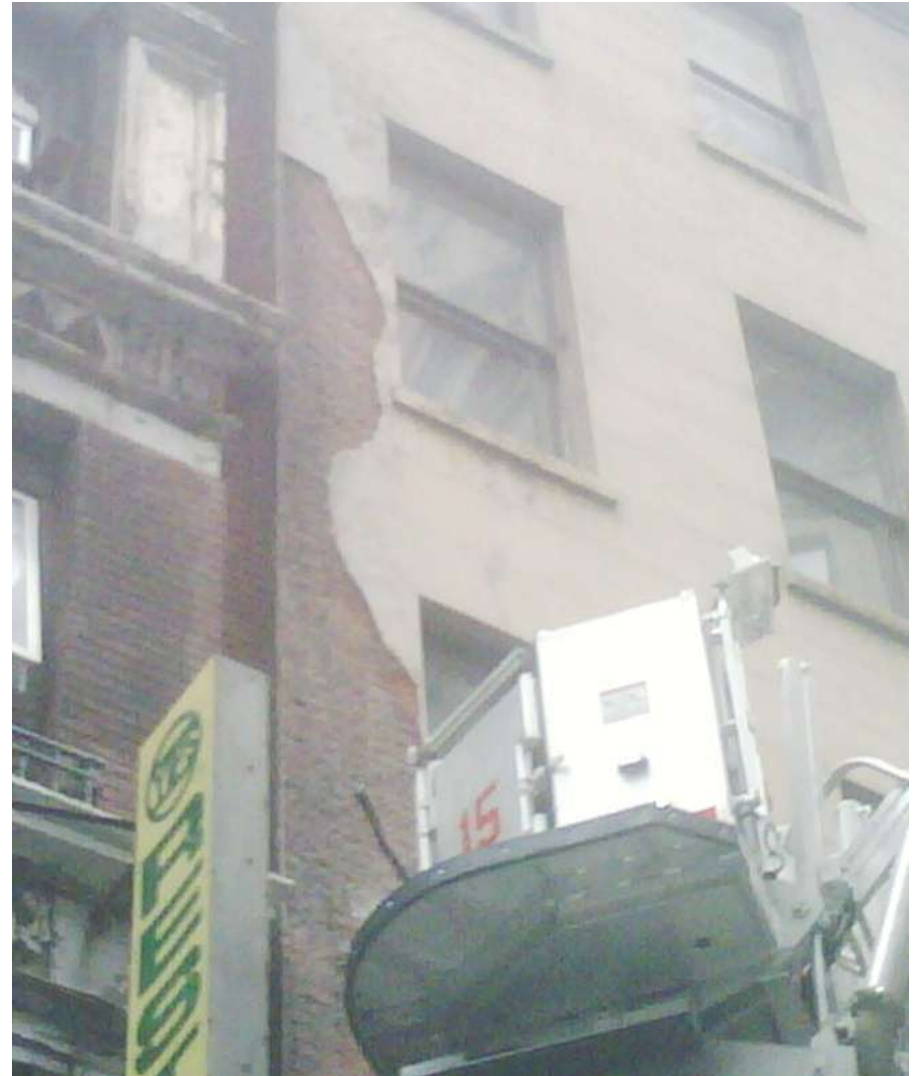
# 3.1.31 Crack and Debonding of Stucco from Masonry

Size and direction of cracks. Thickness of stucco layer. Bulging and separation of stucco layer.

Failure of adherence between stucco and back-up system. Failure of underlying masonry skin. Build-up of water and pressure at the interface of brick and stucco.
