# FAÇADE CONDITIONS

An Illustrated Glossary  
of Visual Symptoms

**Edited by Dan Eschenasy, PE**  
Chief Structural Engineer  
NYC Department of Buildings

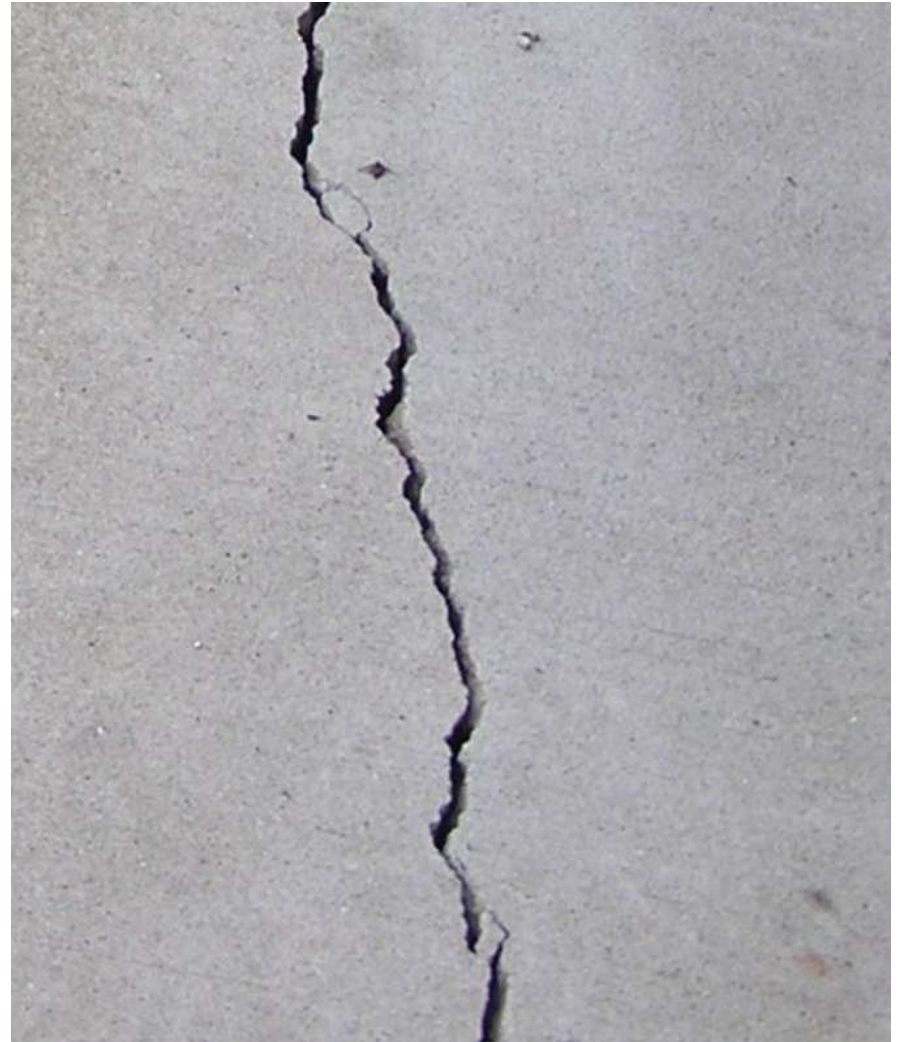
## 3.2.1 Cracks in Reinforced Concrete

Common causes of cracks in concrete are structural or thermal overstress. In exposed façade concrete, cracks are most usually the result of the corrosion of the reinforcing bars. Reinforcing bars not sufficiently protected by the depth of concrete cover, are likely to corrode. Corrosion might be accelerated by the chemical composition and carbonation of the concrete. Subjected to “rust jacking”, concrete will crack or spall. Whatever the originating cause, once cracking starts, it will allow increased water penetration. Consequently corrosion will accelerate. Icing of the rainwater standing in the crack will also contribute to an increase of the crack’s opening.

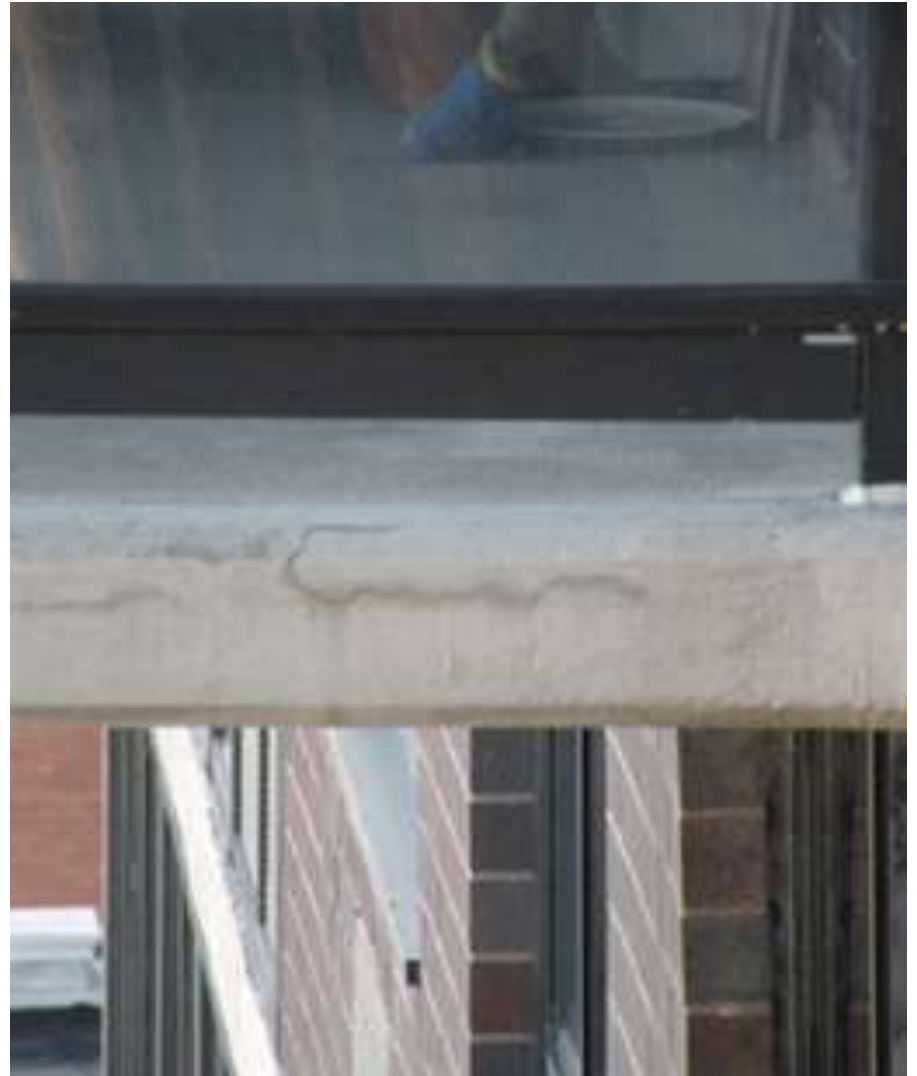
## 3.2.1.a Hairline Crack

Hairline or thin cracks with opening less than 1/32". Barely perceptible.

Incipient reinforcing bar corrosion. When cracks develop early after the concrete pour they may be the result of shrinkage due to improper placement or concrete mix.

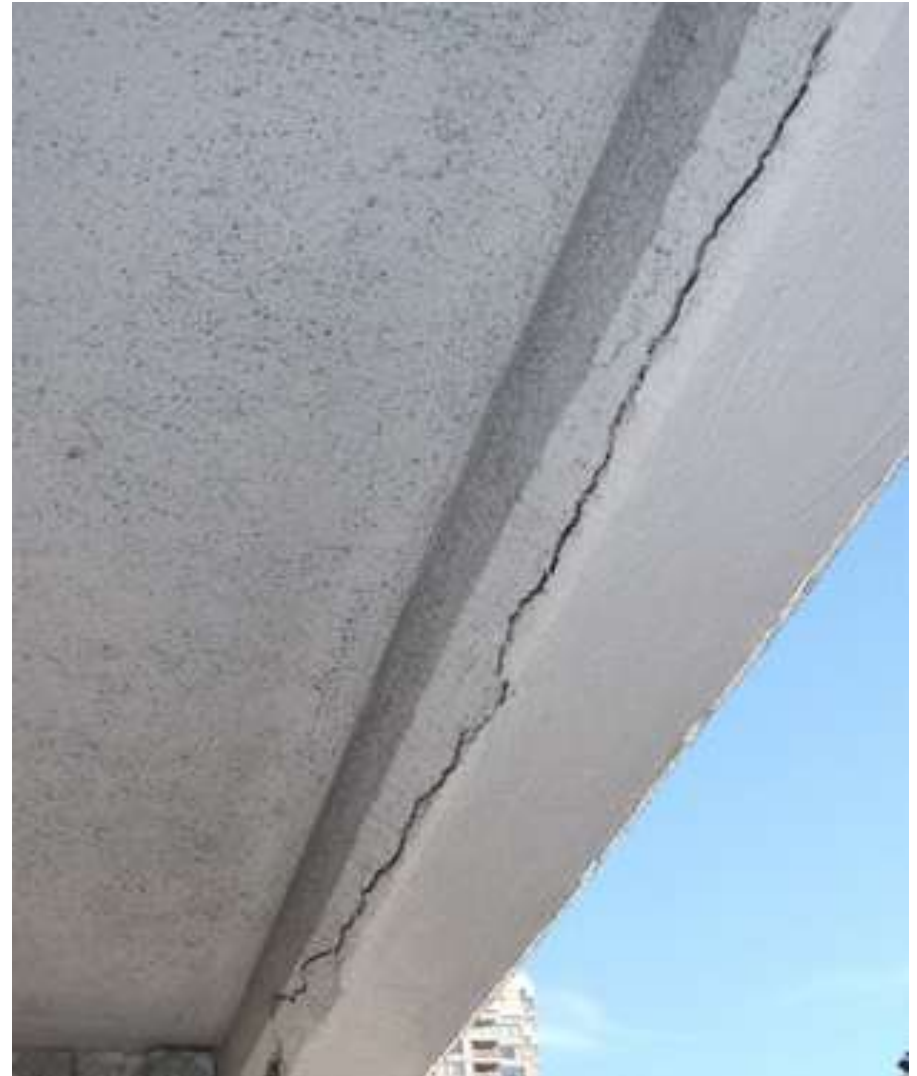
## 3.2.1.b Slight Crack

Surface cracks around openings, spandrels, edges and floor lines. Slight (Small) cracks are those with opening between 1/32" and 3/16". Rust stains.

When the crack follows direction of reinforcing bar it is the result of "rust jacking". It is usually a worsening of a thin crack .

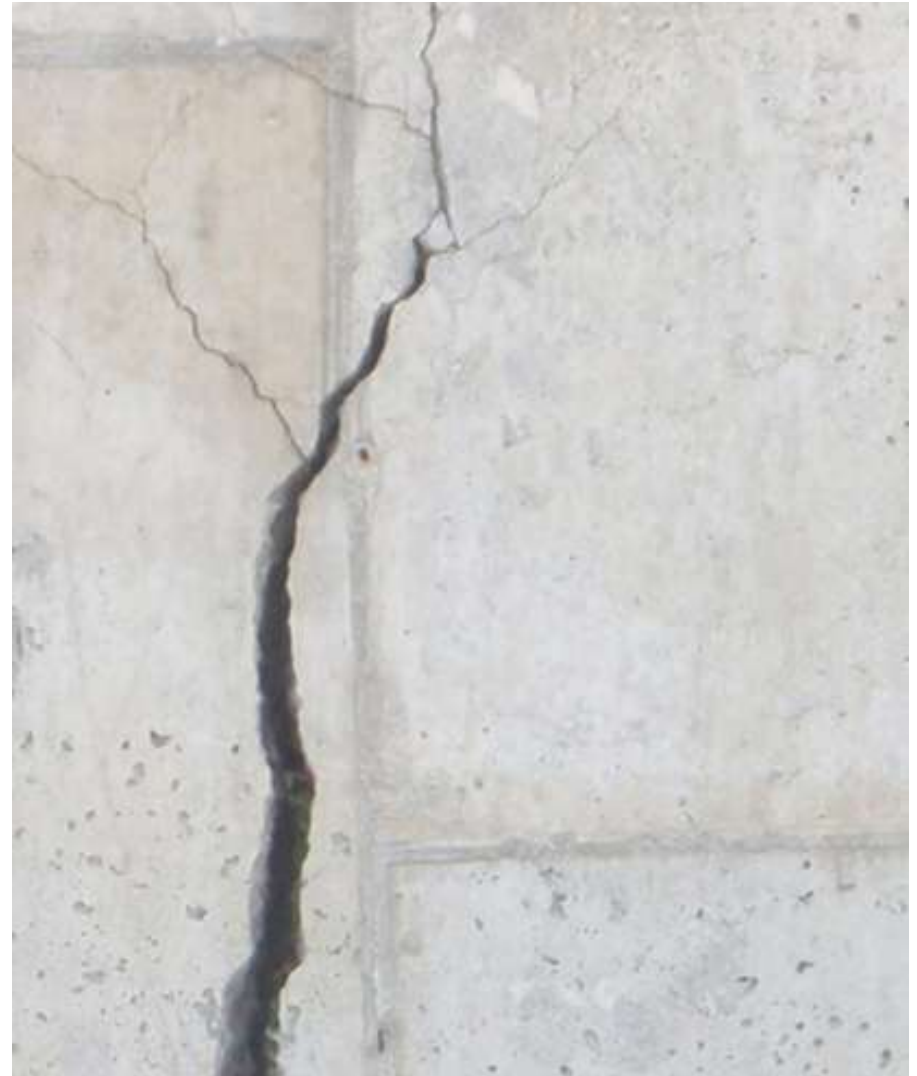
## 3.2.1.c Large Crack

Cracks larger than 3/16" in concrete surface, around openings, spandrels, edges and floor lines.

Excessive corrosion of embedded steel structural shape or reinforcement.

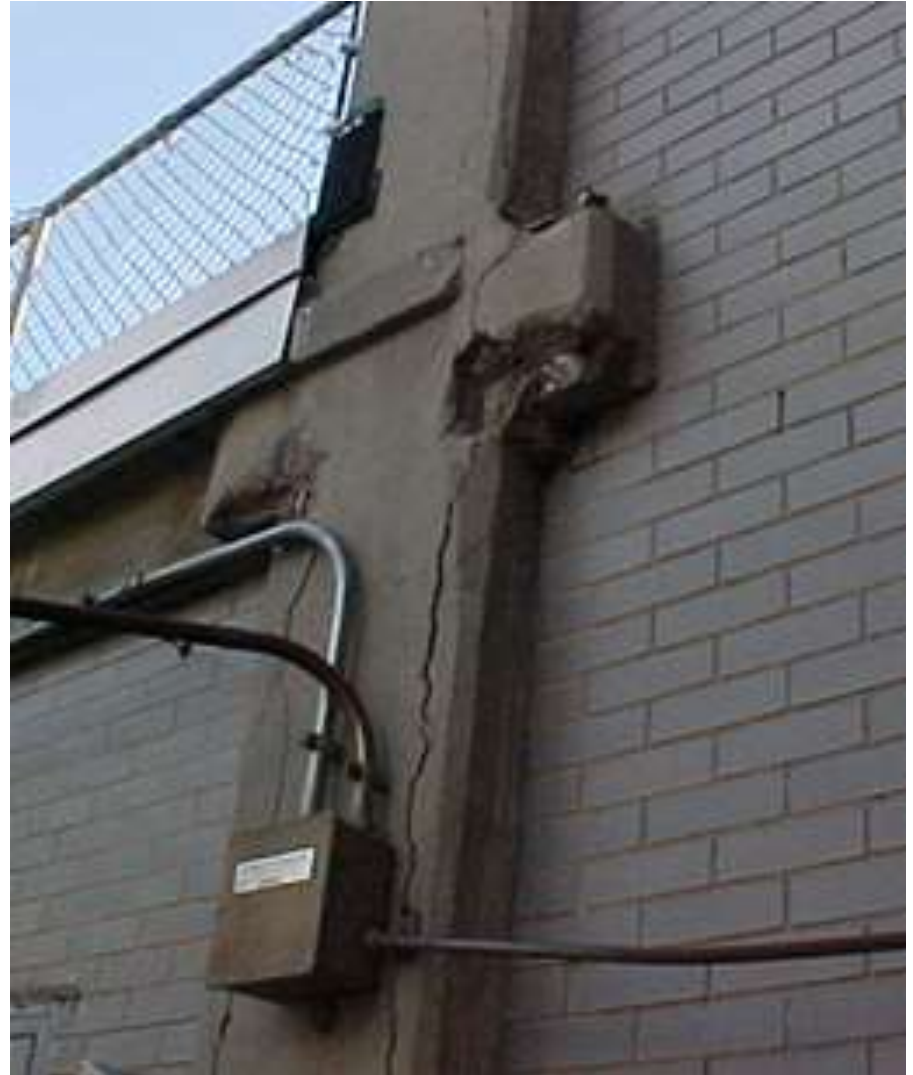
## 3.2.2 Crack and Spall of Concrete Around Steel Member

Cracks of various sizes along concrete cover of exterior steel columns, steel spandrel beams or lintels.

Rust jacking following corrosion of steel element. Usually steel member has structural function.

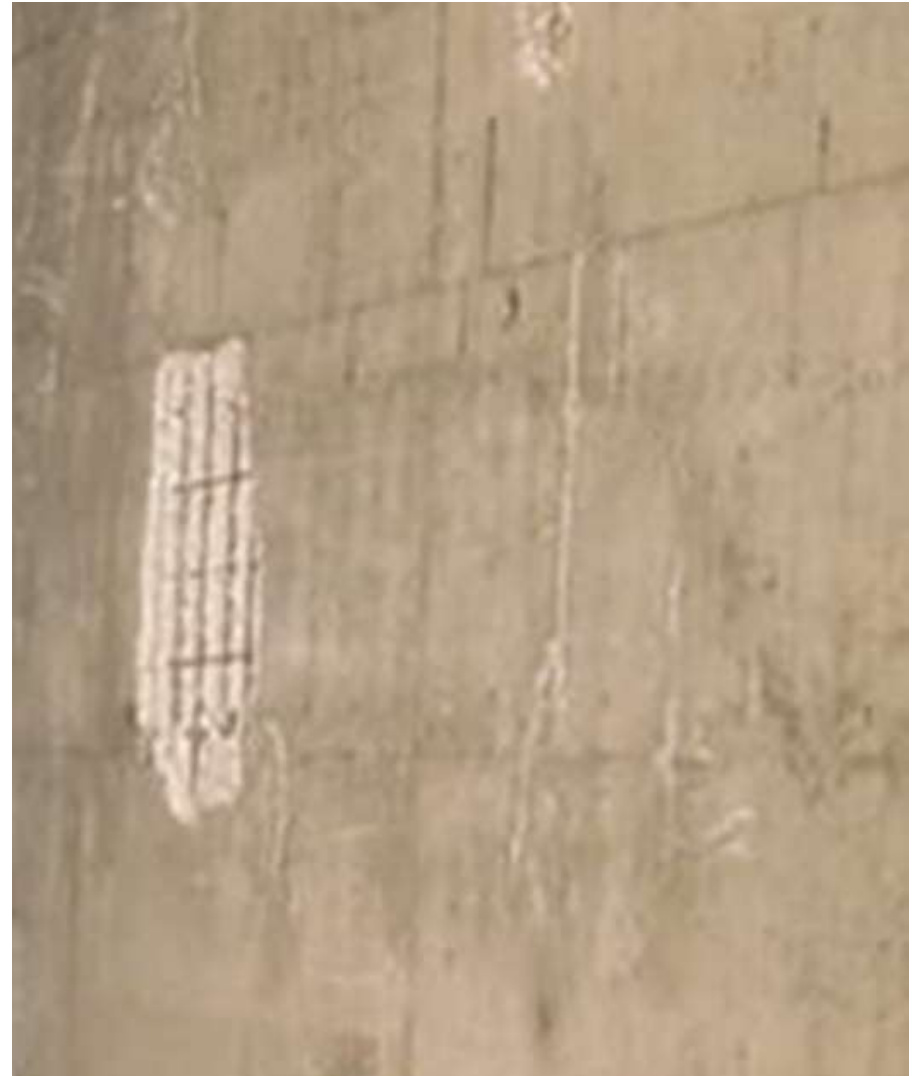
# 3.2.3 Delaminating Concrete Over Reinforcement

Splitting/separation of concrete surface exposing reinforcing steel. Cracking of concrete surfaces in an isolated area with defined borders.

“Rust jacking”. Excessive local corrosion of reinforcing or embedded steel. Lack of sufficient protection against corrosion. Poor quality concrete and/or concrete or rebar placement (insufficient cover).

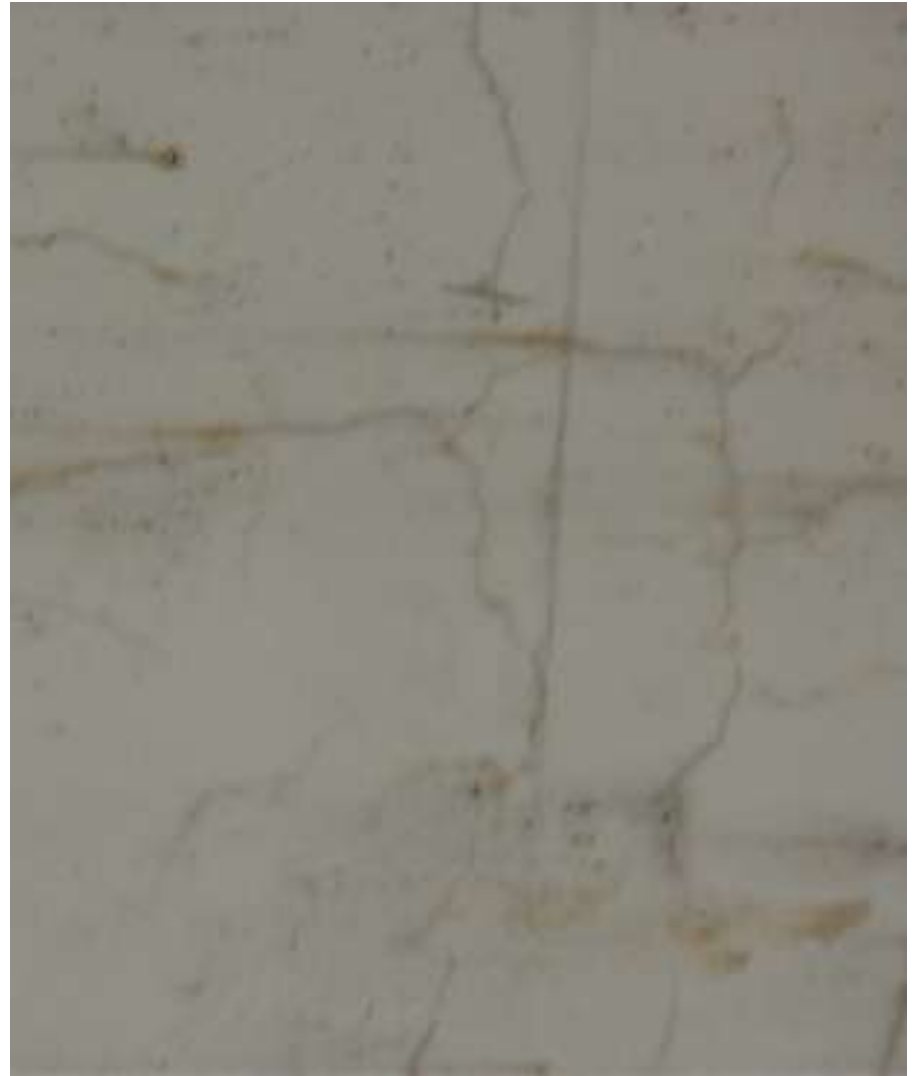
## 3.2.4 Pattern Cracking/Crazing of Concrete

Very fine crack with no clear direction.

***Probable Causes/Deficiencies:*** Differential change in volume between surface of concrete and interior. Poor quality concrete and/or placement. When crazing forms during first year after pour - poor vibrations or curing Alkali- silica reaction.

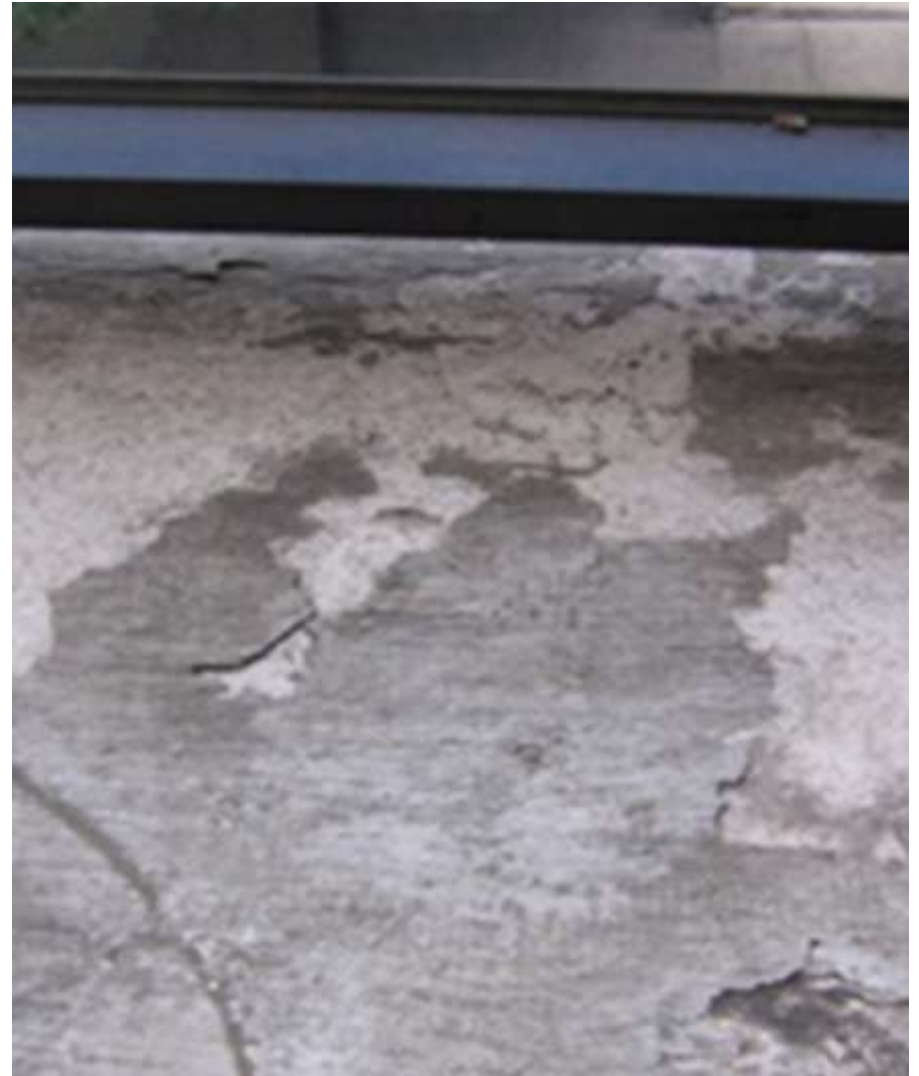
## 3.2.6 Scaling of Concrete (Topping)

Poor quality concrete and/or placement, poor vibrations of concrete leading to the formation of a plane of weakness. Over finishing and/or poor curing practices. Freeze thaw action. Poor quality of prior repairs. Differential thermal expansion topping vs. concrete.

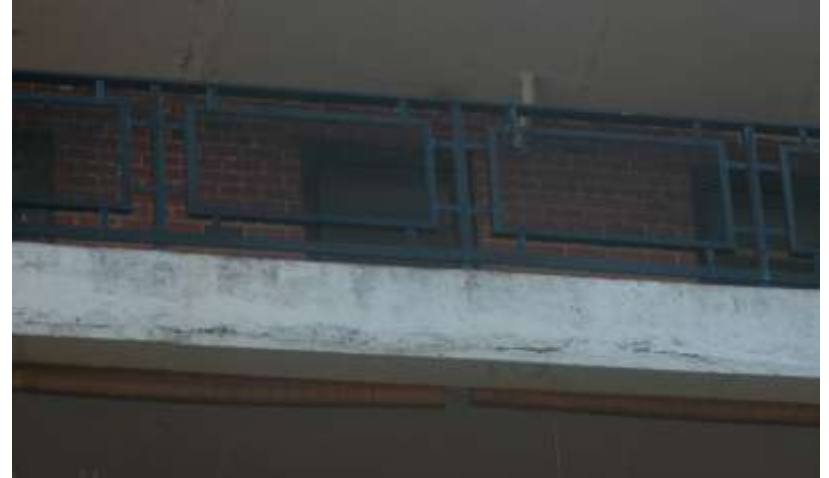
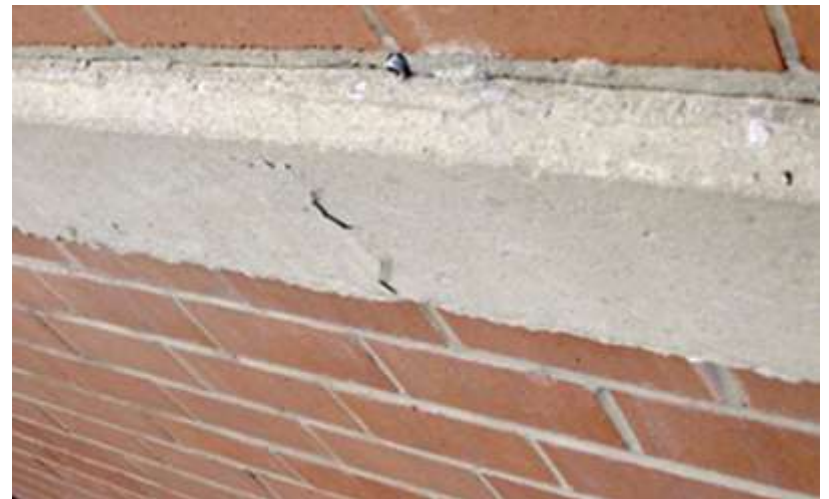
## 3.2.7 Exfoliation of Concrete

Improper forming/finishing of concrete.

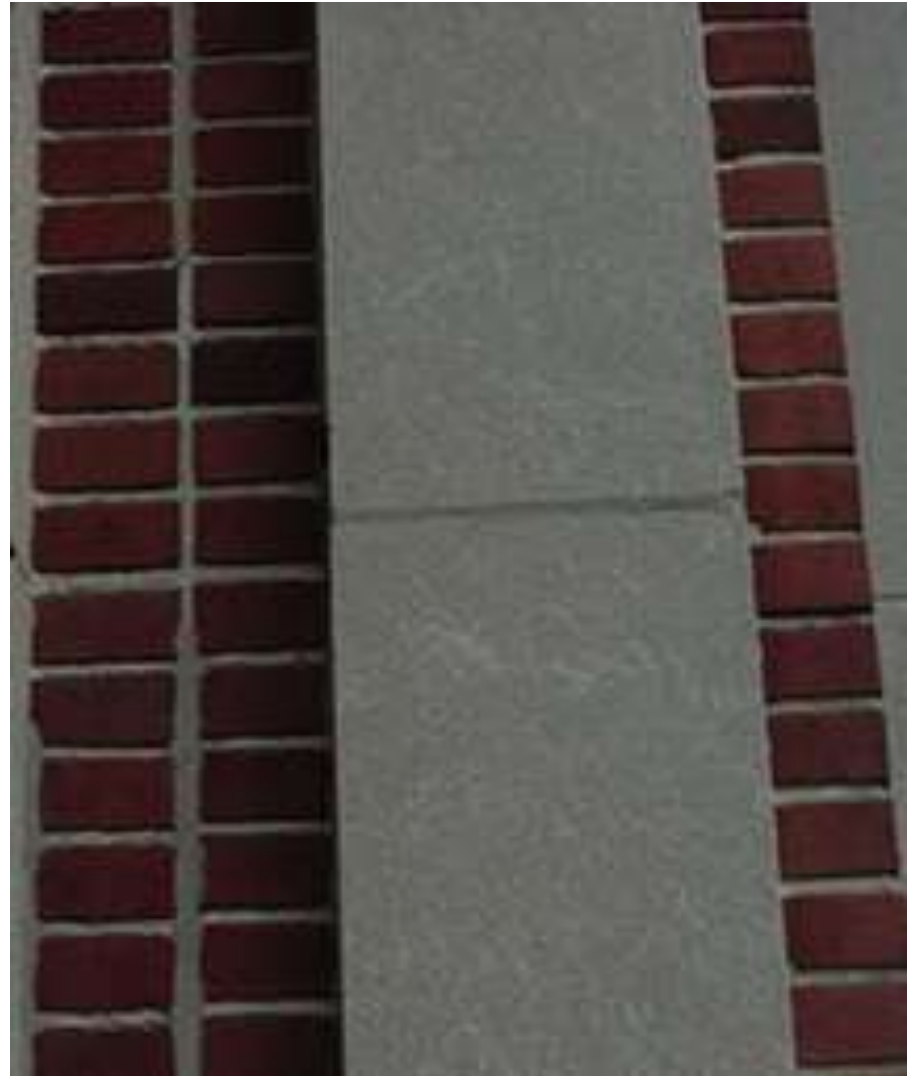
## 3.2.8 Spalling of Cast Stone

Local concentration of compression stresses.  
Uneven mortar in joint. Freeze/Thaw action.

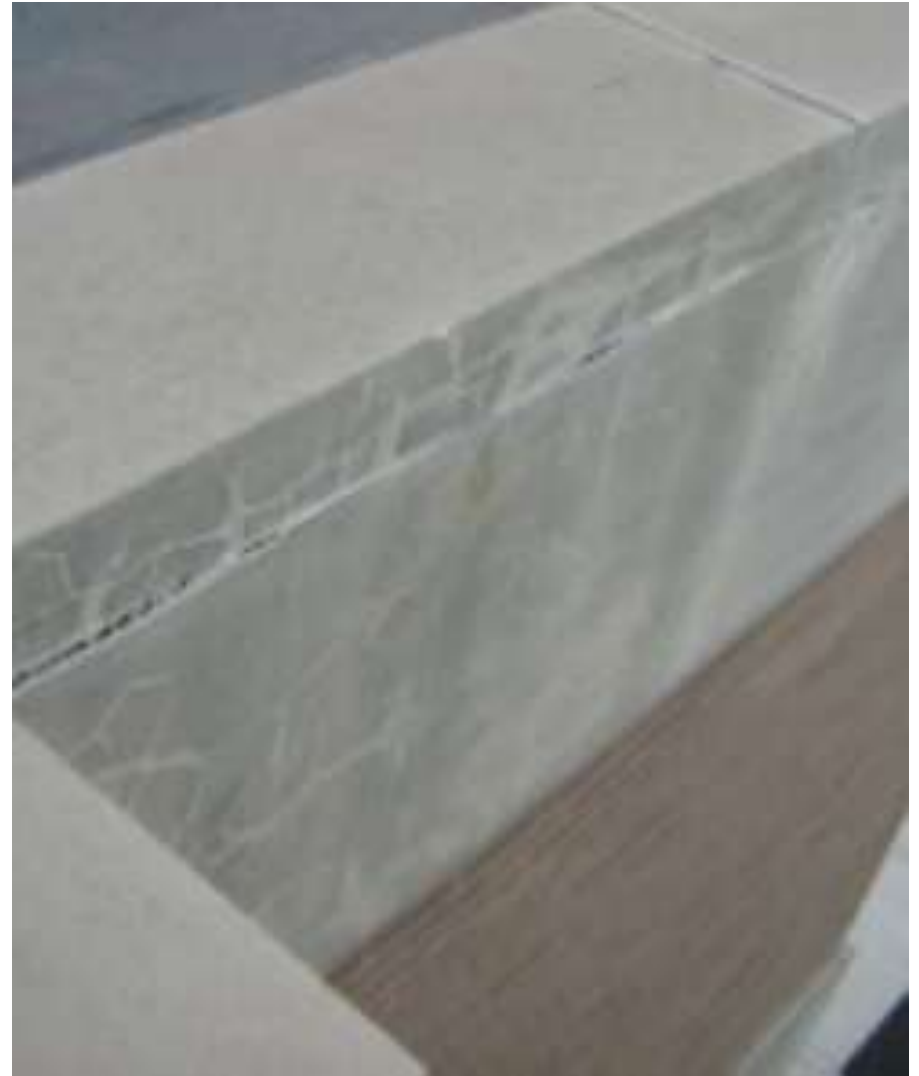
## 3.2.9 Craze Cracking Cast Stone

Integrity of surface. Thin surface flakes or cracked mortar.

Freeze/Thaw action. Alkali-silica reaction from deep into the unit and spreading to the surface

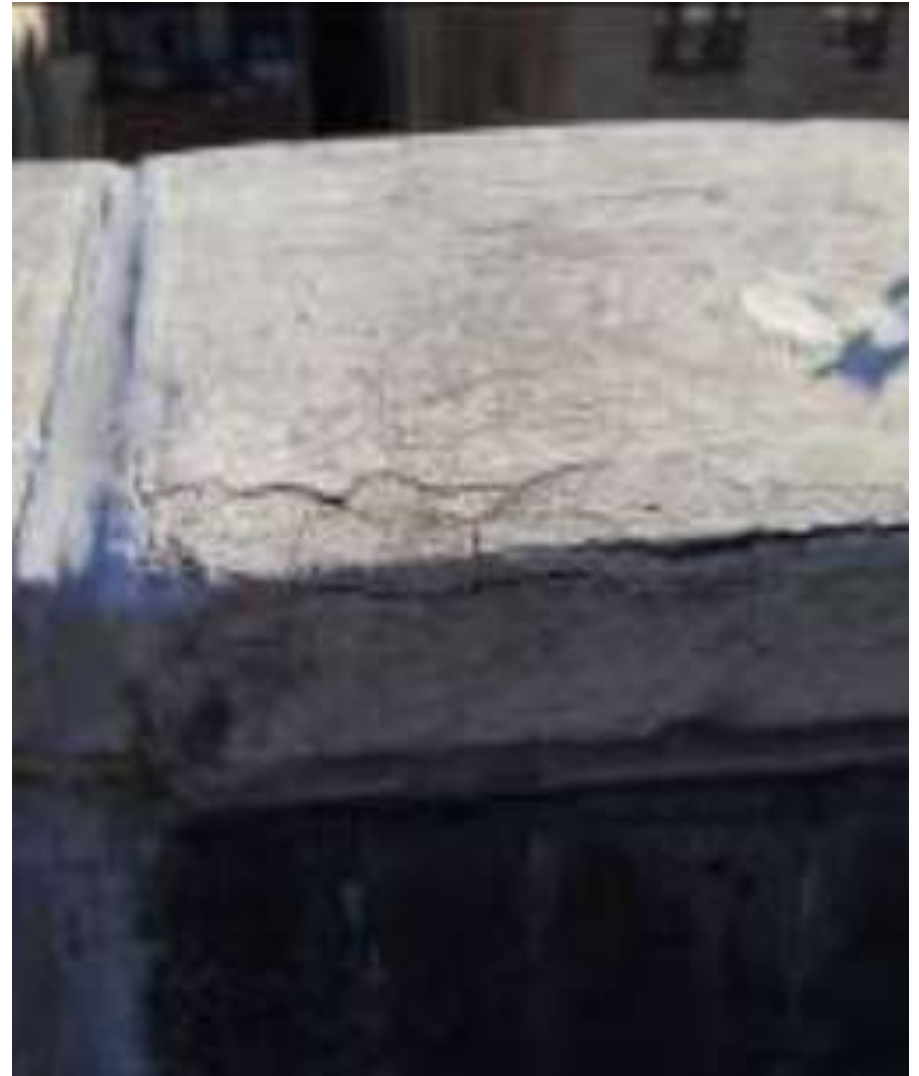
## 3.2.10 Peeling of Cast Stone Surface

Integrity of surface. Thin surface flakes.  
Crazing. Shrinkage cracks.

Freeze/Thaw action. Difference in thermal movement between surface layer and interior of cast stone.

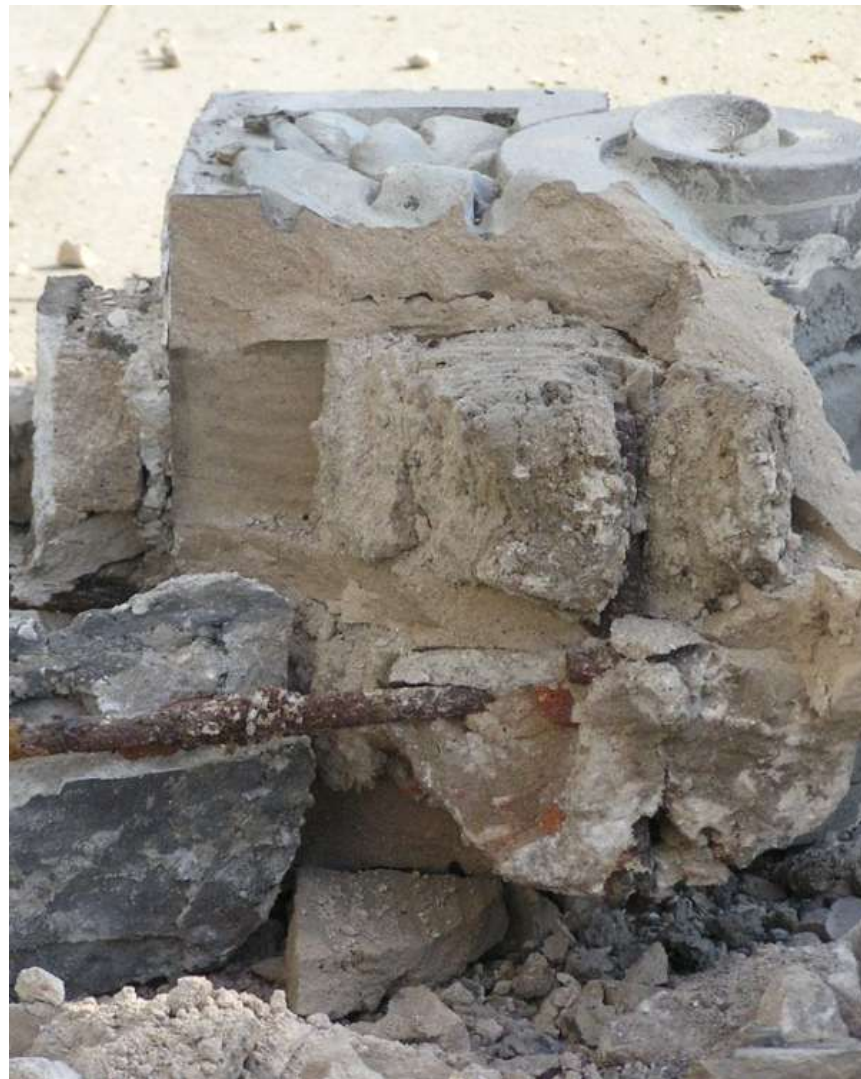
## 3.3 Terra-cotta

Glazed terra-cotta was very popular after 1900 because of its similarity to stone. While it was sometimes used in bearing brick masonry facades, the most extensive usage was as a cladding system for tall buildings. Most commonly used as a hollow unit. The terra-cotta cladding system for transitional facades involved extensive use of steel for support and anchorage. Most of terra-cotta deficiencies can be traced to the original manufacturing and detailing. The most common areas of terra-cotta deficiencies are: surface condition, anchorage/support system and joints.

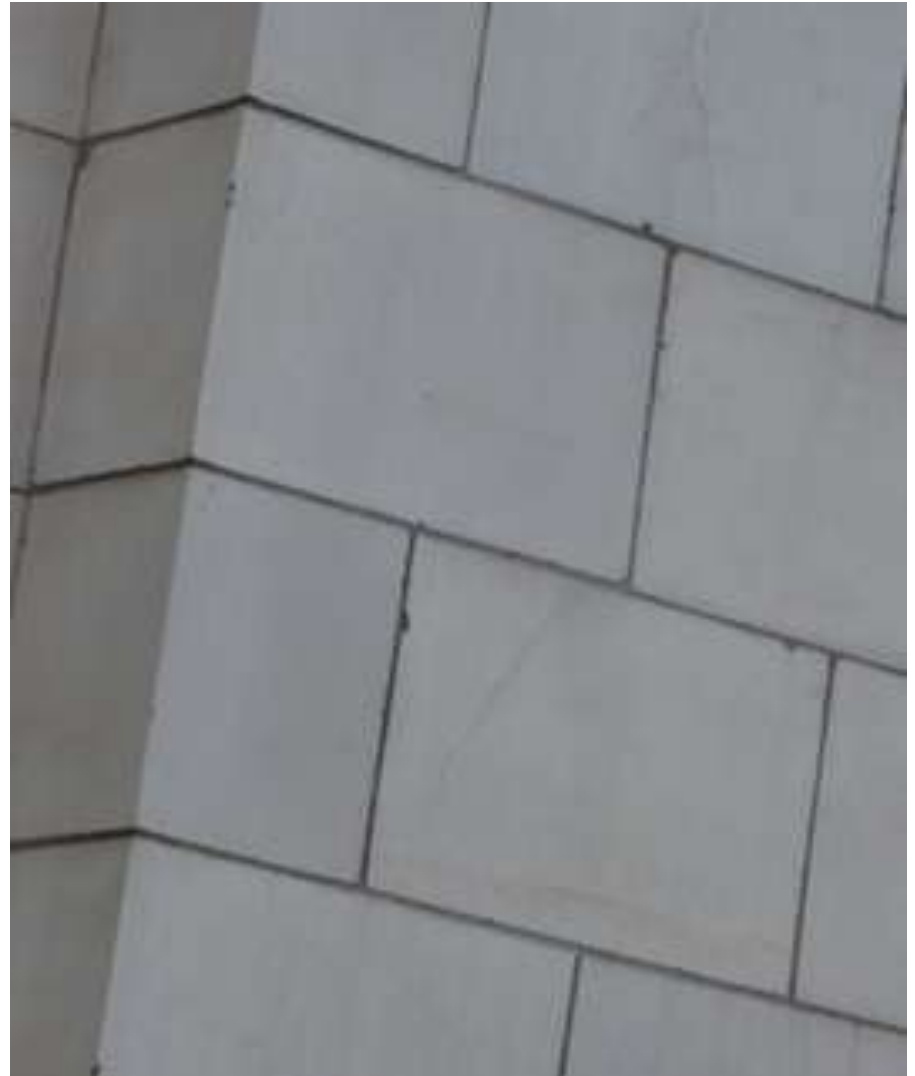
## 3.3.1 Loss of Glaze – Terra-cotta

Abrasion due to wind. Improper manufacture. Surface glazing is broken by increase in volume of terra-cotta mass due to water absorption.

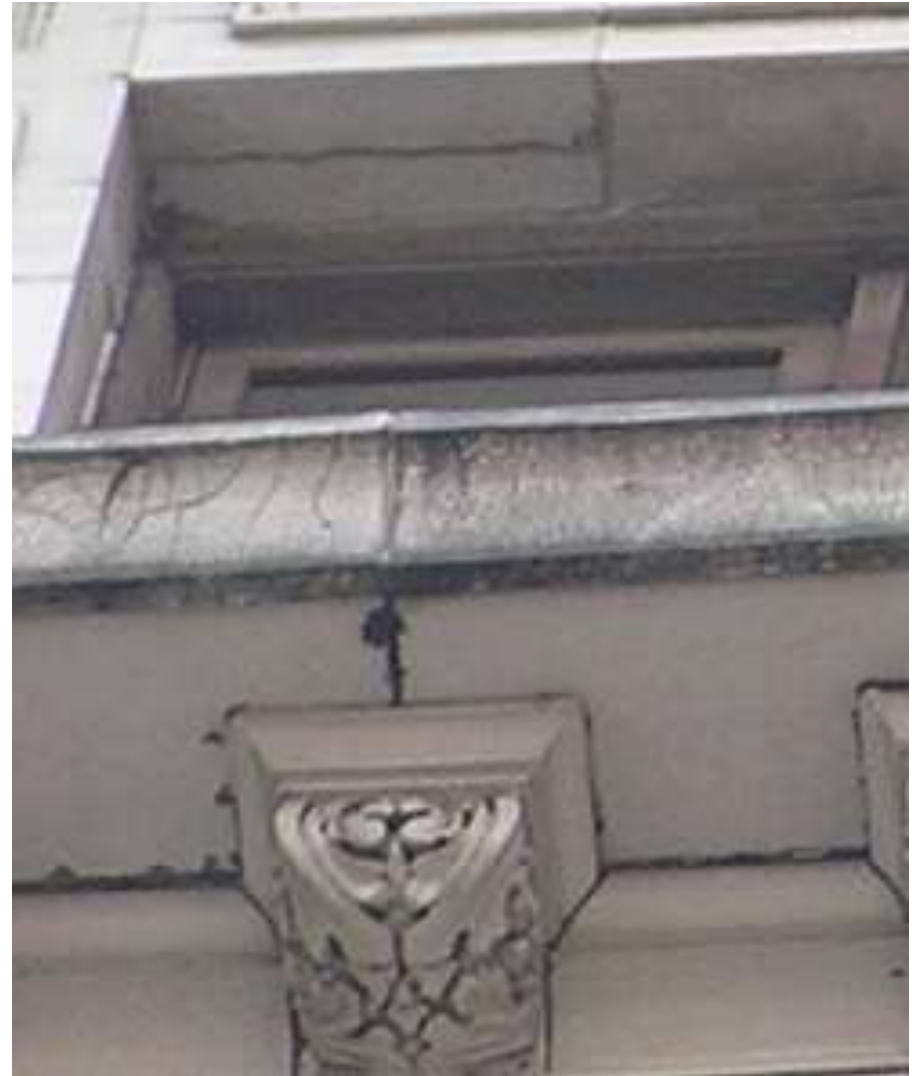
## 3.3.2 Surface Crazeing of Terra-cotta

Traces of surface cracks in glaze with no discernible pattern.

**Probable Causes/Deficiencies:** Increase in volume of terra-cotta mass (that shrank during manufacture) due to long term atmospheric moisture absorption. (Ceramic expansion).

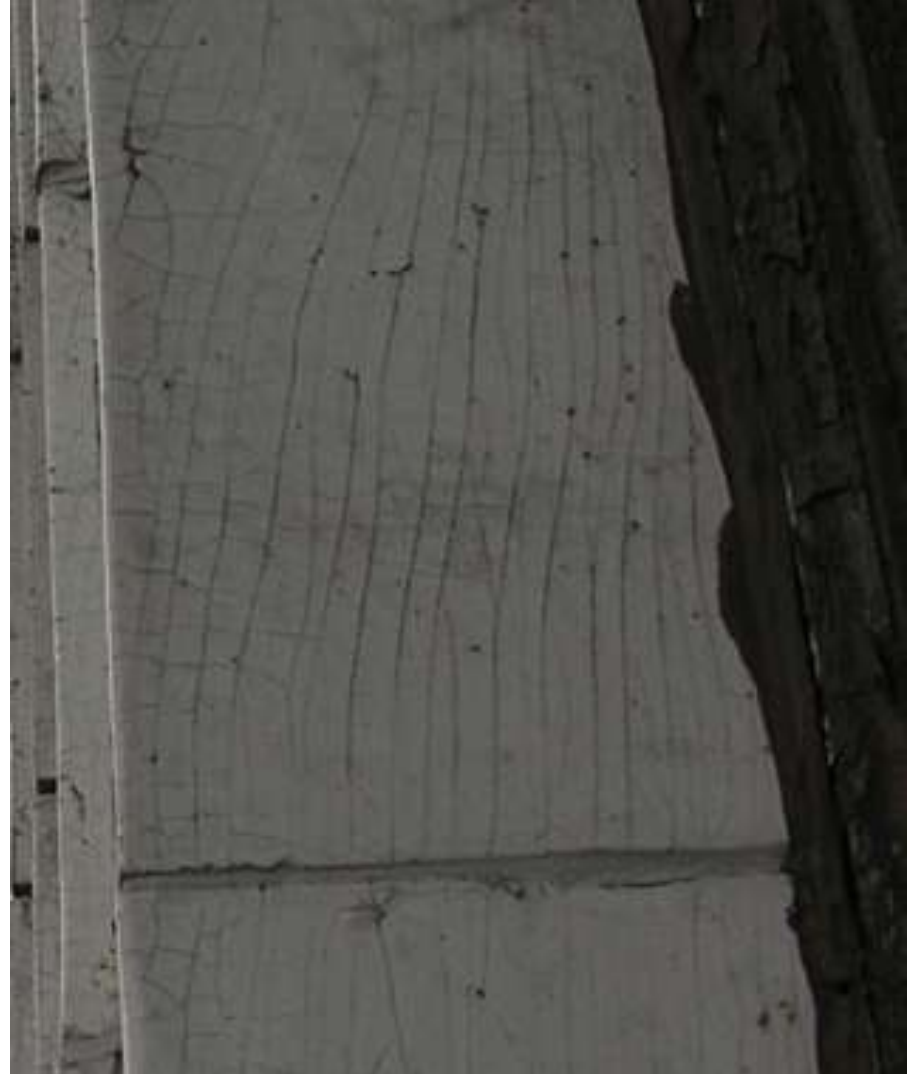
# 3.3.3 Directional Fine Cracking of Terra-cotta Surface

Surface cracking favoring a certain direction.

Manufacture process. The pattern of the surface cracks may be caused by stresses produced by a specific loading of the terra-cotta unit.

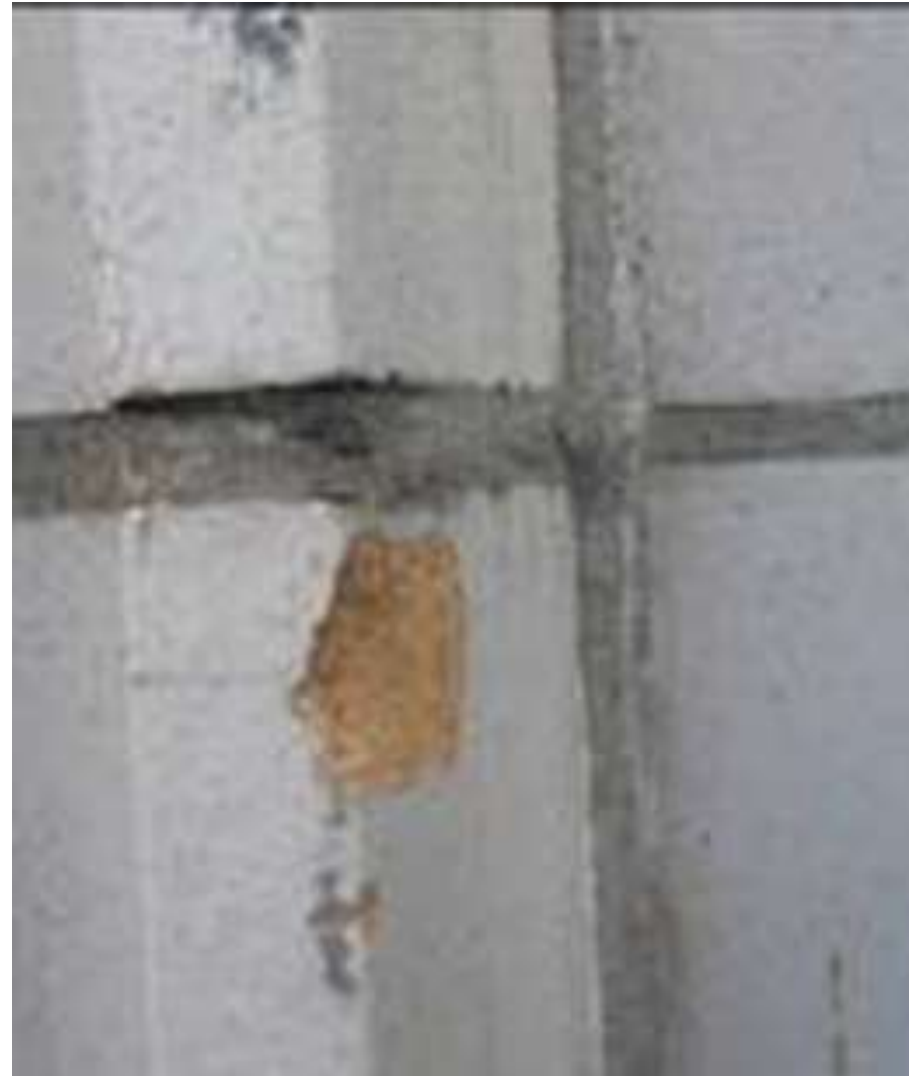
## 3.3.4 Glaze/Surface Chip - Terra-cotta

Trapped water inside the masonry tends to migrate outward. Water penetration through joints or surface cracks. Impact damage (construction equipment).

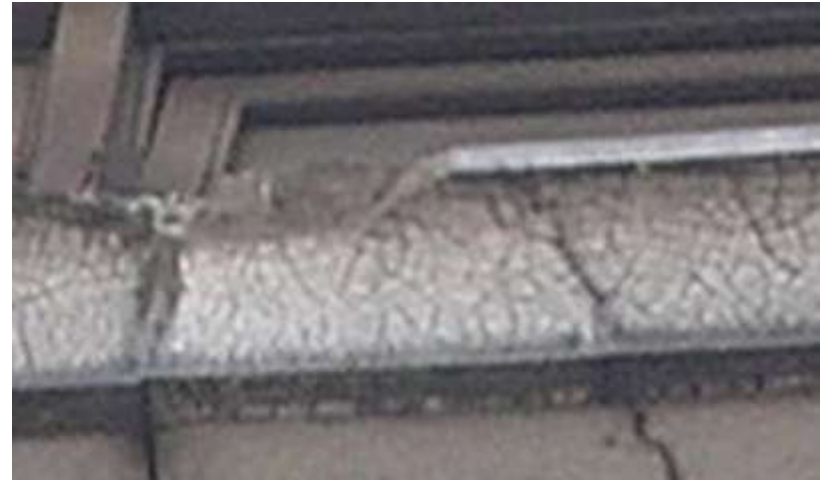
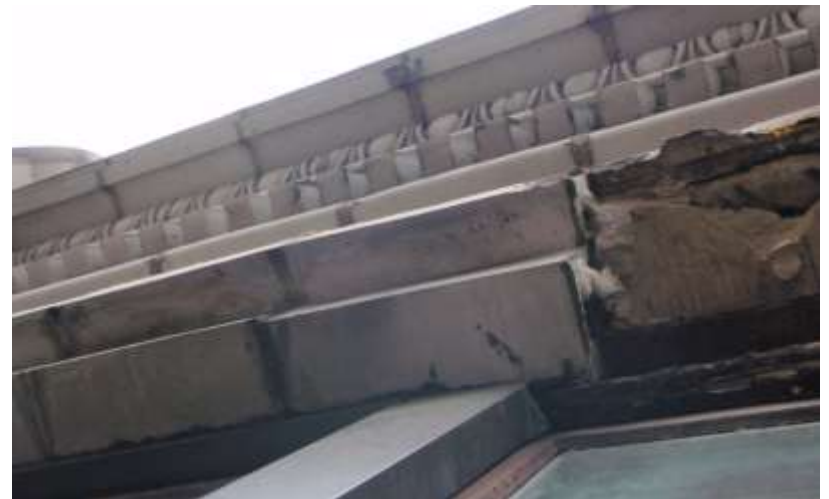
## 3.3.5 Spall - Terra-cotta

Stress concentrations from abutting masonry. Pressure from trapped water. Pressure from freeze/thaw of water penetrating through joints or cracks.

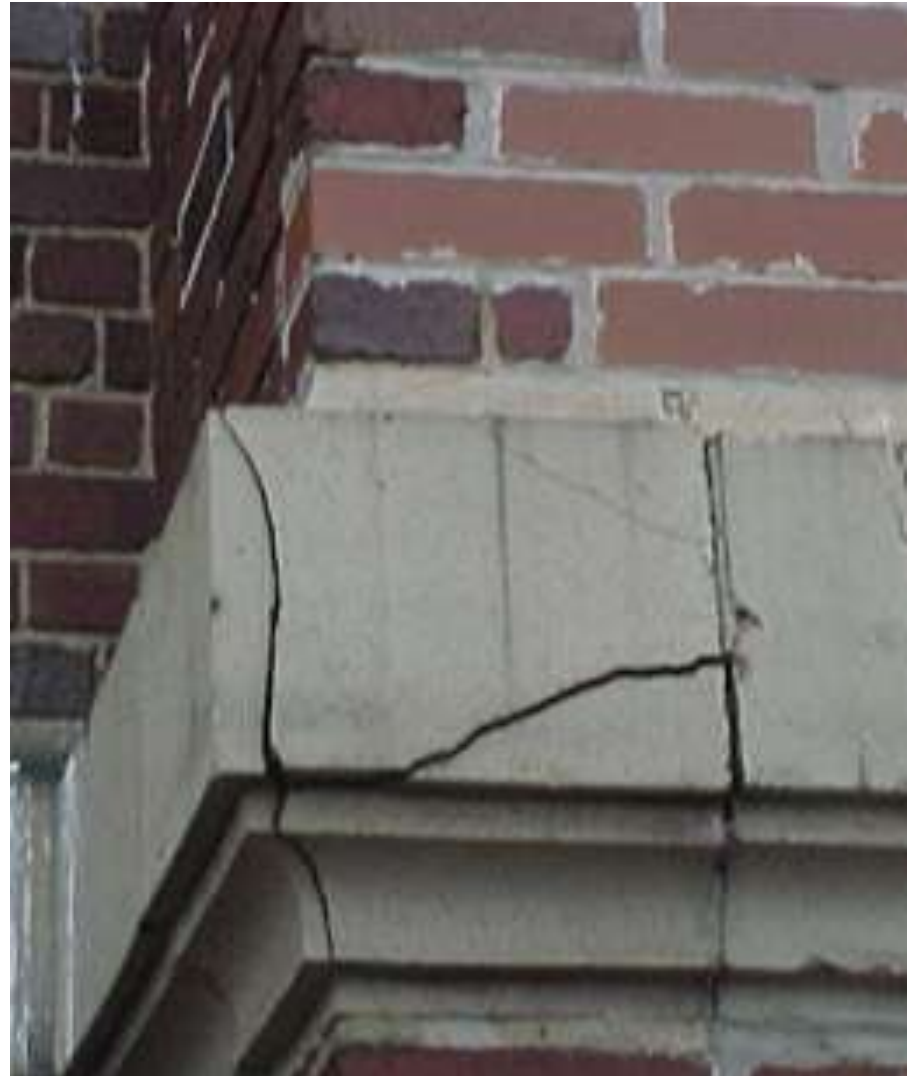
## 3.3.6 Crack in Load Bearing Terra-cotta Unit

Cracks in units used as bearing masonry systems (unanchored by steel rods).

Local stress concentration. Freeze/thaw. Change in volume of water trapped in terra cotta cavity. Clogged or missing weepholes. Thermal movement of façade.

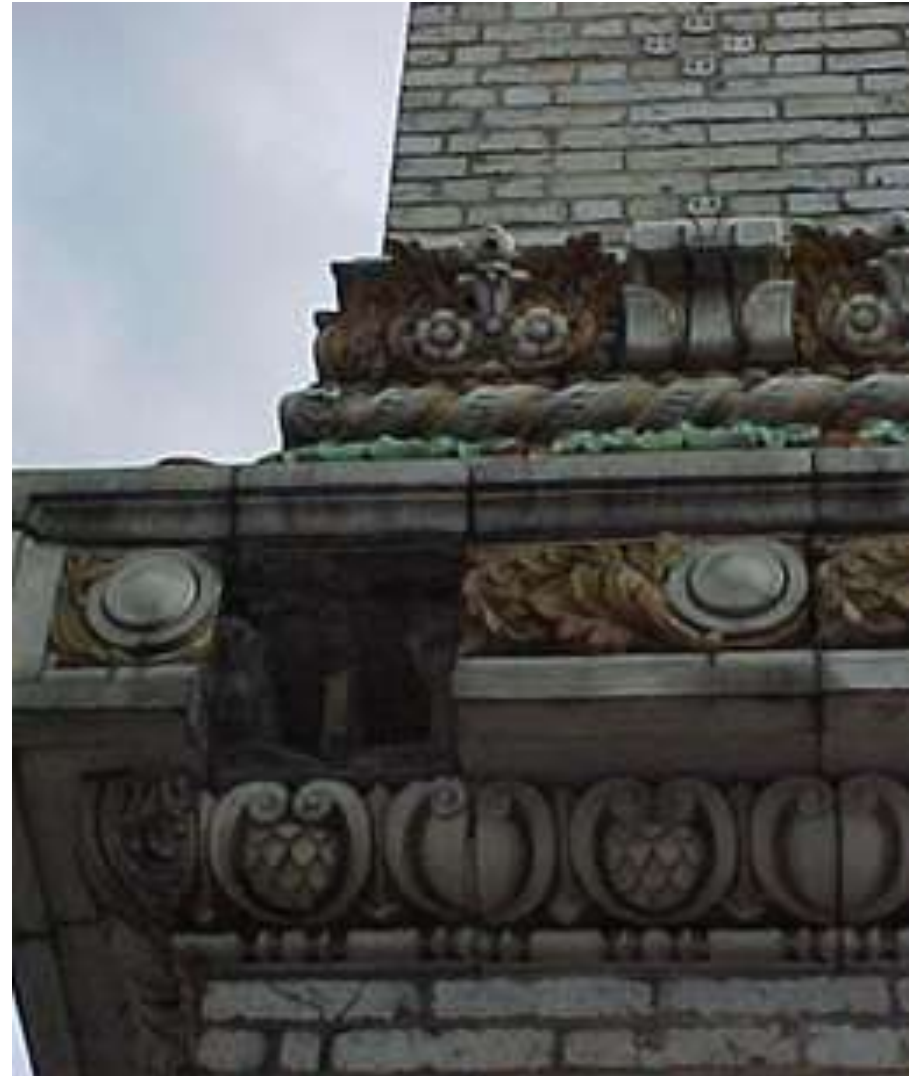
## 3.3.7 Missing Terra-cotta Unit

Entire units missing.

Preventive removal of deteriorating units.  
Collapsed units due to poor or deteriorated anchorage. Fracture of unit due to rust jacking. Steel lacking corrosion protection.  
Water penetration at horizontal ornate surfaces.

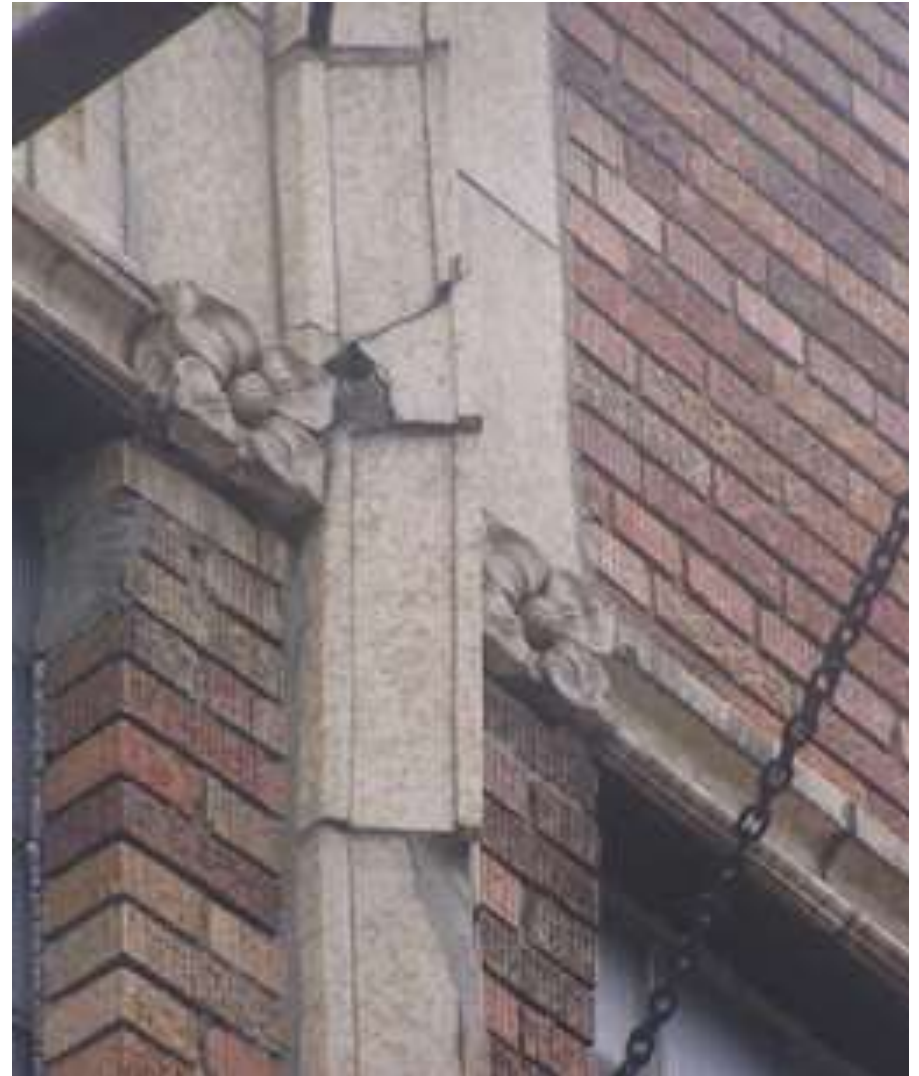
## 3.3.8 Cracked and Fragmented Terra-cotta Units

Deep cracks that led to separation or fragmentation of units. Cracks and surface spalls. Out of plane displacement of units. Condition in photo typical at vertical ornate fins.

Stress concentration due to changes in load transfer or movement of the building or of the façade. Linear, vertical ceramic expansion.

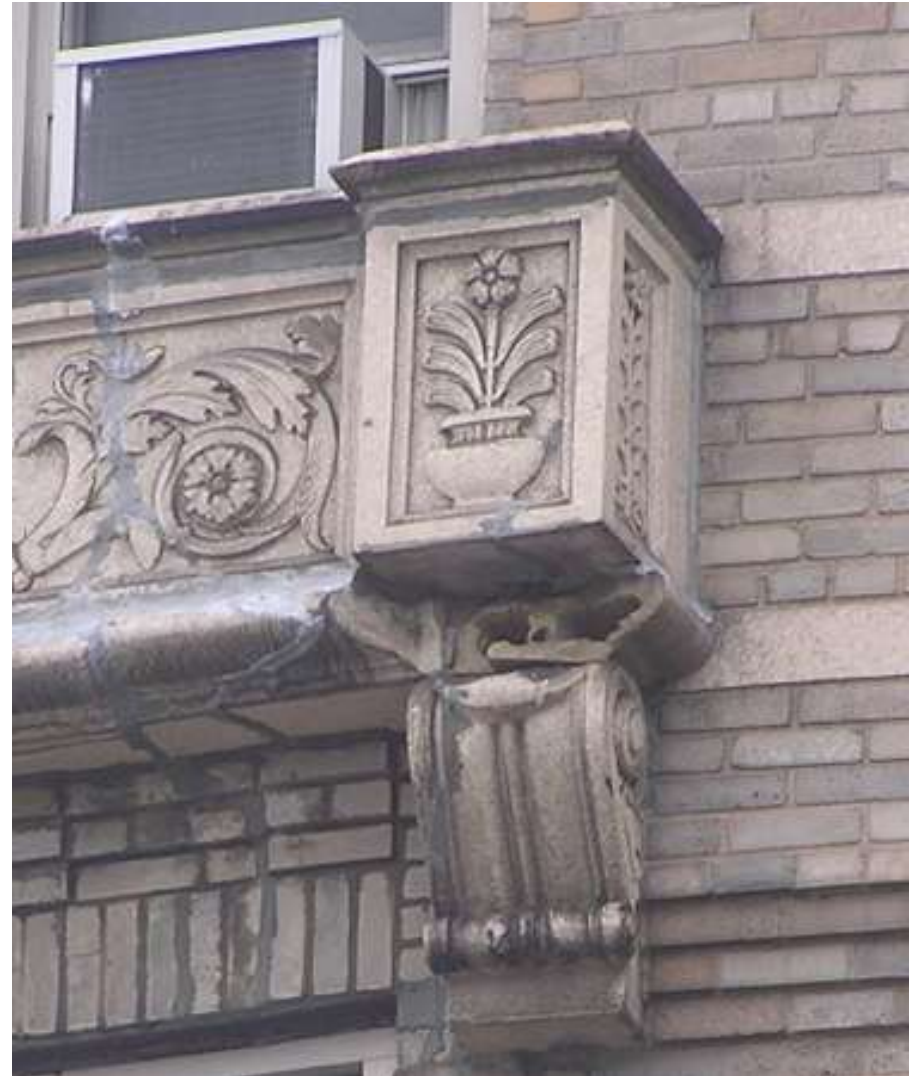
## 3.3.9 Broken Terra-cotta Unit

Fragment of terra-cotta units missing.  
Visible hollow structure.

Water penetration through cracks and open joints.  
Rust jacking. Freeze-thaw damage.
