# FAÇADE CONDITIONS

An Illustrated Glossary  
of Visual Symptoms

**Edited by Dan Eschenasy, PE**  
Chief Structural Engineer  
NYC Department of Buildings

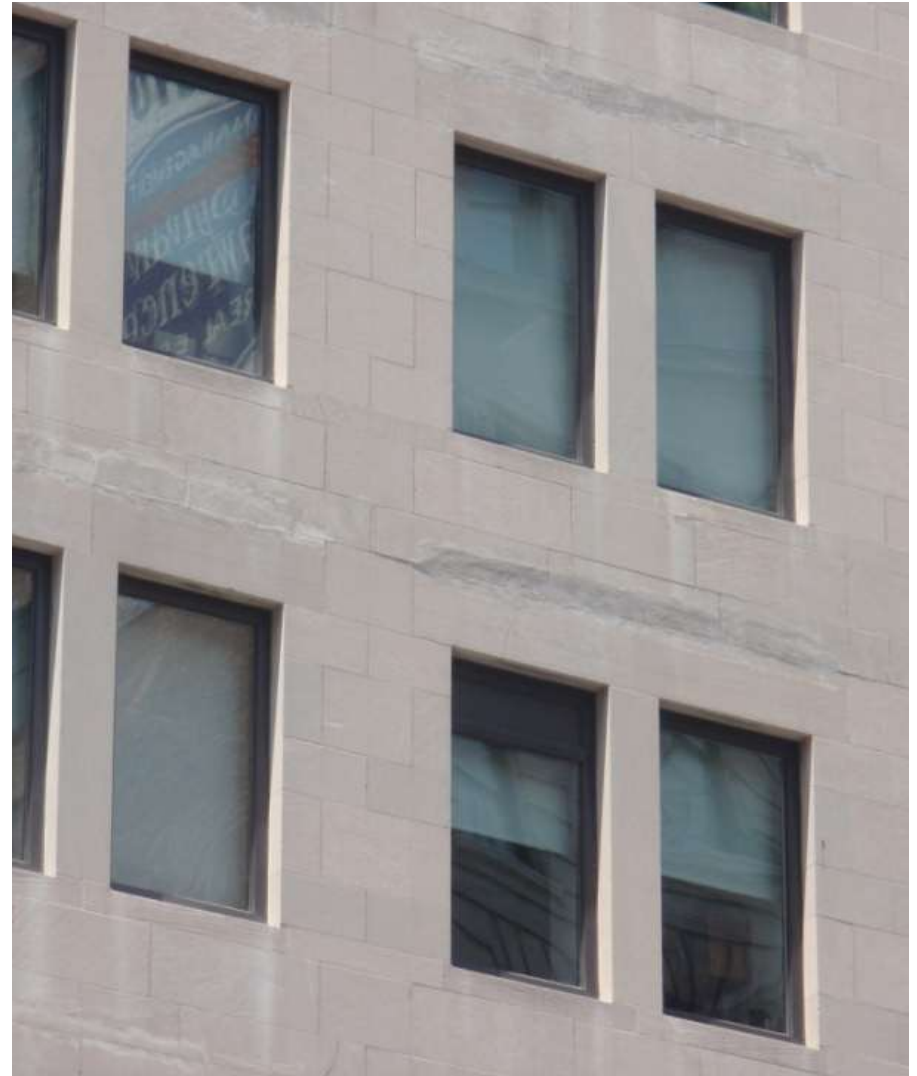
## 3.4 Stone Facades

Dimensional stone facades have been used since the 1800's in New York City. More recent facades use thin stone veneer and slab type veneer. Stone facing was used in all façade systems - bearing masonry, transitional, cavity walls, etc. In older façade systems, the most common backing was masonry. In more recent usages the backing can be steel or steel studs. In most cases the stones elements are anchored into the backing for lateral support ( that in some cases is also designed as support for the weight of the stone). Some facades include stone only as decorative elements (bases, bands, etc...). The principal elements of a stone façade is type and quality of the natural stone used, alignment of units, tightness of joints, types and condition of anchorage and of support.

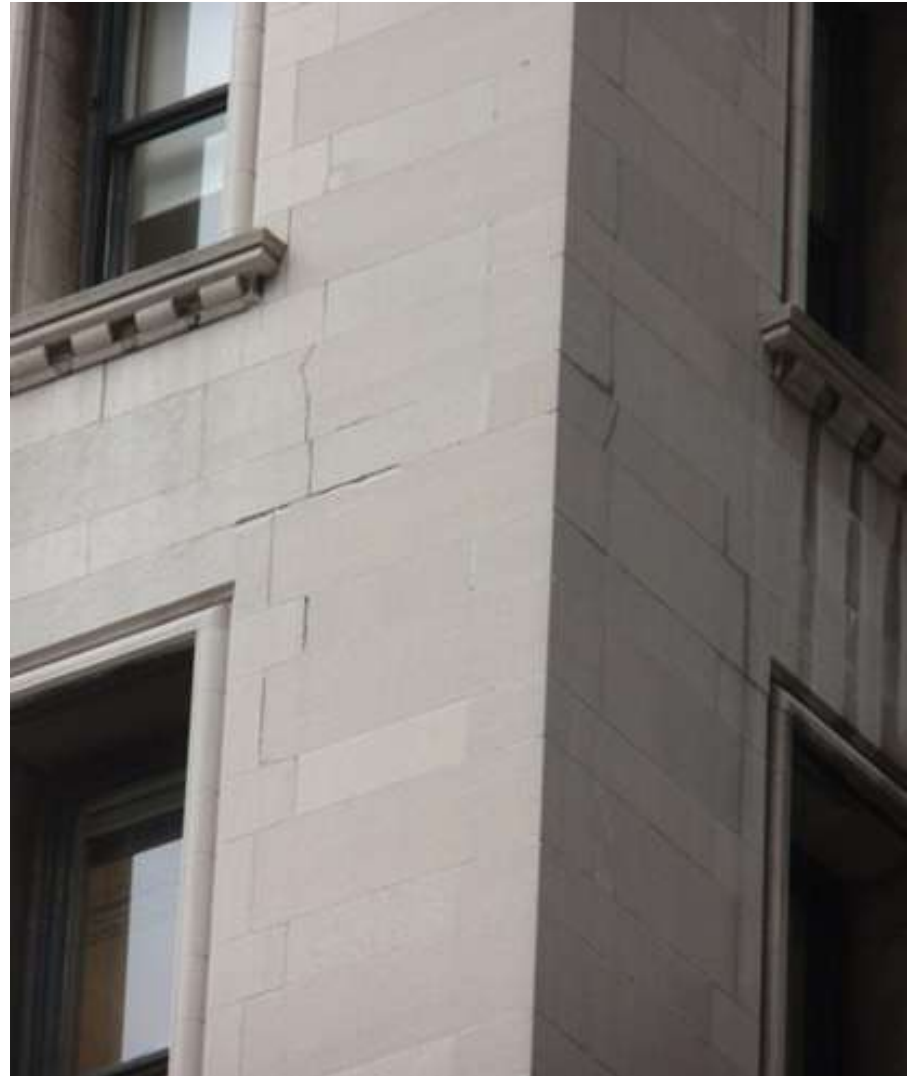
## 3.4.1 Crack in Stone

Location, size and direction of crack.  
Condition of mortar in joints. Support system for stone. Rust stains.

Natural imperfections of stone are exploited by water and freezing cycles. Concentration of vertical stresses due to non-uniform transmission of loads from above.  
Excessive movement of supporting elements.  
Corrosion of supporting steel frame.  
Thermal movement of envelope.

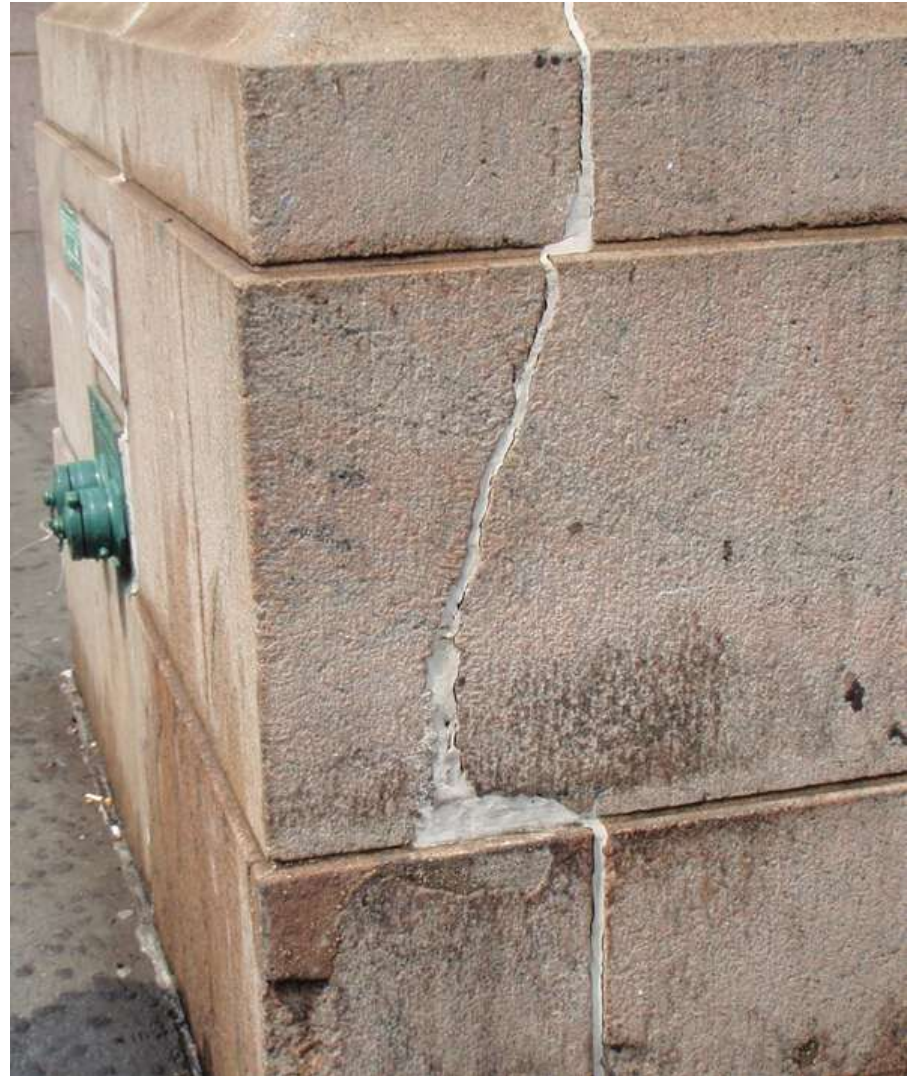
## 3.4.2 Crack in Corner Stone

Crack at base of stone façade. Extent of crack in vertical direction. Direction of crack. Condition of mortar in joints. Rust stains.

Concentration of vertical stresses at corner.  
Thermal movement of façade above.  
Freezing of water present in incipient cracks.  
Movement of supported elements.  
Accidental impact from street vehicular traffic.

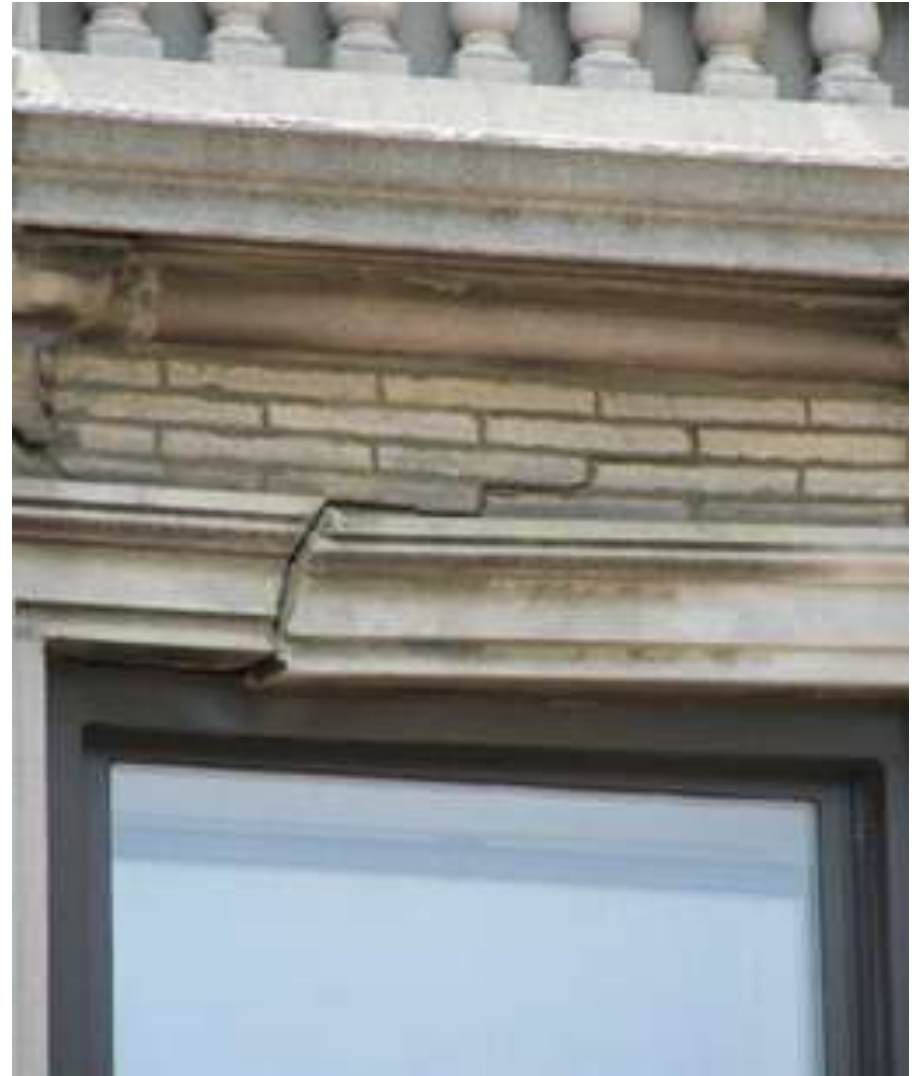
# 3.4.3 Cracked and Fragmented Stone Unit

Lack of vertical or horizontal alignment.  
Presence of cracks. Displacement.  
Movement occurring along joints or along separating cracks. Lack of mortar in adjoining joints. Condition of supporting frame, weeps, condition of surrounding façade.

Water penetration and ice buildup in the back of the stone, loosening of anchorage or vertical support, pressure from corrosion byproducts, movement of the building structure.

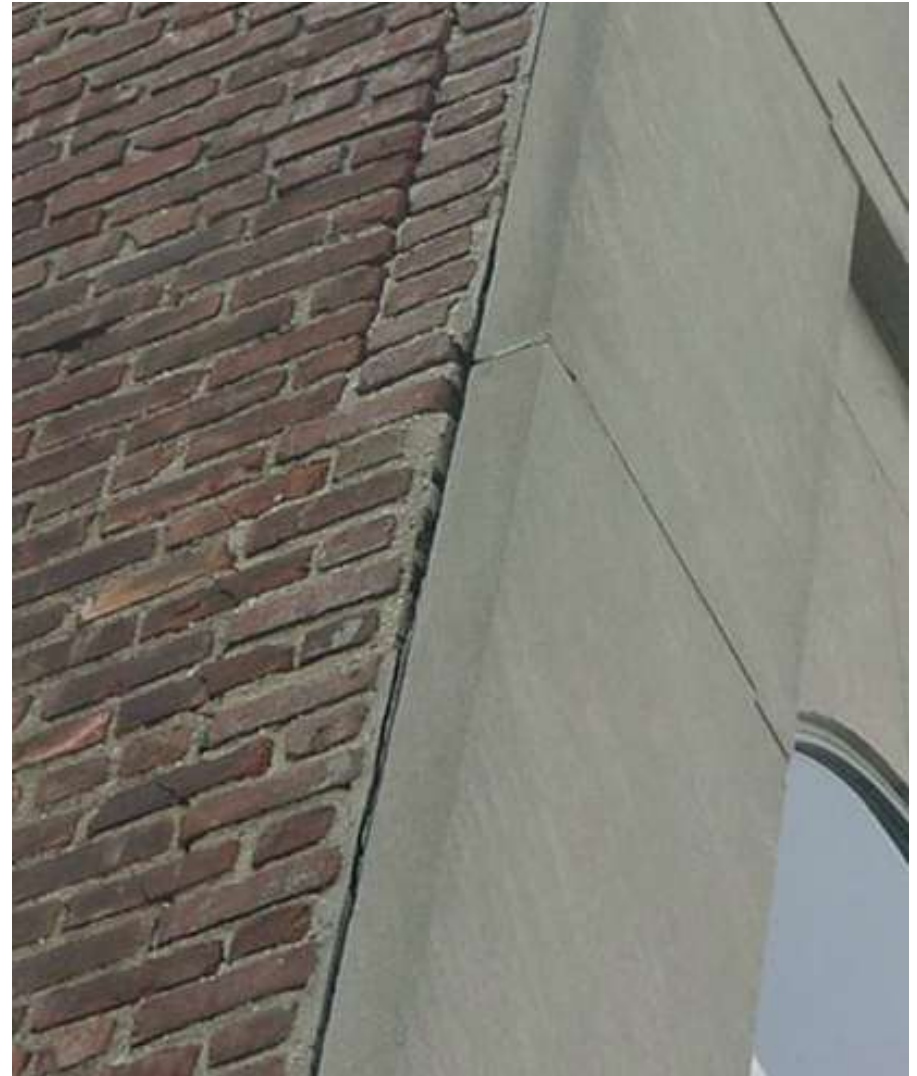
Out-of-vertical plane movement of panel system, away from backing system. Separation along joints. Displacement/position of face stone in relationship of façade or of underlying structure. Alignment of panels. Presence and condition of weepholes.

Failure or loosening of anchorage, sliding of stone off horizontal supports. Movement of underlying system (e.g. frame shortening). Ice buildup between backup masonry and face panels.

When stone element carries vertical load from above the condition can lead to a buckling failure.

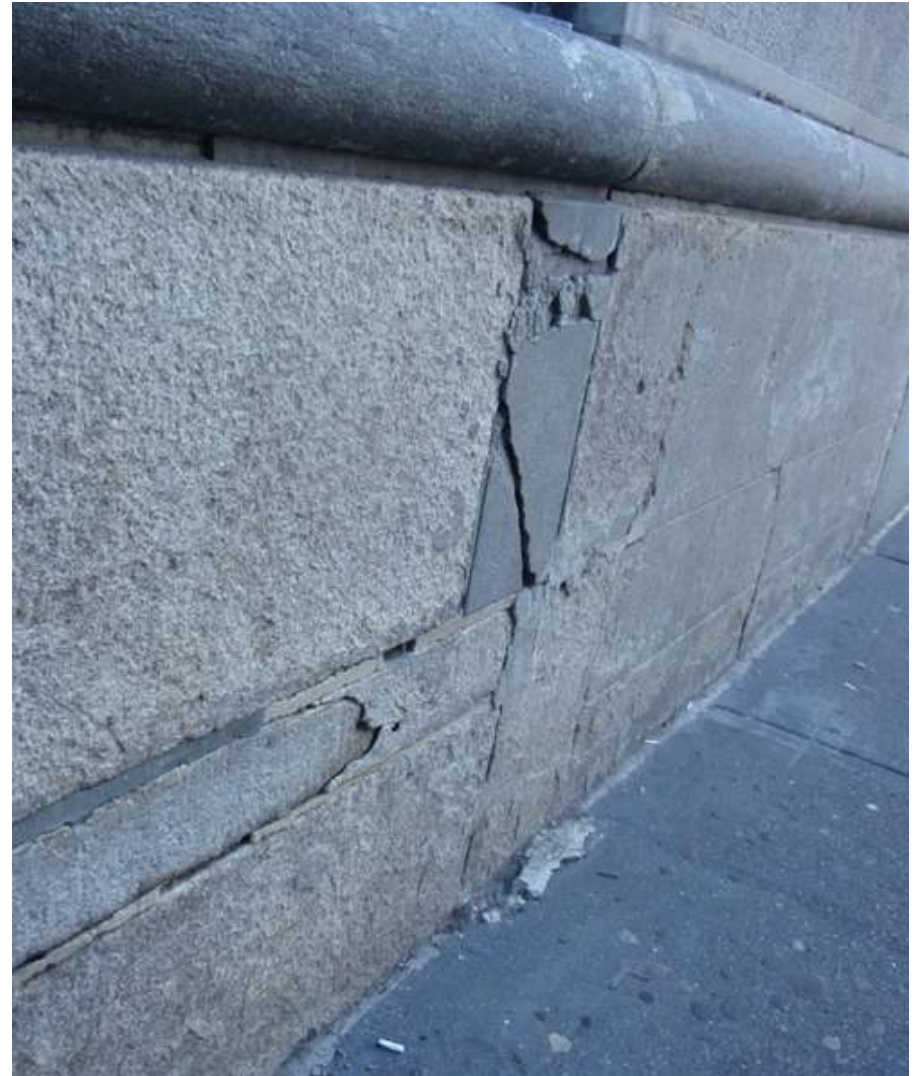
## 3.4.5 Peeling/Delamination of Stone

Long term effect of rain water, icing. Separation occurs along natural bedding plane of stone. When occurring in vicinity of sidewalk—splashing with deicing chemicals.

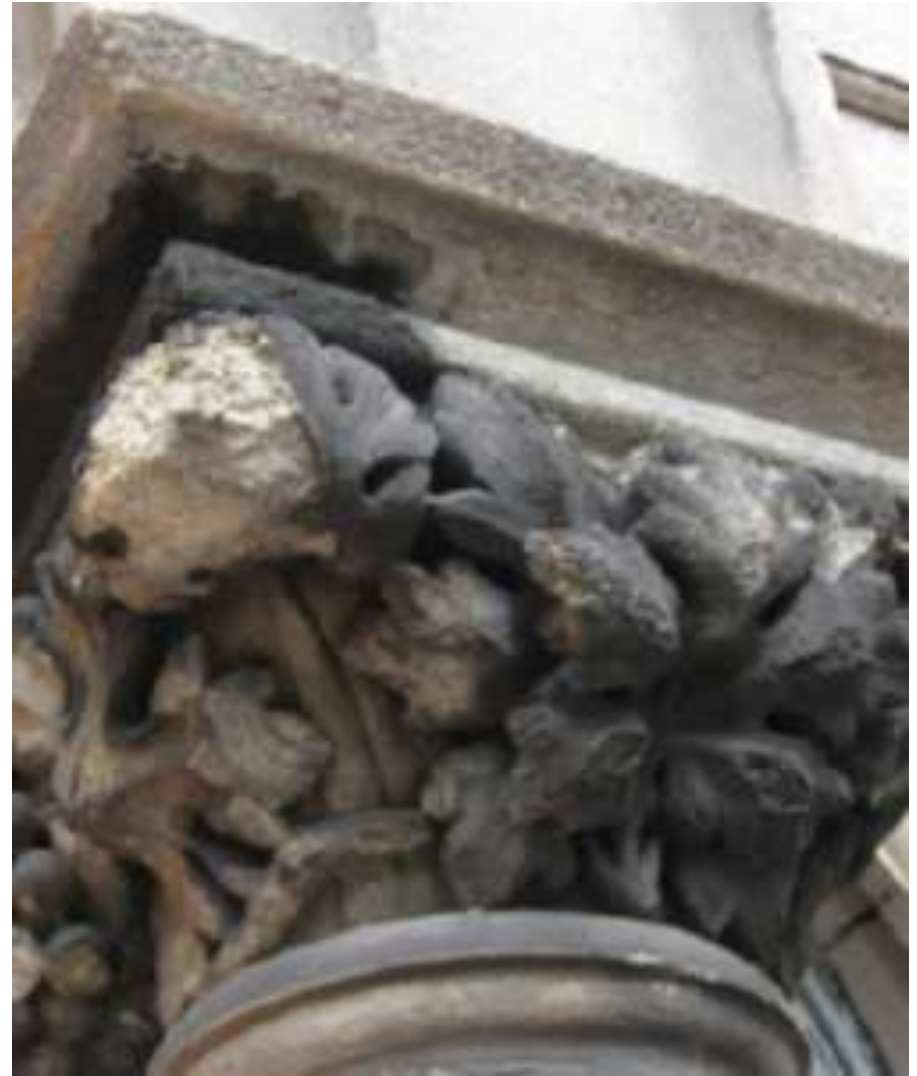
## 3.4.6 Gypsum Crust

Atmospheric acidity. Atmospheric particles incrusting in gypsum components. Chemical disintegration of gypsum components in stone.

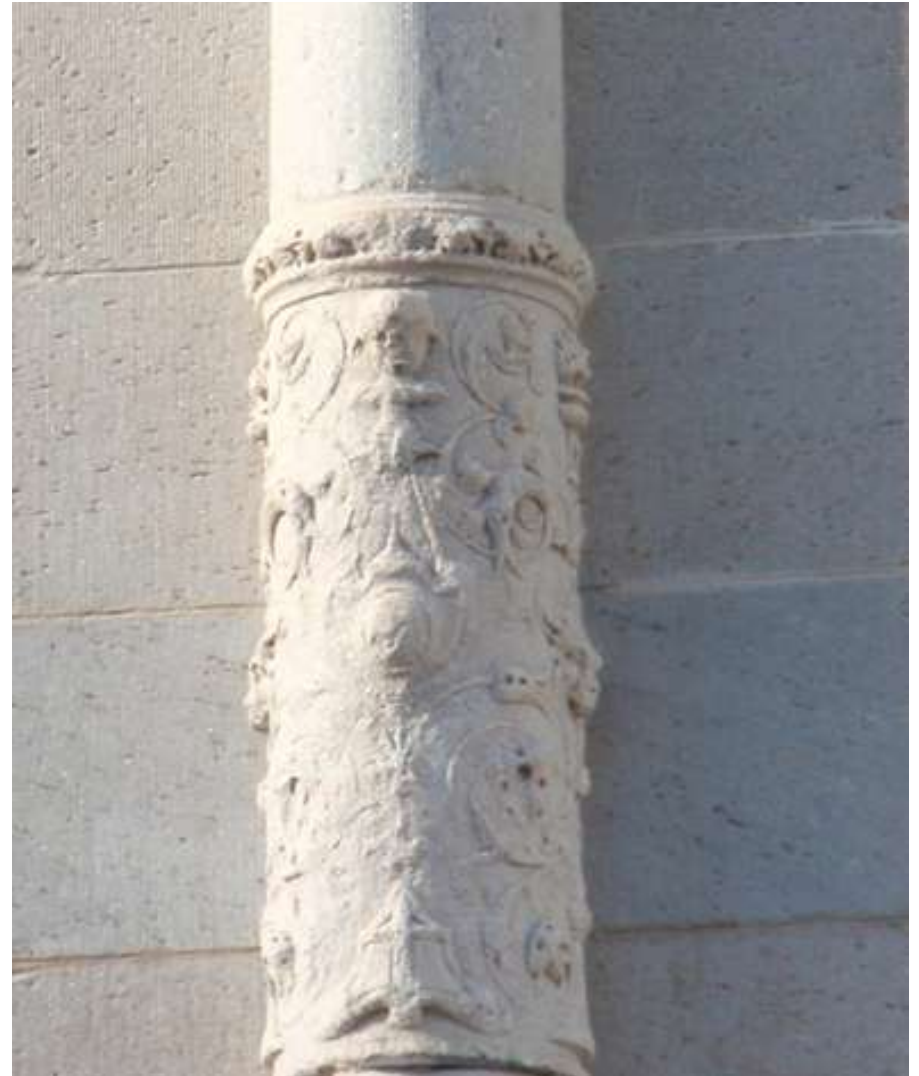
## 3.4.7 Erosion of Stone

Slow wearing away of stone surface and edges. Especially noticeable around decorative sculptures or carvings.

Long term action of wind and rain.

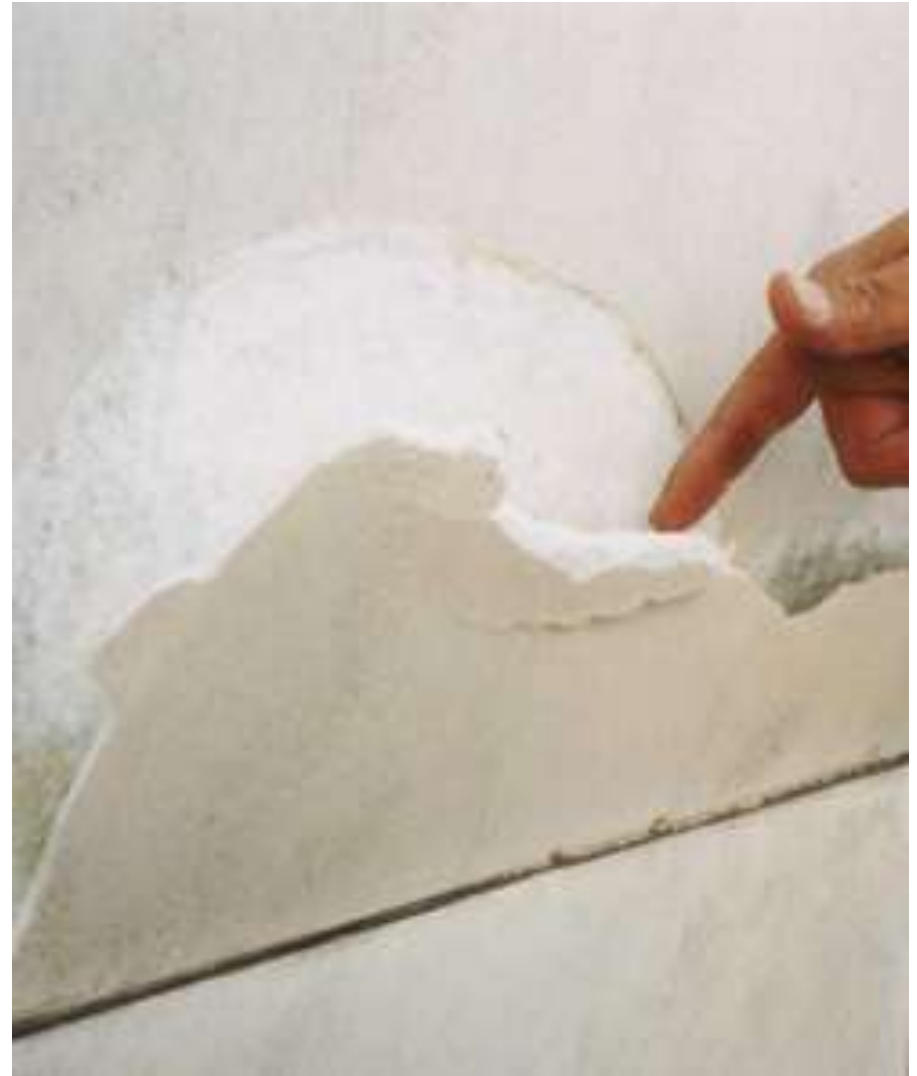
## 3.4.8 Spalling of Stone

Surface breakage of stone (fragments of various sizes), depth of spall. Irregular surface cracks (star shaped) that might precede spalls.

Increase in localized internal pressure or localized pressure from adjoining elements. Natural imperfections of stone exploited by water and ice lensing. Decomposition or increase in volume of some inclusions.

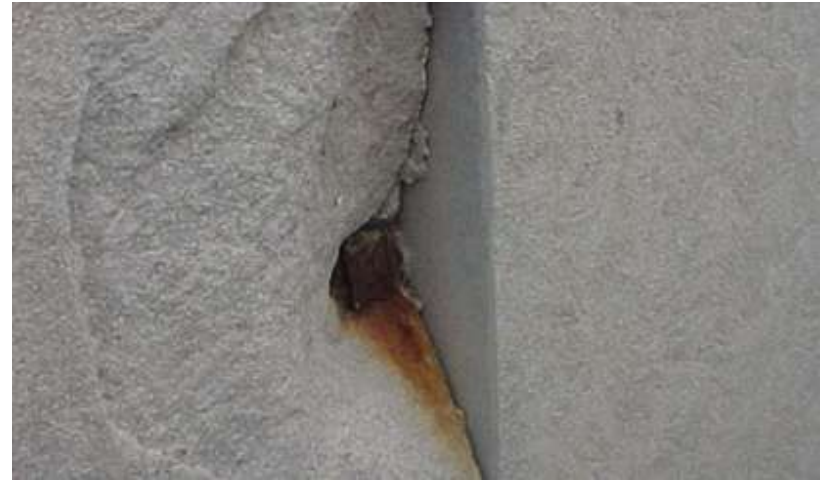
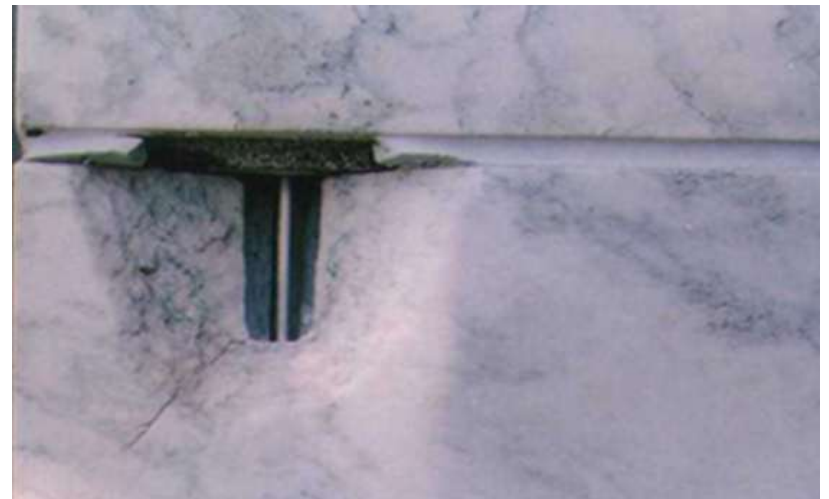
# 3.4.9 Corrosion of Steel Anchorage/Insert

Craters and surface breakage of stone, rust coloring, rusted steel elements, shifting of stone.

“Rust jacking” when stone installation used anchors of materials susceptible to corrosion. Decomposition of some inclusions. Corrosion of some metal components (e.g. shutter anchors). Concentration of stresses around anchors. Stone movement blocked by anchor. Insufficient cover of anchor

Capacity of anchors to support stone. Capacity, condition of remaining anchors to support the stone. Hidden deterioration of anchors.

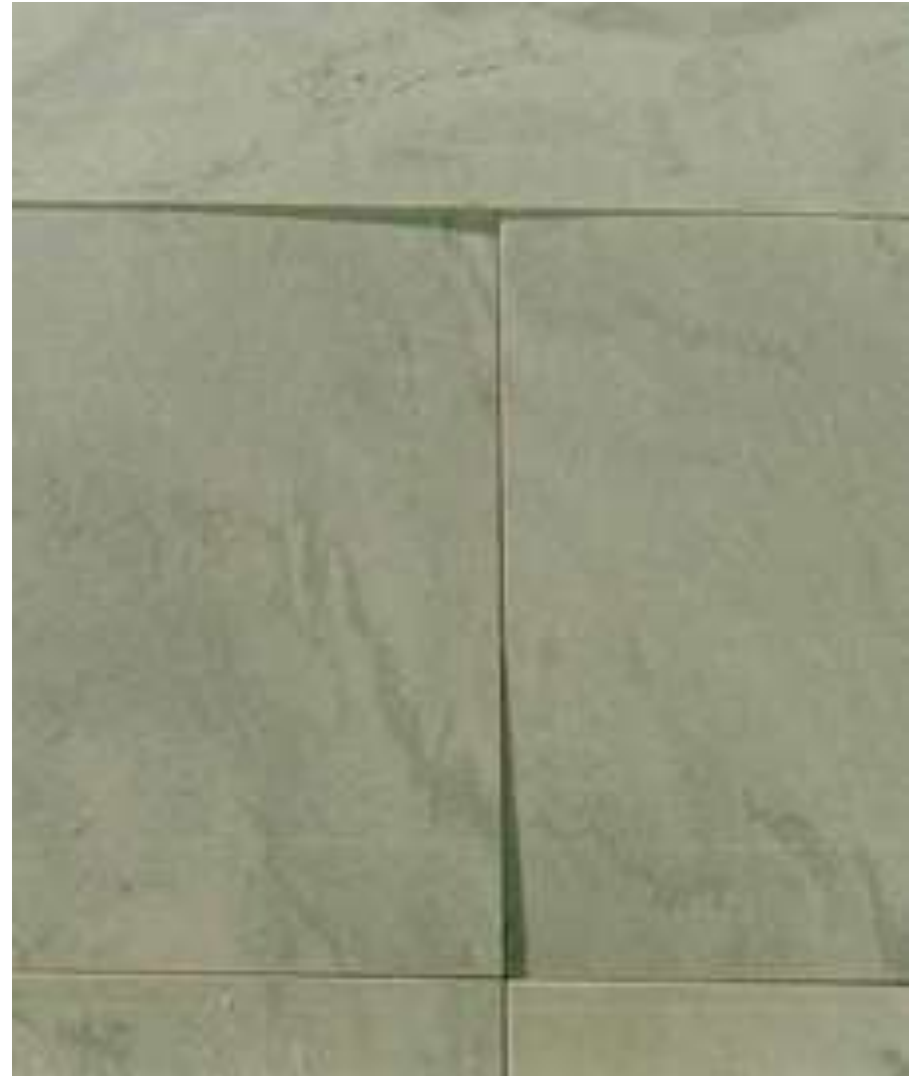
# 3.4.11 Bowing of Marble Panels

Usually on thin marble panels. (Can occur in limestone). Permanent expansion of stone panel (due to hysteresis - accumulation over time of irreversible thermal expansion) is restrained by adjoining panels or anchors.

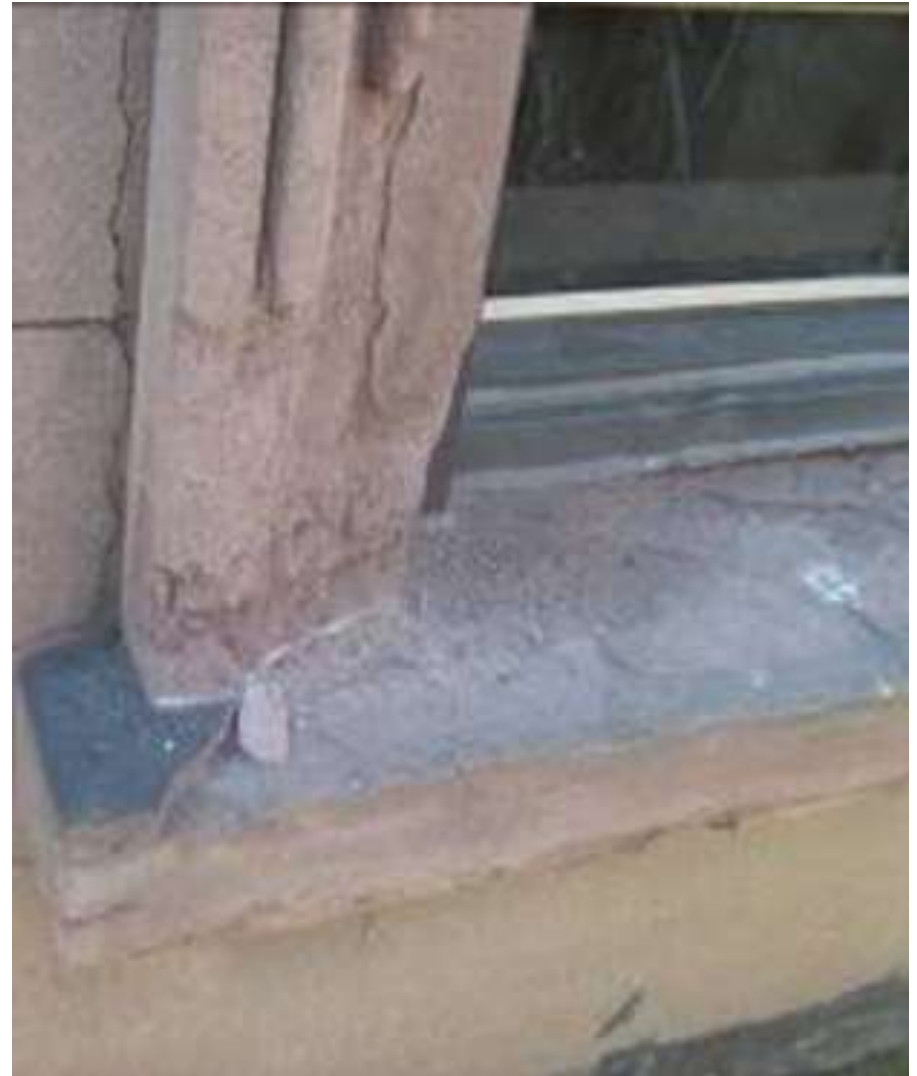
# 3.5.1 Disaggregating Brownstone

Crumbling or degradation of stone material.

Poor quality of original stone. Separation of sand from binder component of stone.  
Erosion of binder.

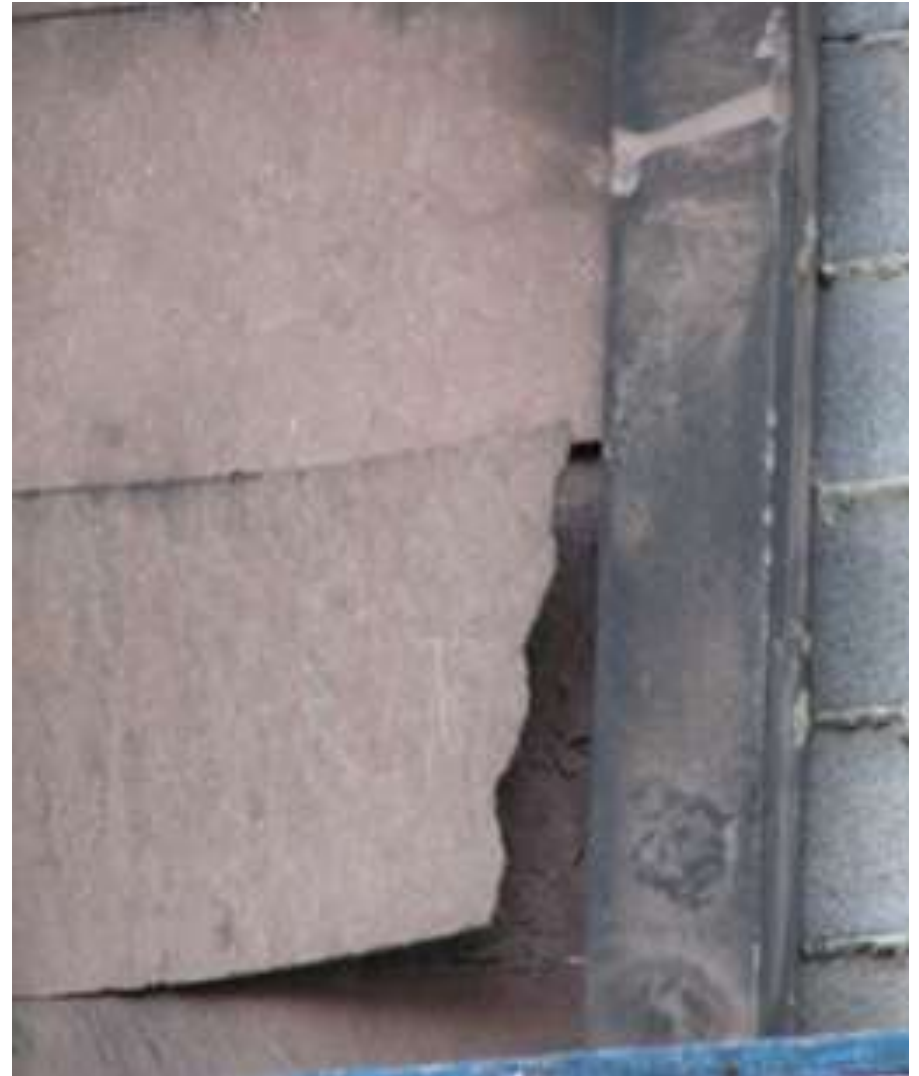
## 3.5.2 Exfoliating/Delaminating Brownstone

Improper original setting of brownstone and poor quality of brownstone allow weathering and delamination.

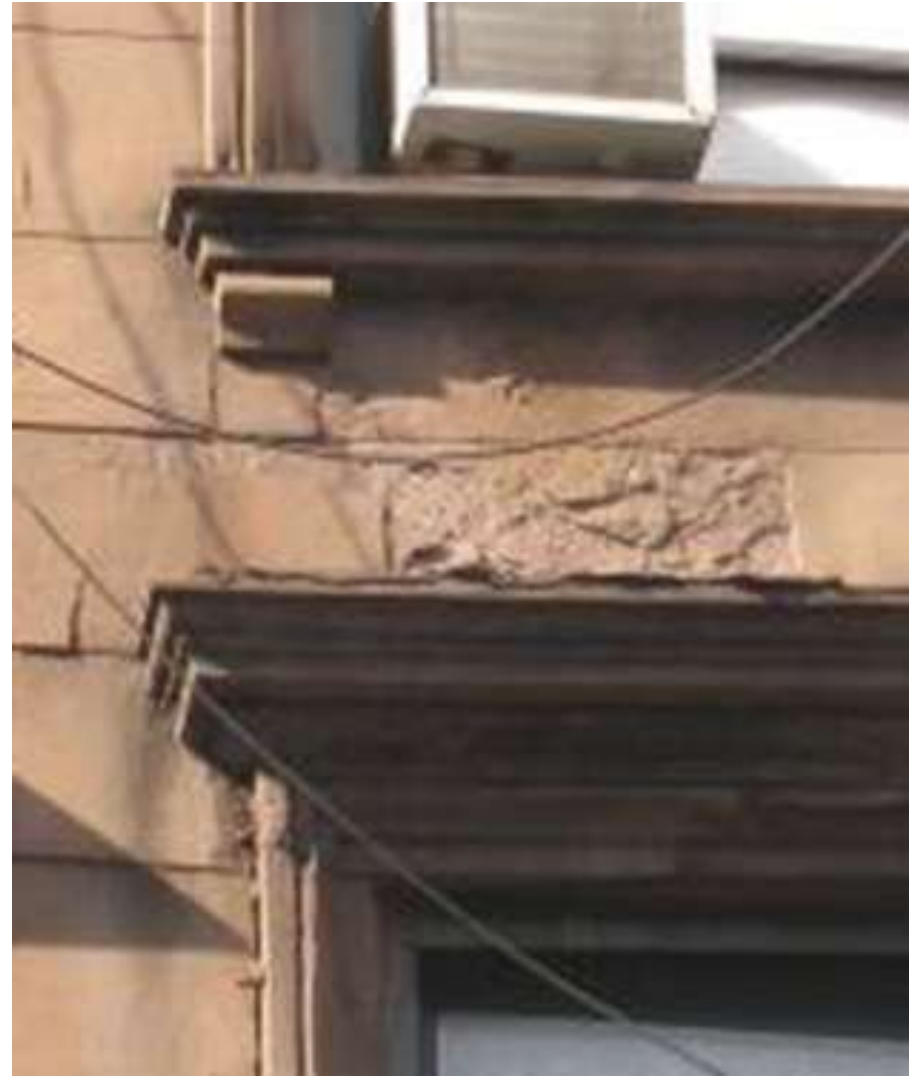
## 3.5.3 Scaling of Brownstone

Thin stone crust deterioration similar to fish scales. Separation does not follow stone structure.

Poor quality of brownstone allows weathering.

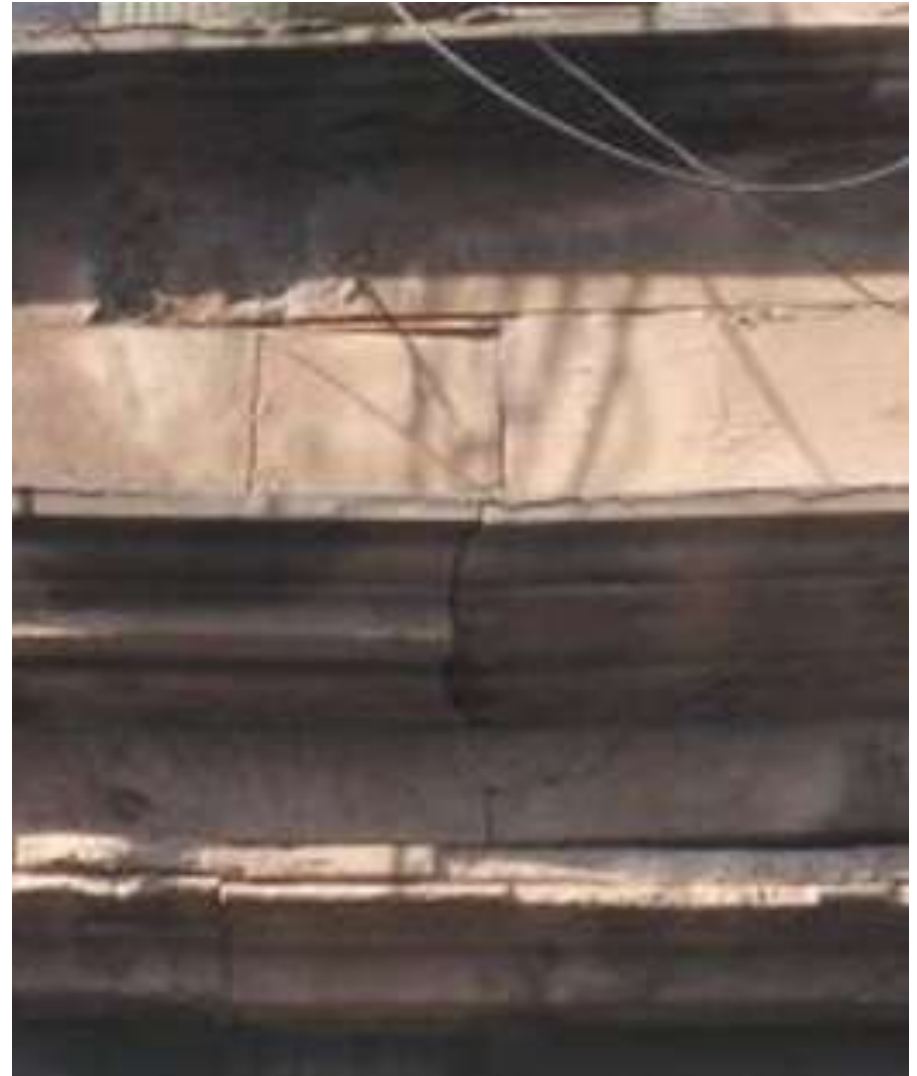
## 3.5.4 Sagging Brownstone Lintel

Separation of stones, deterioration or opening of joints between stone pieces.  
Deterioration of entire stone assemblage.

Improper original setting of brownstone.  
Deterioration of brownstone attachment to support. Deteriorating stones and joints allow water access and subsequent corrosion of the supporting steel.

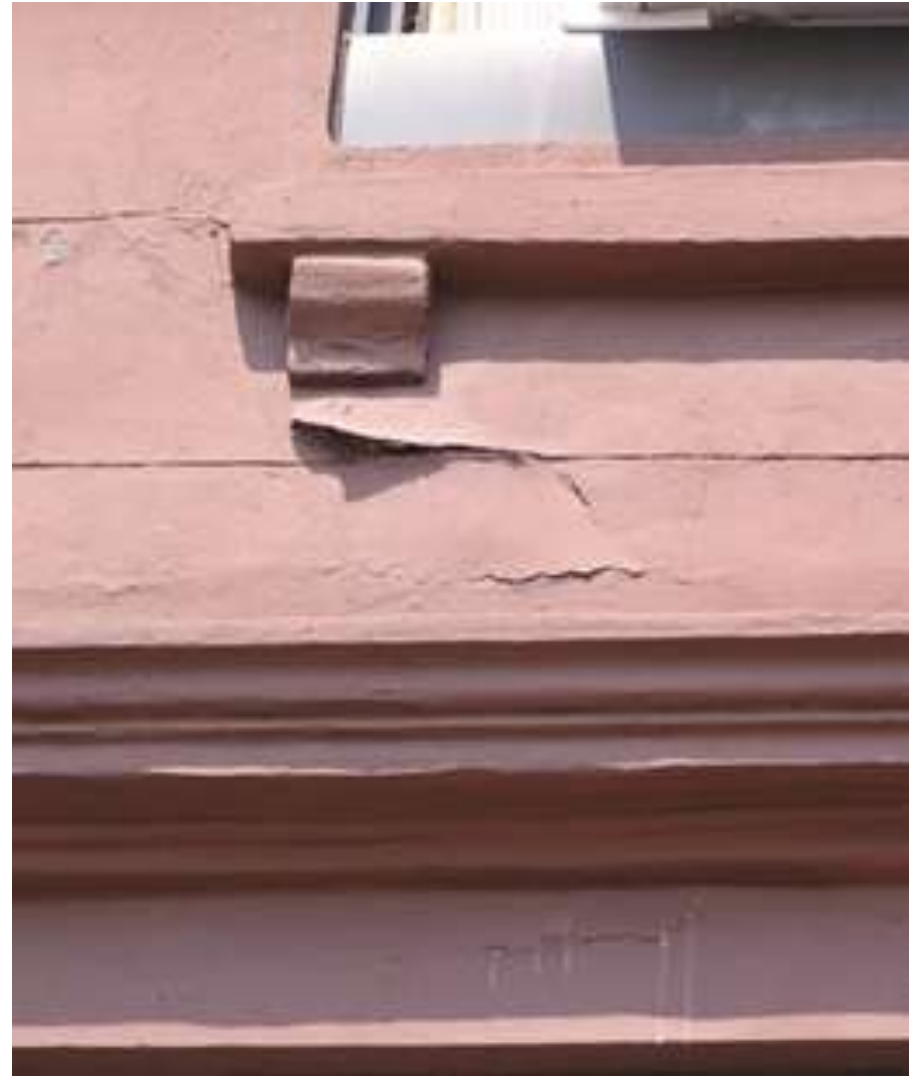
# 3.5.5 Failure of Brownstone Repair Coating

Trapped moisture turning to vapor (and exerting pressure on surface layer). Improper repair mix, insufficient removal of deteriorated brownstone. Improper surface preparation.

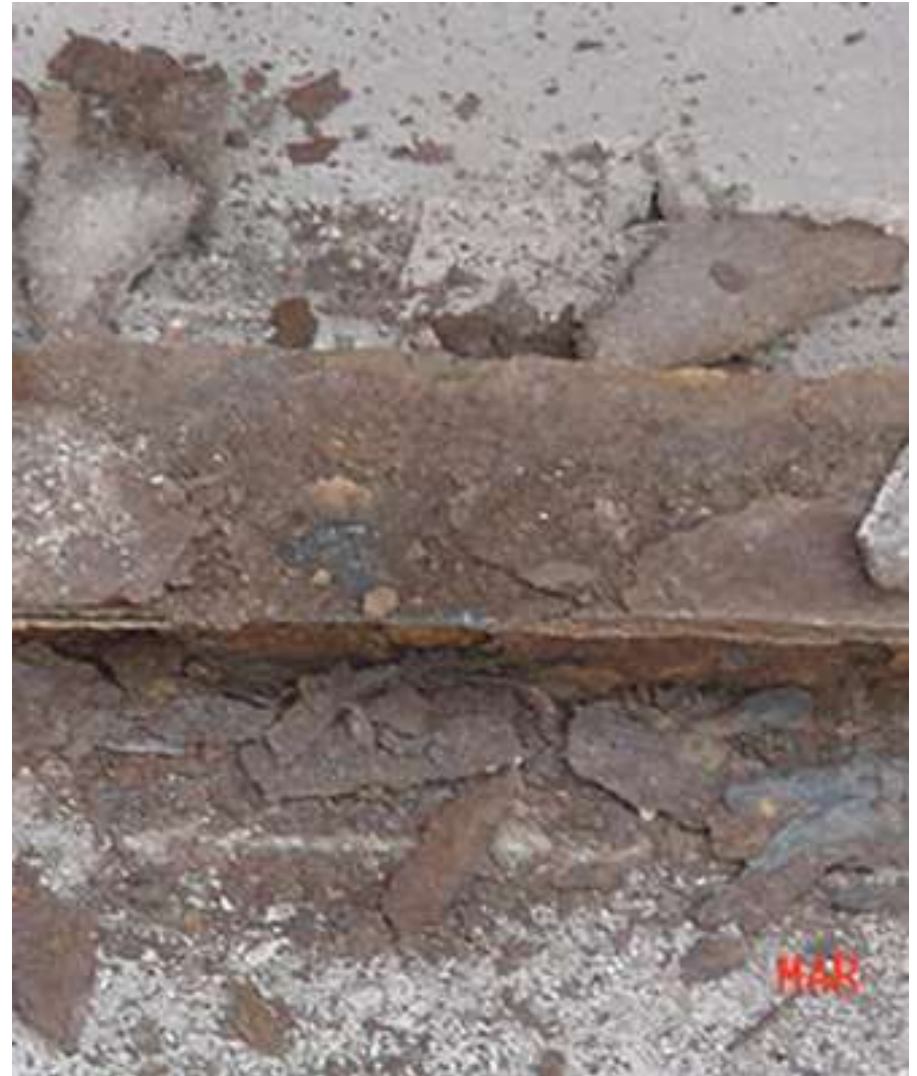
## 3.6 Corrosion of Metals

Metals can be found in buildings as basic components of the structure. They are also found in devices and systems used to support and/or anchor façade elements. Corrosion is the most common form of deterioration of metals in buildings. It is an electrochemical oxidation process that results in the deterioration (separation and loss of mass) of the metal.

Most commonly corrosion (rust) occurs on steel that is exposed to air and humidity. Other forms of corrosion are galvanic and pitting of metals. As steel is rarely present at the very surface of a façade, only in some cases can visual inspections directly determine presence of corrosion. But if rust is rarely visible, the damage resulting from “rust jacking“, cracks or movement of façade materials, can be easily observed. Corrosion of metals in buildings may affect not only the performance of the envelope but also the reliability of the structural frame.

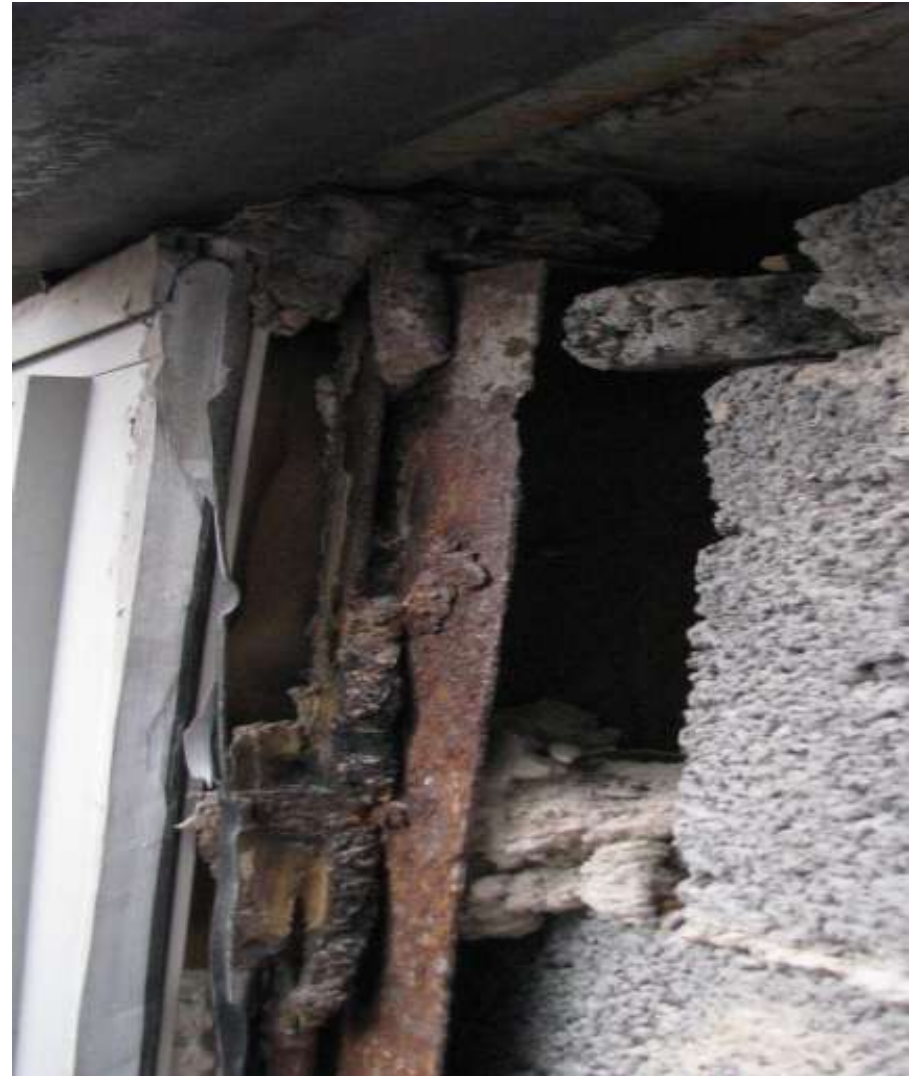
## 3.6.1 Corroding Window Frame

Steel Jamb corrosion, not visible without probing.

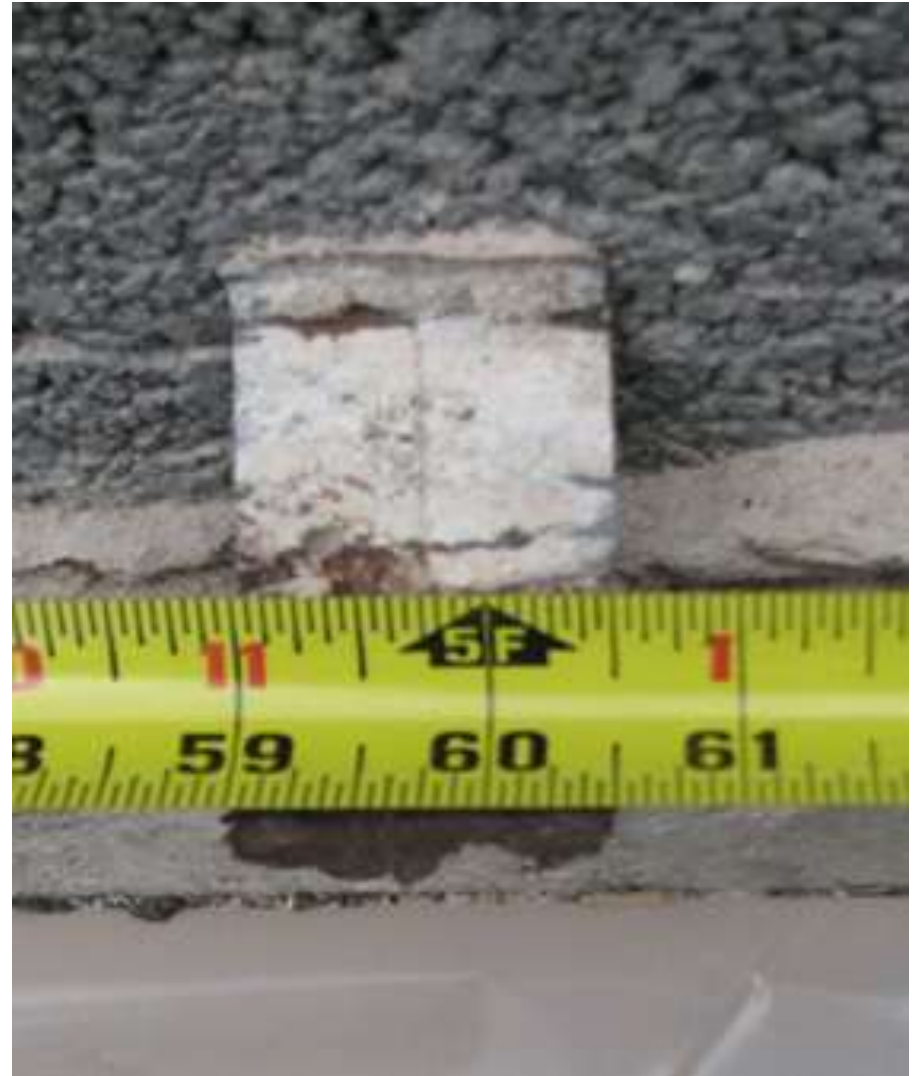
## 3.6.2 Corroding Veneer Anchor

Not visible without probing.  
Anchors should be galvanized or have other sufficient type of protection against rust.  
Stainless steel is preferred.

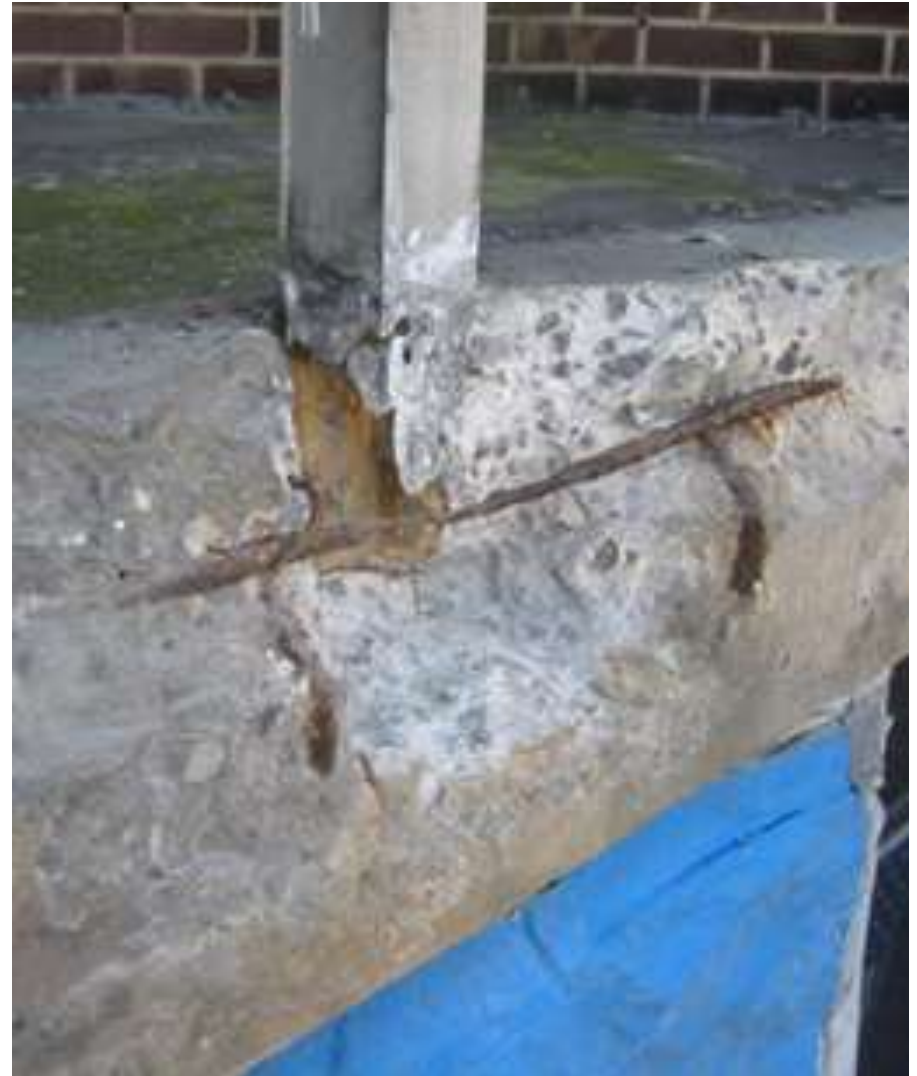
## 3.6.3 Galvanic Corrosion

Corrosion resulting from contact of two dissimilar metals. (e.g. aluminum post and steel reinforcing). Dissimilar metals should be isolated from each other.

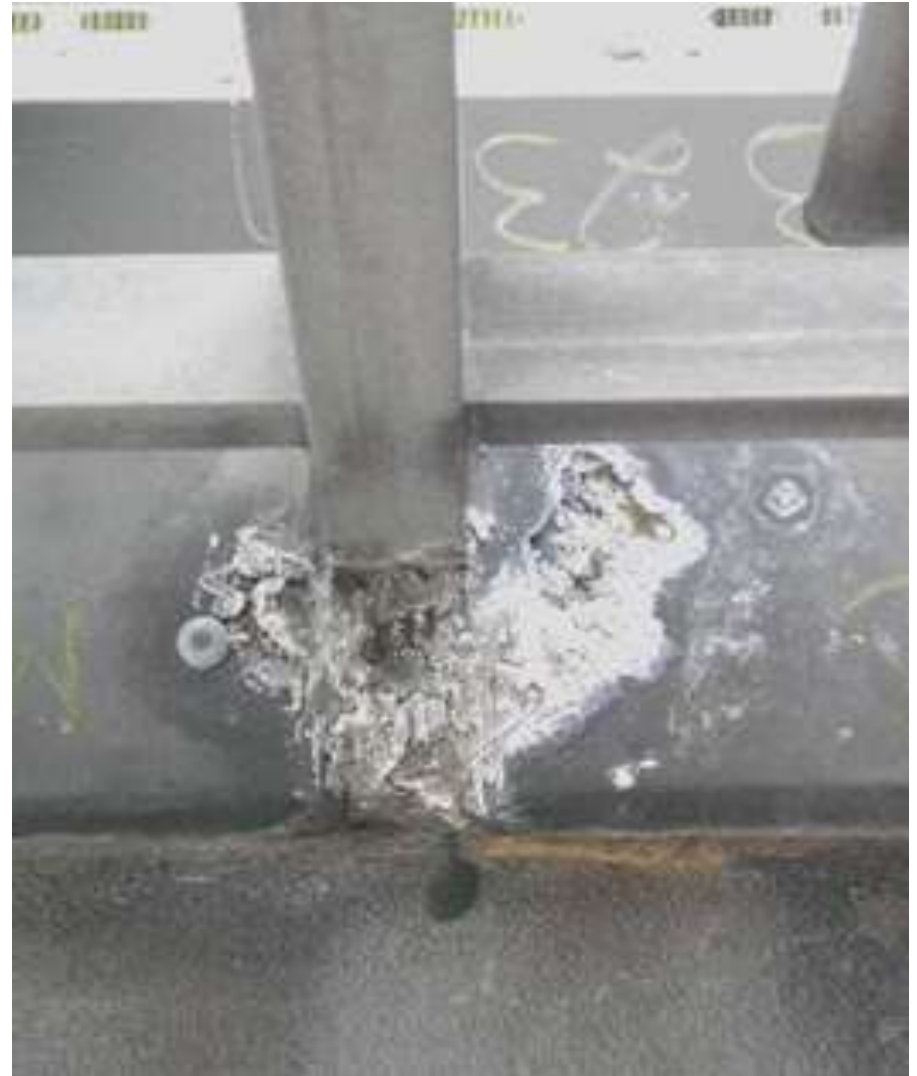
## 3.6.4 Pitting / Crevice Corrosion

Corrosion occurring due to stagnant chloride solution in holes. Can affect aluminum and stainless steel as well.
