# FAÇADE CONDITIONS

An Illustrated Glossary  
of Visual Symptoms

**Edited by Dan Eschenasy, PE**  
Chief Structural Engineer  
NYC Department of Buildings

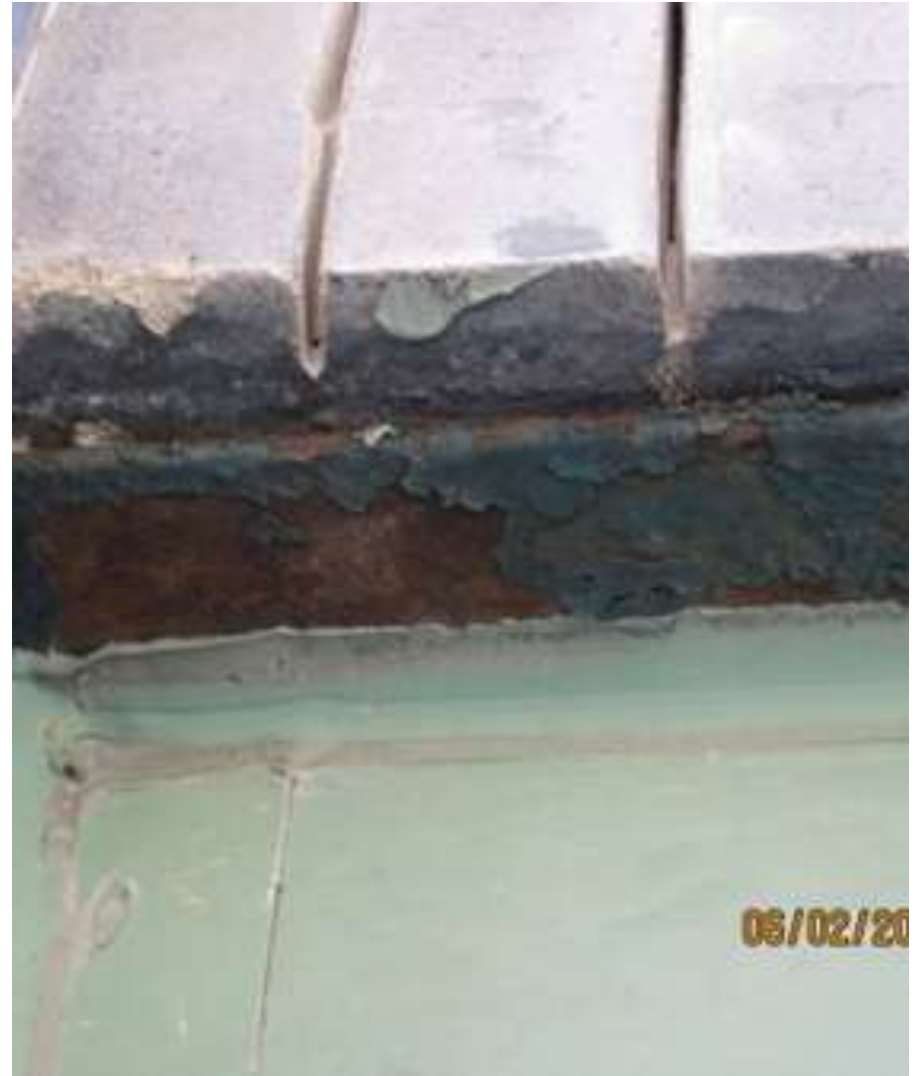
## 3.6.5 Loose, Flaking Paint

Paint is a steel protective treatment. Loss of paint due to weathering leads to the surface corrosion.

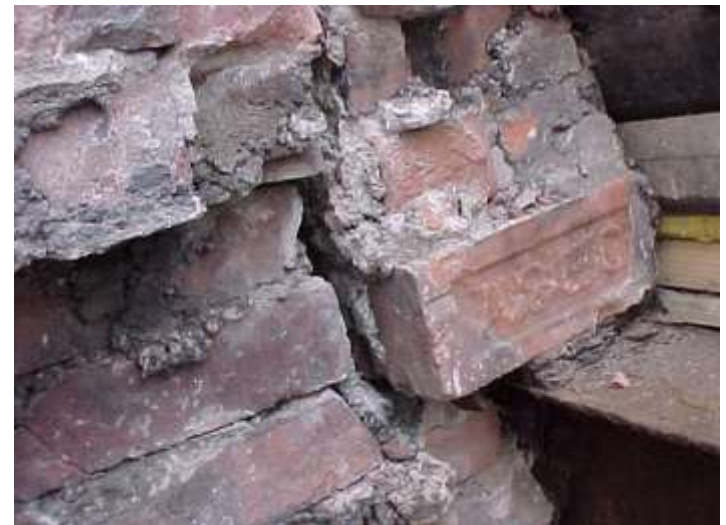
## 3.6.6 Corrosion Effects – “Rust Jacking”

*Rust jacking* is a term used in the vernacular to describe the pressure resulting from steel corrosion. The corrosion byproducts have a volume several times larger (4 to 6 times) than that of the steel. As corrosion continues over time the byproducts start to exert pressure (“jack”) on the adjoining materials. These materials might crack or deteriorate as they are subjected to forces they have not been designed for. (see incipient crack in bottom picture.)

The arrows in the top picture contrast a section of steel after corrosion products were cleaned off to a section where the rust “jacks” the brick vertically. The thickness of the cleaned steel is smaller than that of the original metal, while the thickness including the exfoliated rust is significantly larger than the original metal.

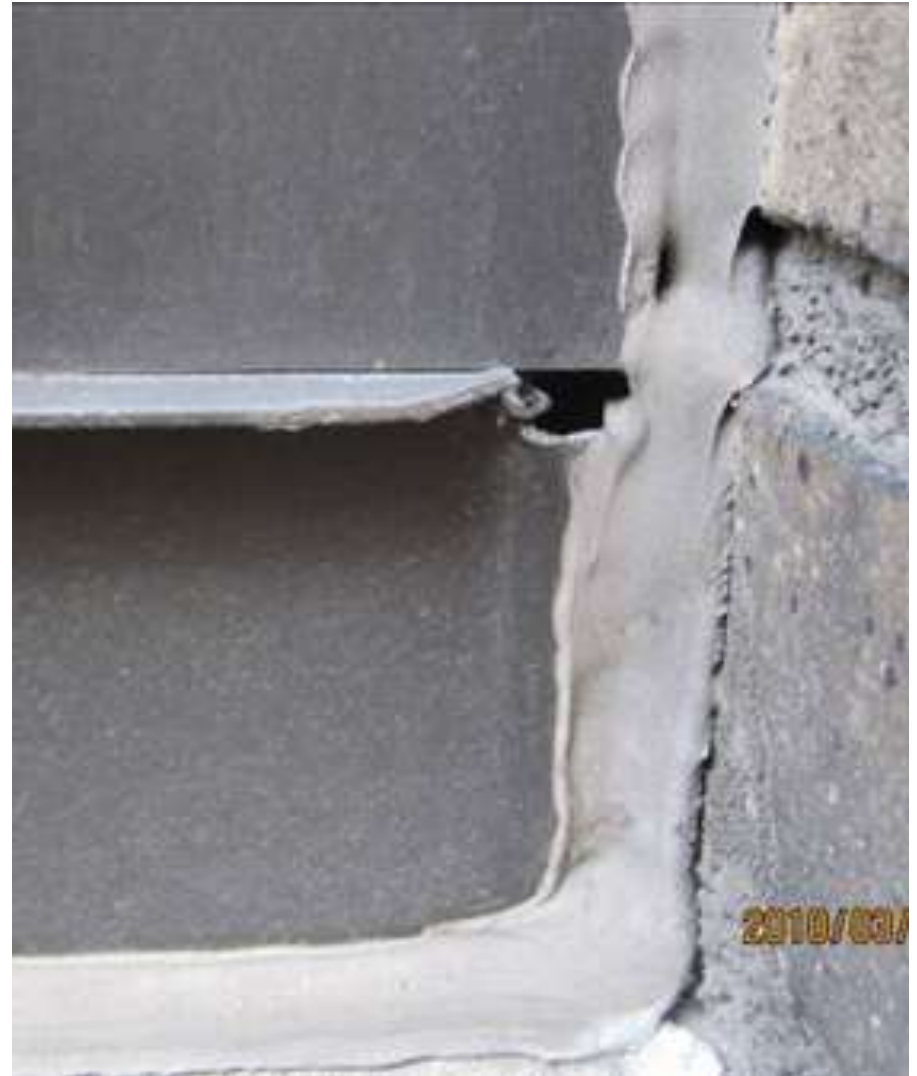
# 4.1.1 Missing / Curling Sealant Around Window Frame

Presence and condition of sealant. Signs of water infiltration.

Improper installation/application of sealant.  
Improper curing of urethane based sealant.  
Aging of sealant.

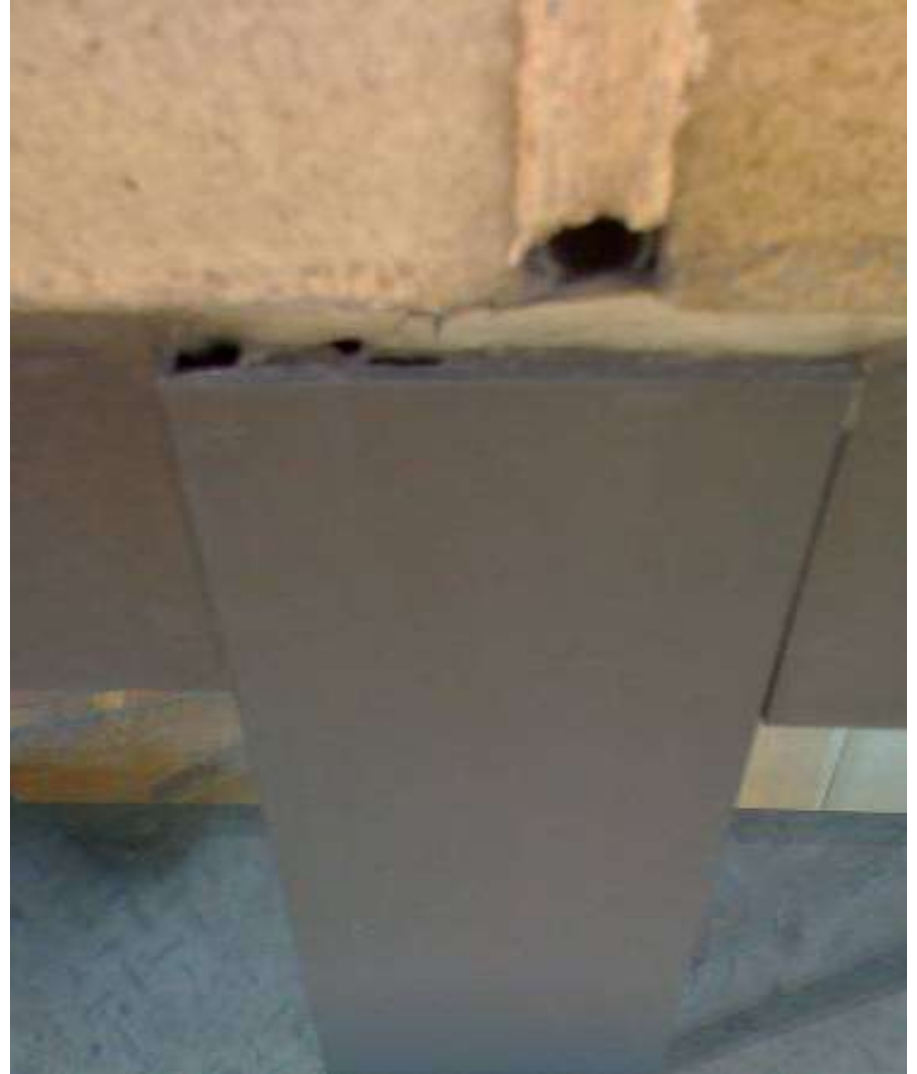
## 4.1.2 Gap in Sealant (Window Frame and Masonry)

Continuity of sealant. Condition of sealant.  
Signs of water infiltration.

Improper installation/application of sealant.  
Improper curing of sealant. Loss of elasticity  
of sealant due to aging. Adhesive failure.  
Loss of cohesion of sealant. Local rust of  
frame material. Organic growth.

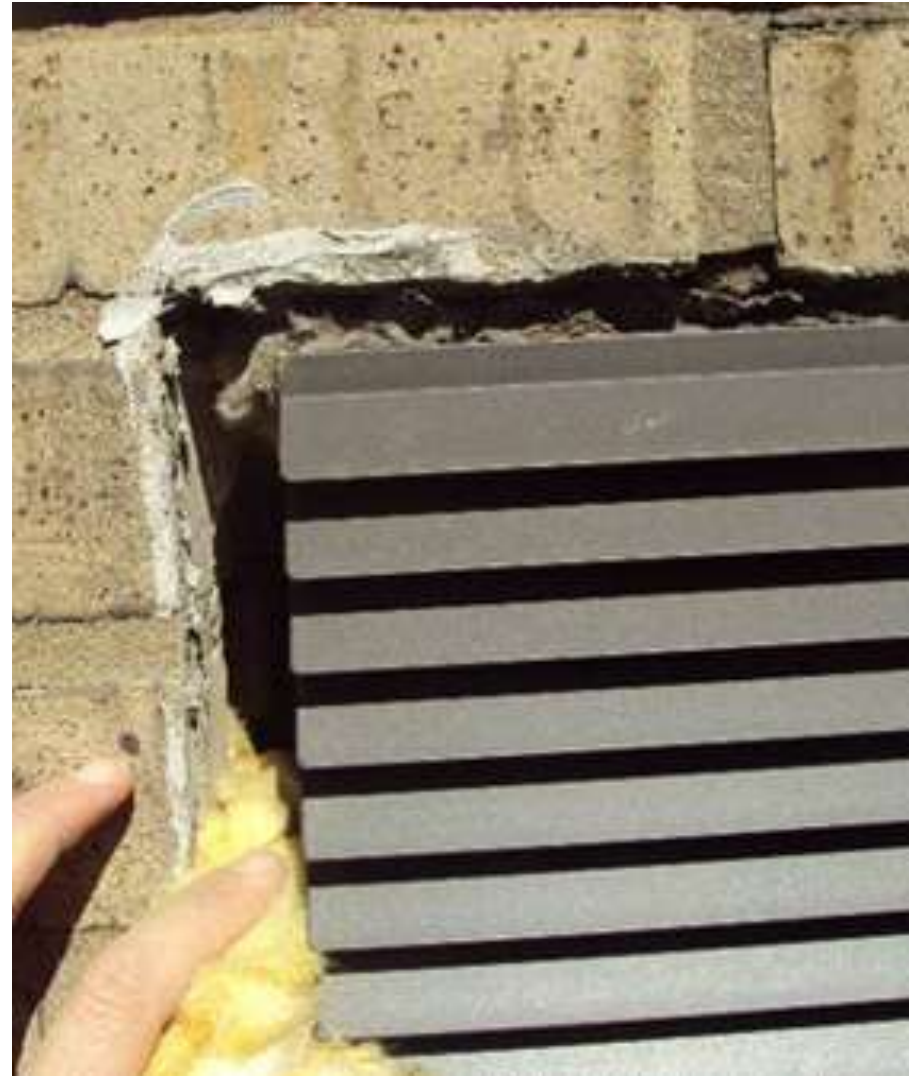
## 4.1.3 Missing Sealant at Sleeve

Presence and condition of sealant. Signs of water infiltration. Organic growth.

Improper original anchorage of louver or application of sealant. Aging or weathering of sealant. Improper size (undersized) of louver in rough masonry opening.

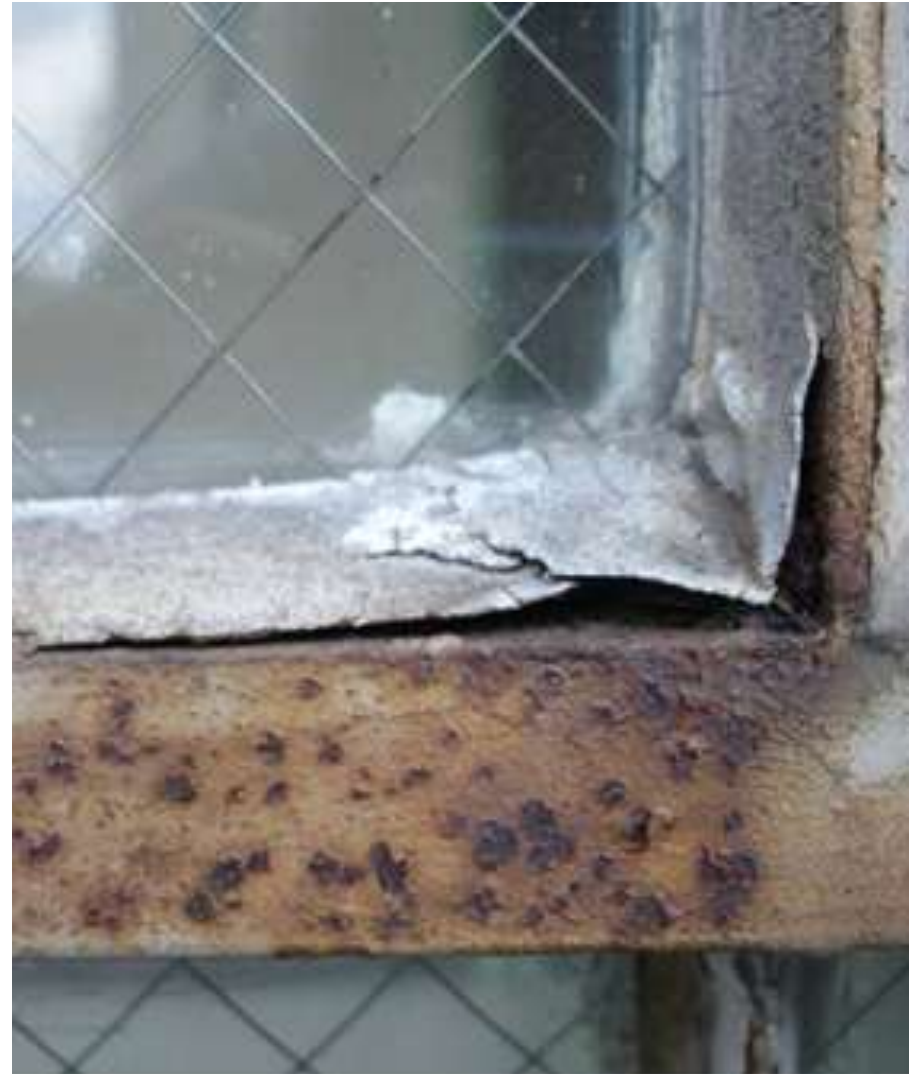
## 4.1.4 Dried/Cracked Caulking Around Glass

Missing or chipped sealant (caulking/putty) around window panel. Dried or cracked sealant.

Aging, weathering of sealant. Corrosion of base metal.

Water infiltration, increased rate of corrosion, loss of thickness.

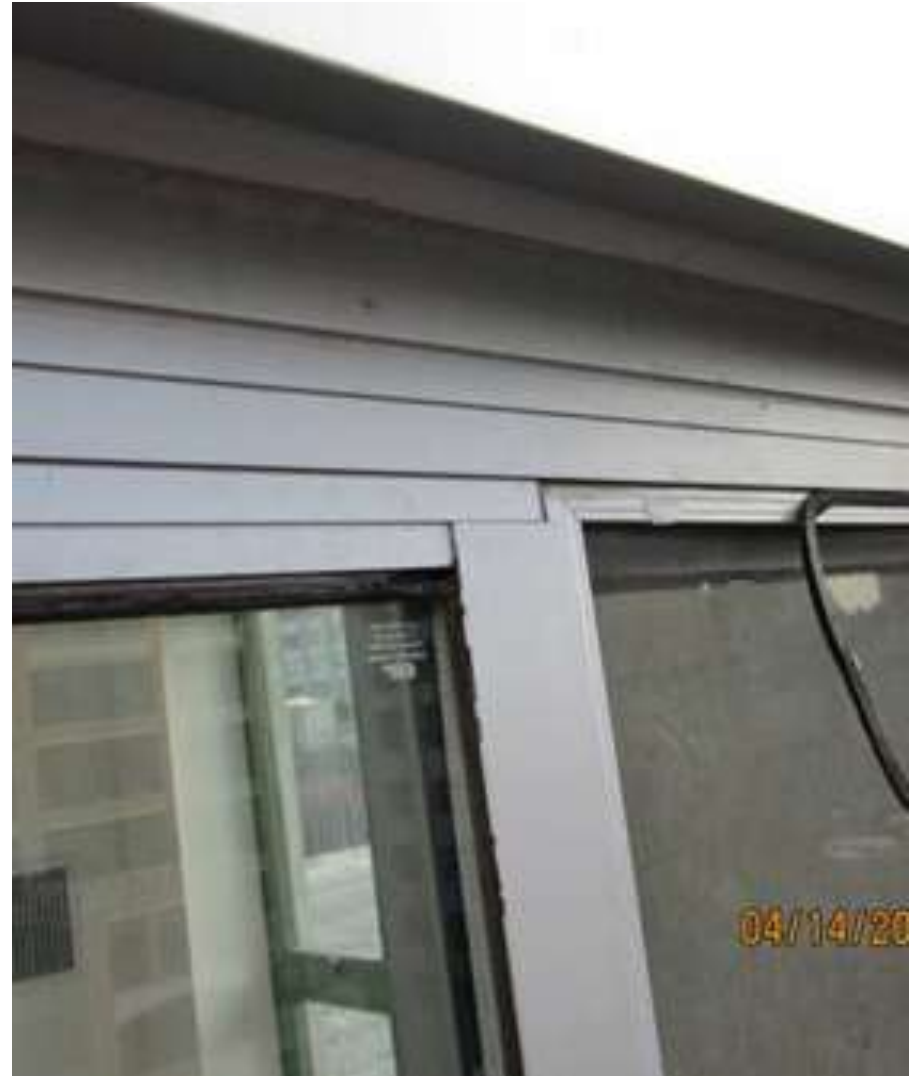
## 4.1.6 Hanging or Loose Gasket At Window Frame

Aging and weathering of gasket material, lack of adhesion.

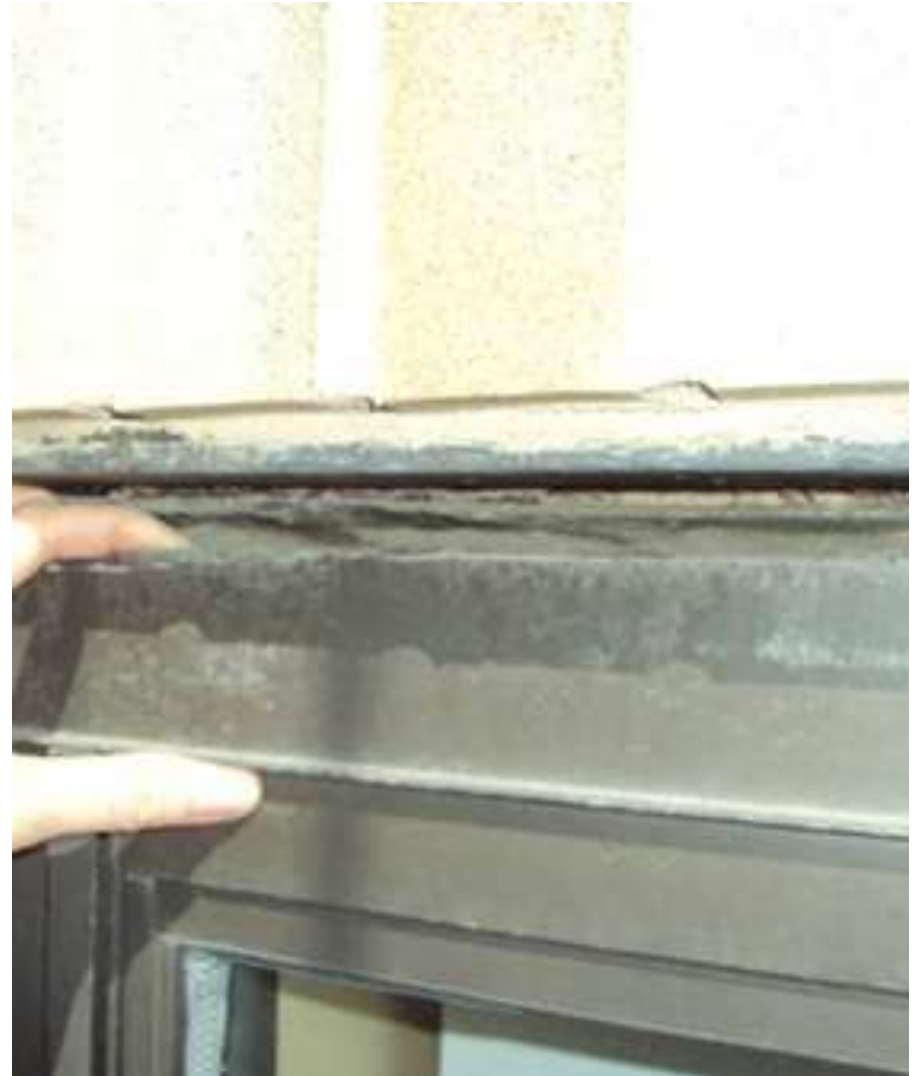
# 4.1.7 Loose Trim at Window Frame

Alignment of trim. Signs of water infiltration.

Deficient installation, age, water infiltration.  
Corrosion at lintel.

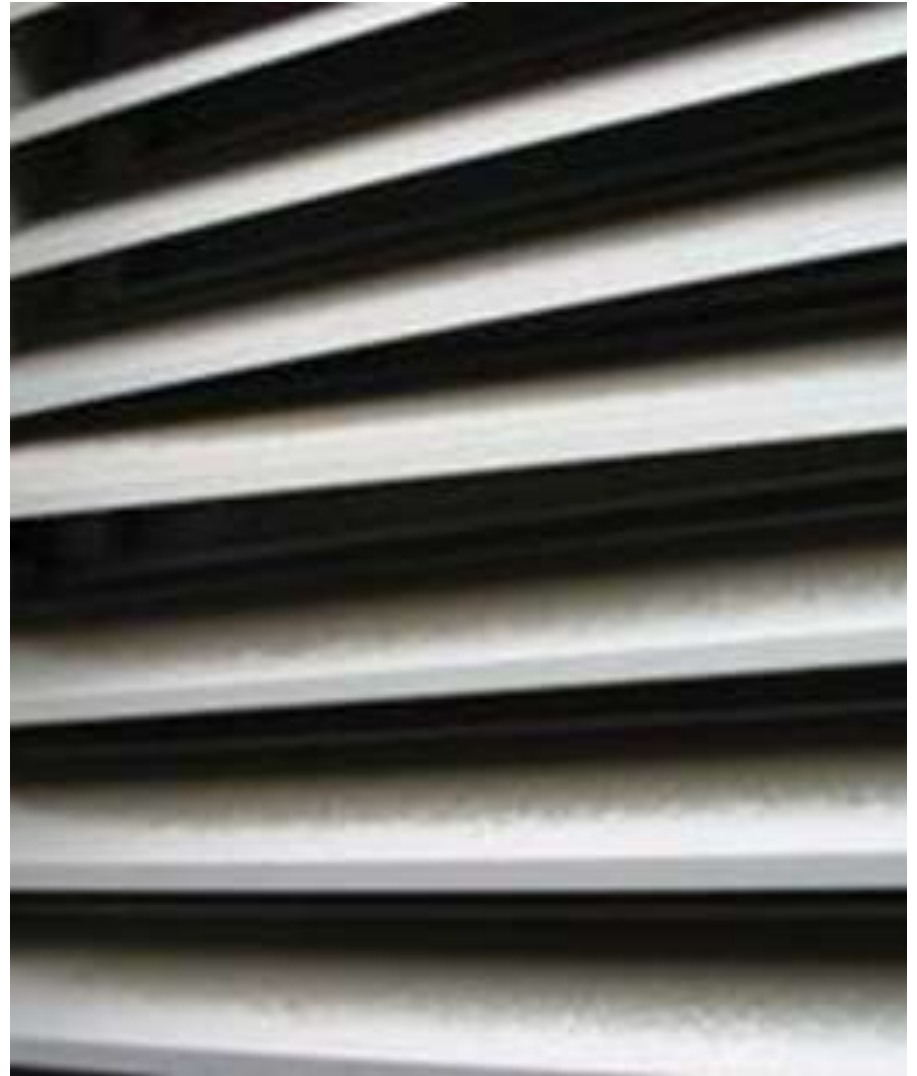
## 4.1.8 Loose Louver Blade

Installation defect. Deterioration of connection.

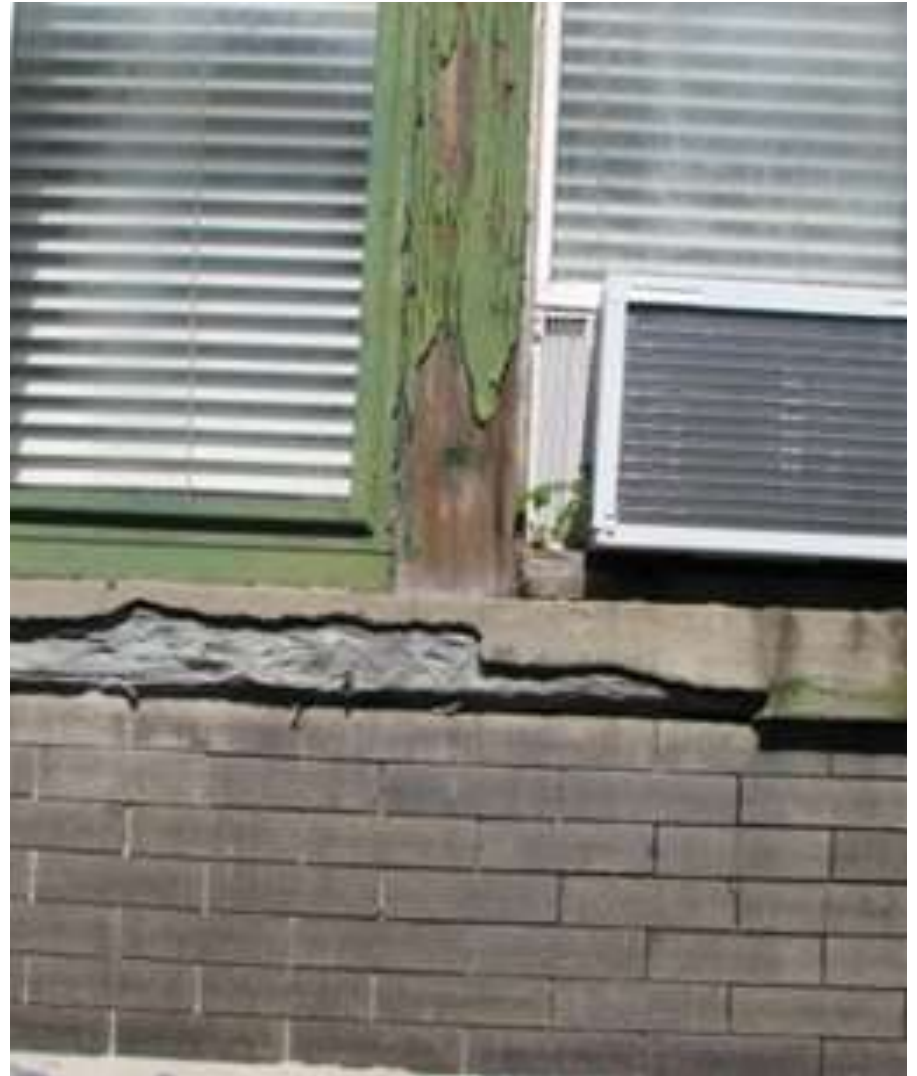
# 4.1.9 Deteriorating Window Frame (Wood)

Condition of frame. Condition of paint.  
Water stains. Decay of wood.  
Splitting of wood.

Aging and weathering of protective paint.  
Inadequacy of paint.

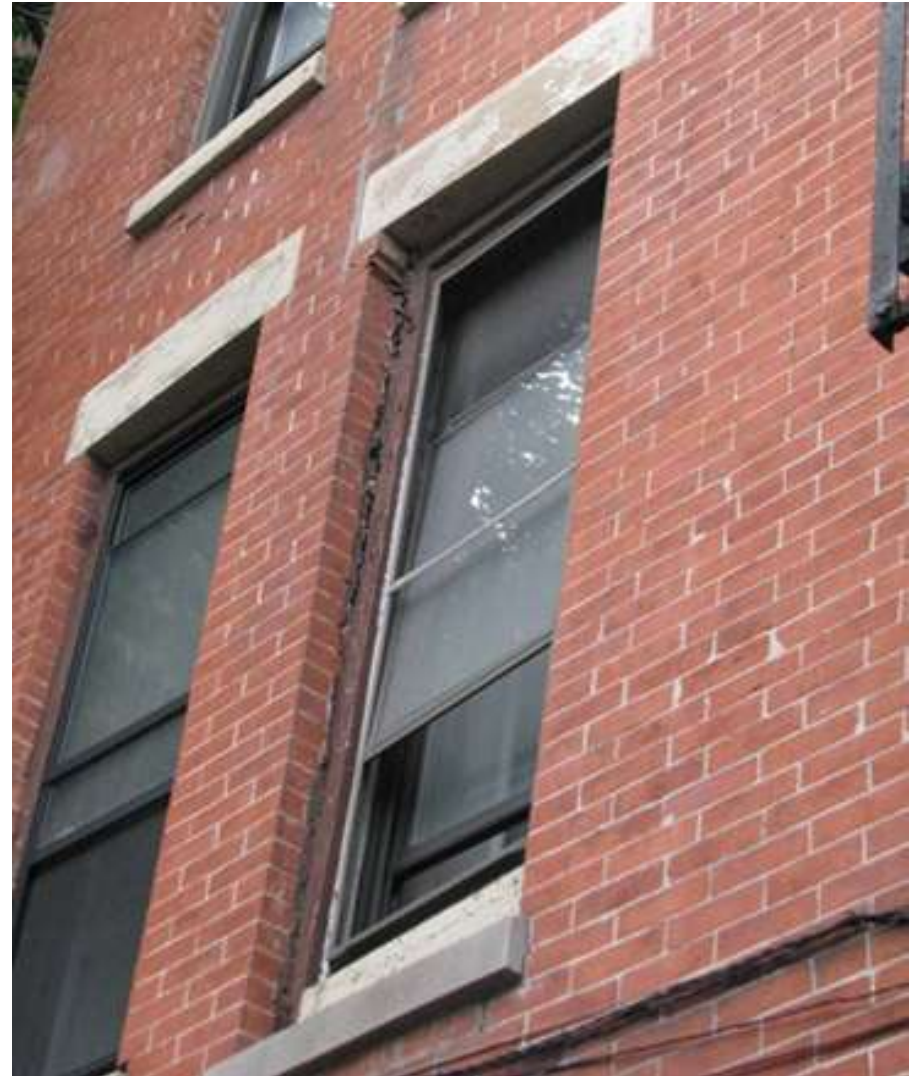
# 4.1.10 Wood Frame Separated From Brick and Displaced

Condition of frame. Frame alignment. Cracks, voids around frame.

Decay of wood. Shrinkage of wood.  
Inadequacy of frame attachment to masonry.

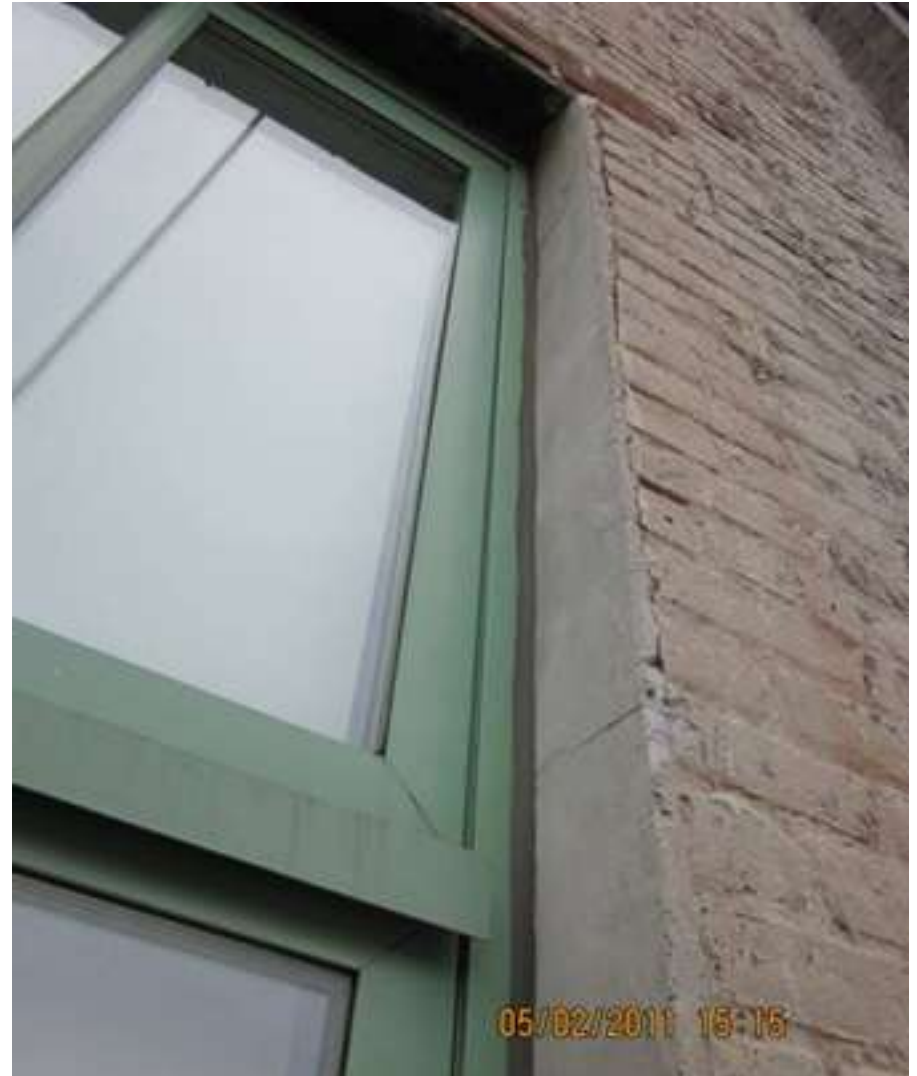
# 4.1.11 Cracked Parging at Window Jamb

Condition of parging around opening

Differential movement. Insufficient thickness of parging, lack of mesh in parging. Corrosion at concealed anchors.

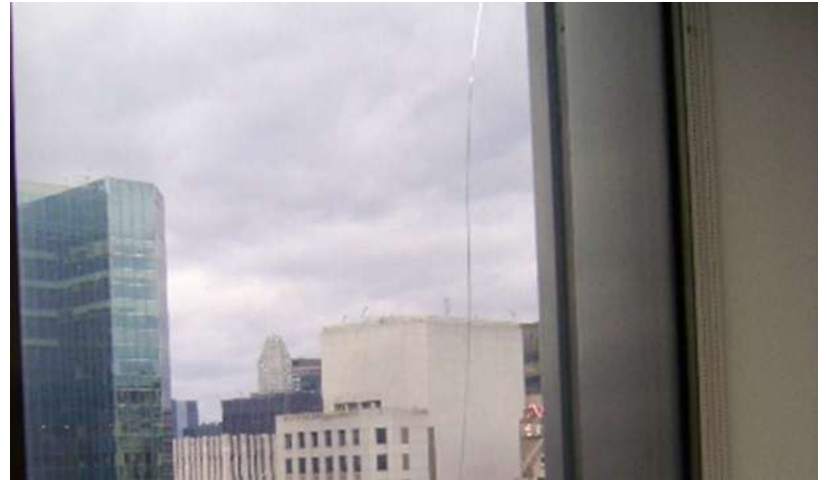
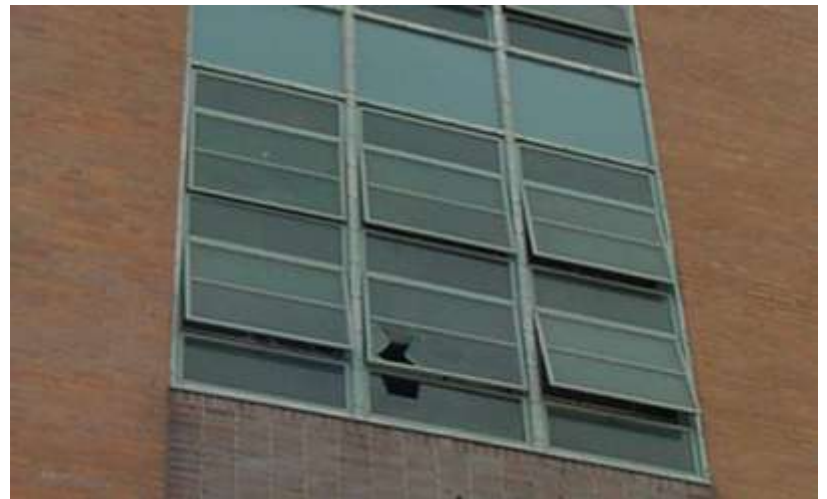
# 4.1.12 Cracked/Broken Glass

Integrity.

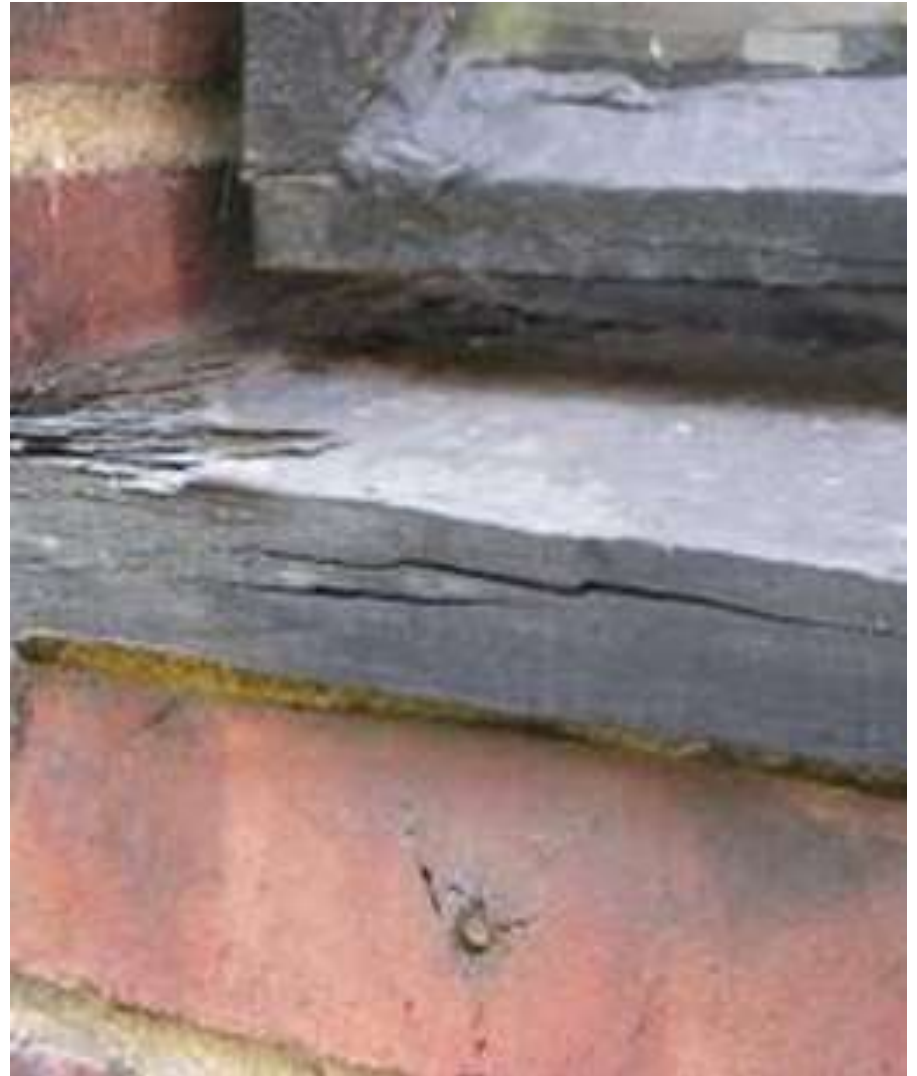
# 4.2.1 Exfoliating of Slate Window Sill

Loose shards, horizontal separation along stone layers.

Poor stone quality. Water infiltration and freeze/thaw cycles separate the bedding planes of the stone.

Additional water penetration and icing.

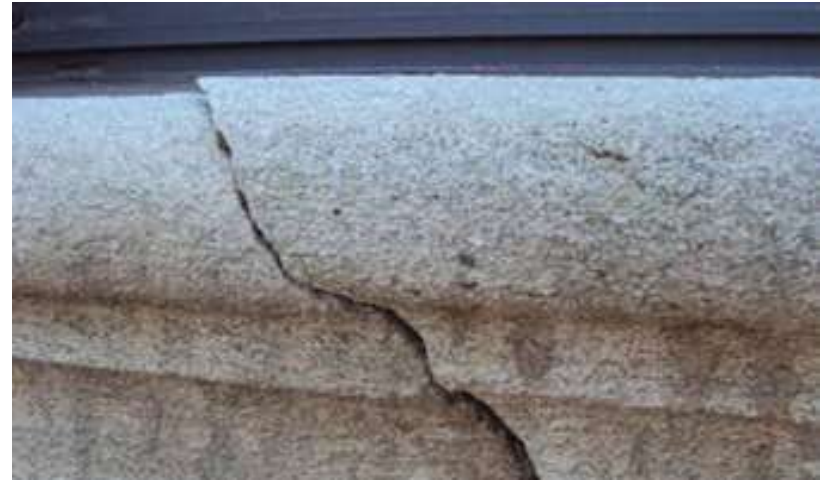
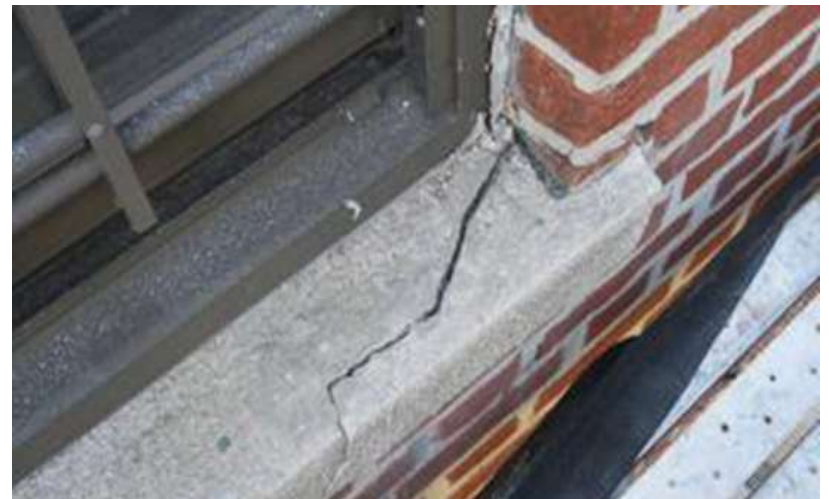
## 4.2.3 Masonry Cracks Around Sill

### ***What To Look For:***

Location and size of crack. Deformation at window frame, condition of sealant, protrusions in adjacent façade areas that should be flush or smooth.

### ***Probable Causes/Deficiencies:***

Overstress due to movement/load transfer from above or behind. Corrosion of concealed anchor.

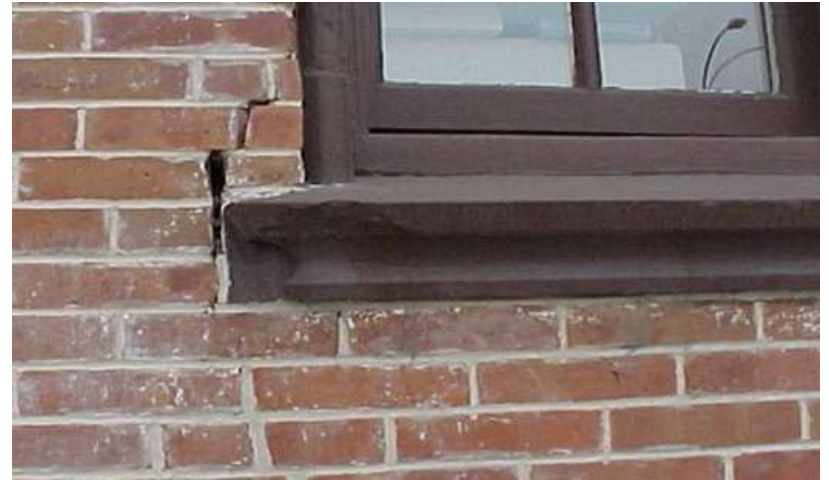
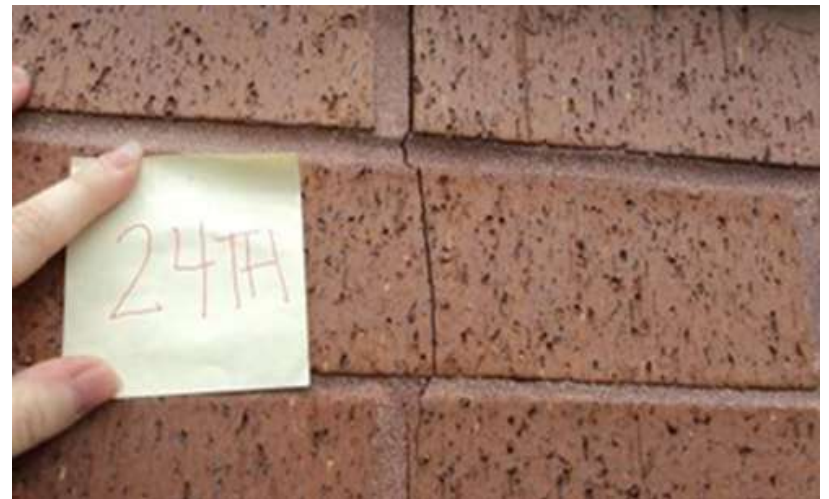
## 4.2.4 Corroding Lintel In Masonry (Isolated Lintel)

### ***What To Look For:***

Presence of rust or rust stains, changes in apparent thickness of flange of steel lintel, especially at the support end embedded in masonry, cracks in masonry. Photo displays insufficiently repaired lintel corrosion.

### ***Probable Causes/Deficiencies:***

Lack of corrosion protection (flashing or paint). Lintel installed too close to exterior face of brick.

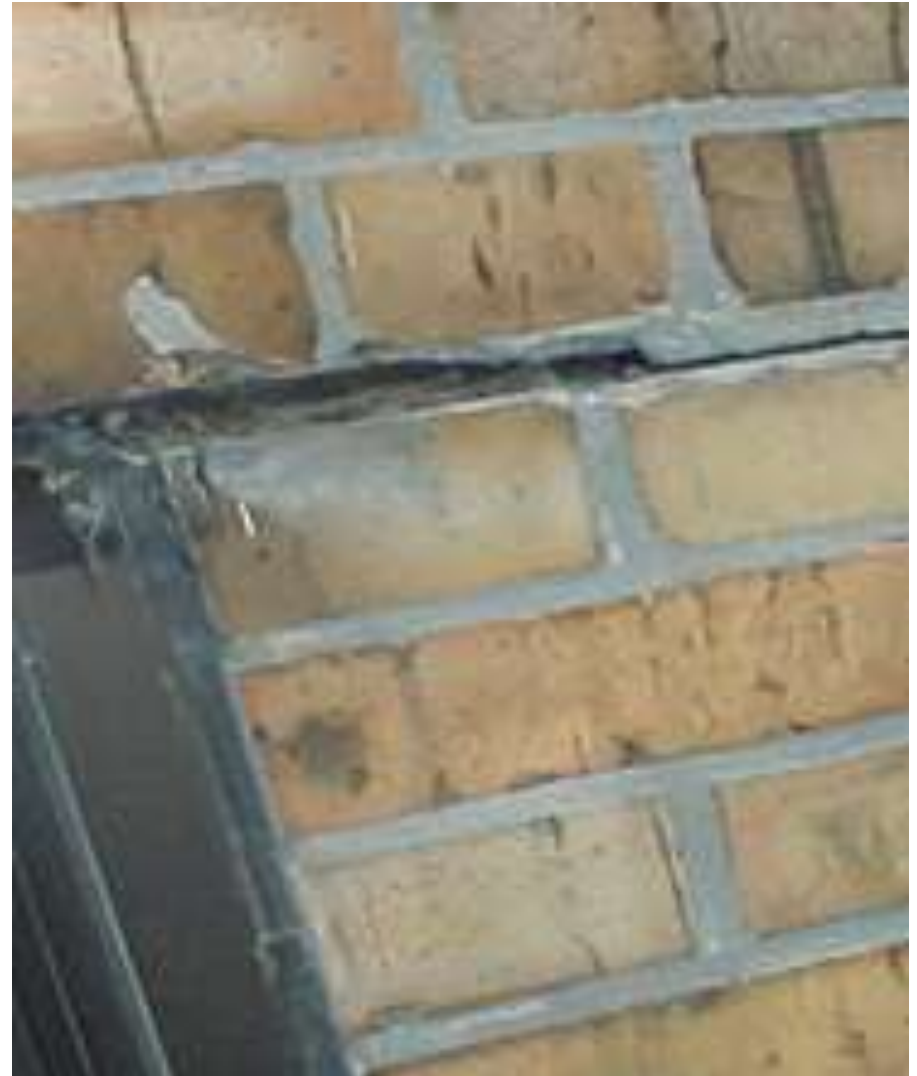
## 4.2.5 Masonry Crack Due to Lintel Corrosion

### ***What To Look For:***

Cracks in masonry originating at the end of the steel lintel. Direction and size of cracks. Cracks usually start at end of steel lintel but do not extend to adjoining openings.

### ***Probable Causes/Deficiencies:***

Rust jacking at embedded end of lintel.

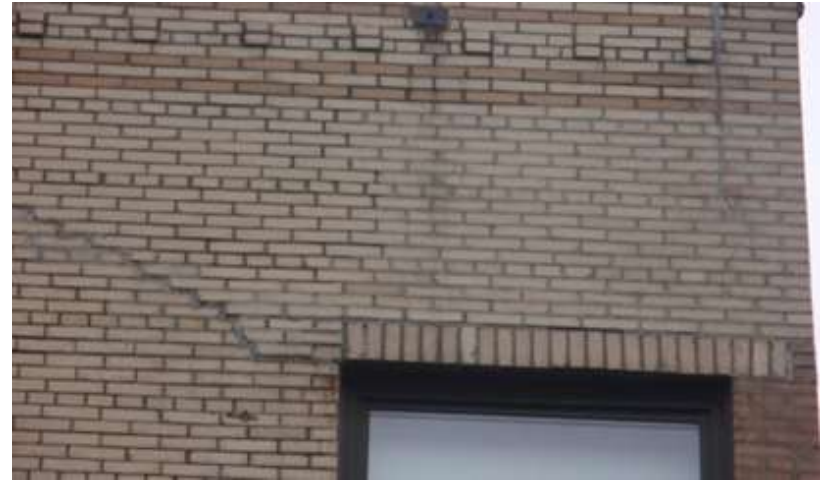
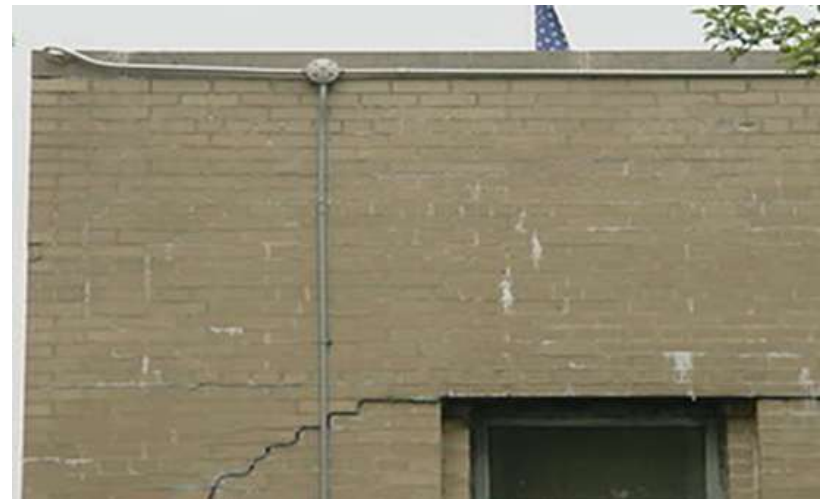
## 4.2.6 Bowed Steel Lintel

***What To Look For:***

Horizontality of lintel. Presence of rust or rust stains. Gap between lintel and masonry units above. Deformation of window frame.

***Probable Causes/Deficiencies:***

Corrosion around lintel mid-span. Absence or deterioration of corrosion protection. Improperly sized steel.

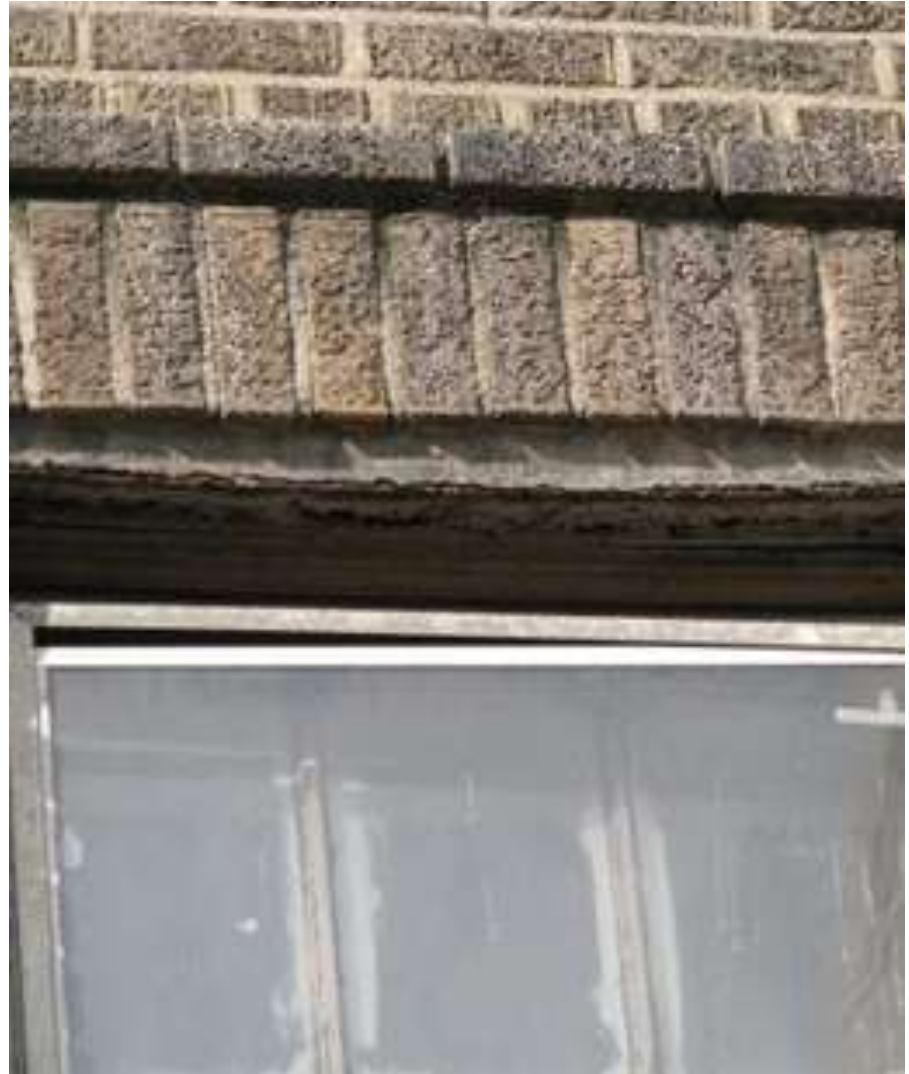
## 4.2.7 Crack at Underside of Stone Lintel

***What To Look For:***

Condition of decorative stone/concrete covering steel lintel. Observe from below.

***Probable Causes/Deficiencies:***

Rust jacking allowed by insufficient or missing corrosion protection. Differential deformation lintel and stone covering.

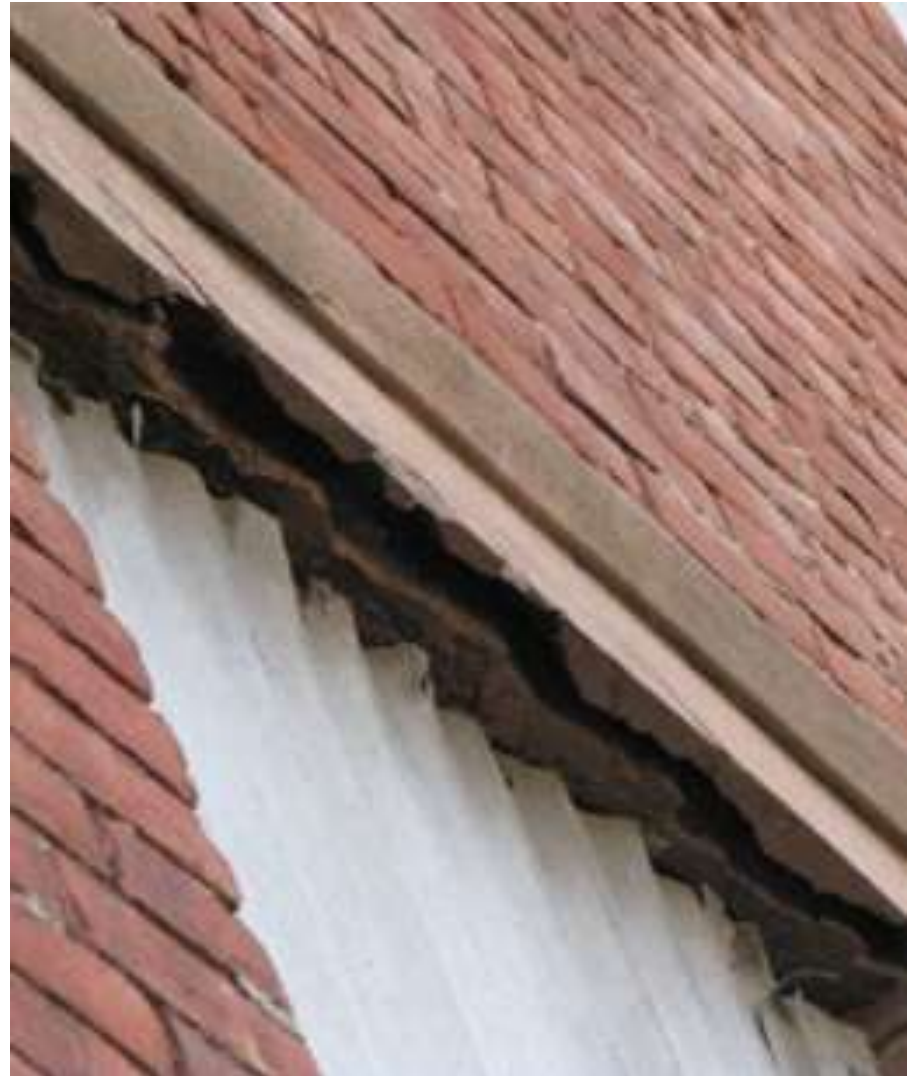
## 4.2.8 Loose, Flaking Paint at Steel Lintel/Frame

### ***What To Look For:***

Adherence and condition of paint, signs of corrosion, loss of steel thickness.

### ***Probable Causes/Deficiencies:***

Aging, weathering, paint type non-compatible with substrate, poorly installed flashing.

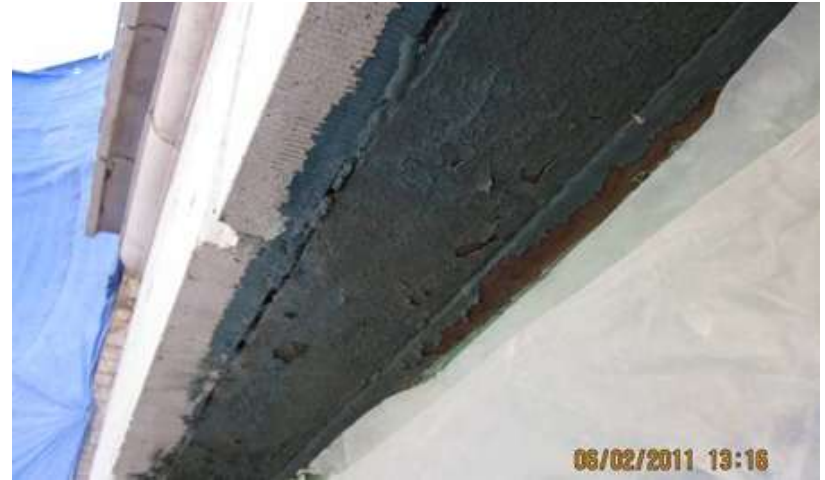
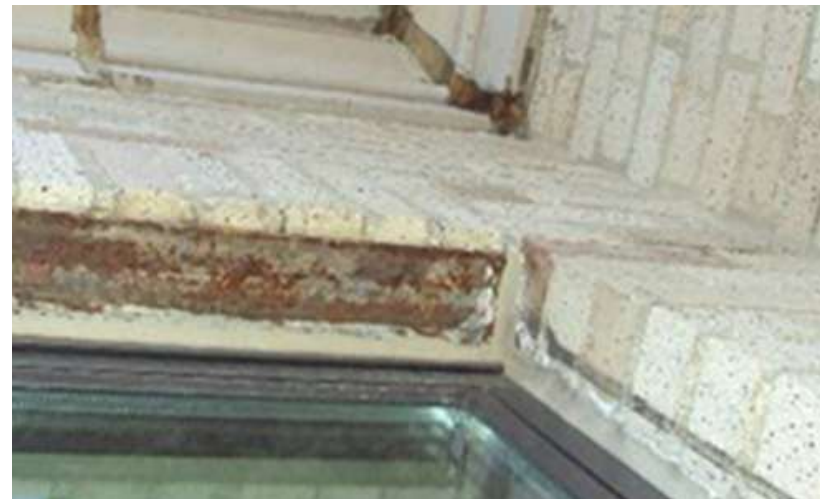
## 4.2.9 Loss of Cast Stone Unit

***What To Look For:***

Missing or deteriorated cast stone unit.

***Probable Causes/Deficiencies:***

Rust jacking. Differential deformation lintel and stone covering. Lack of anchorage. Removed as a precautionary measure.

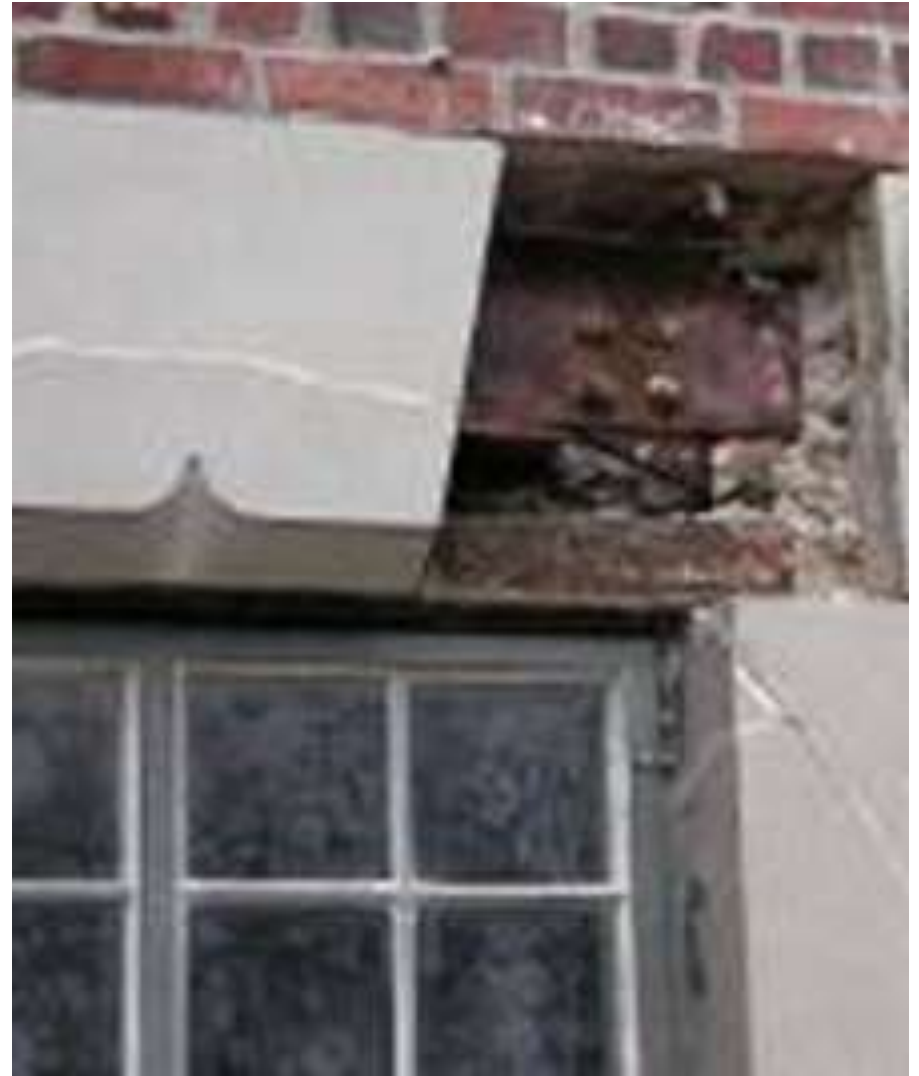
# 4.2.10 Crack of Masonry Jamb at Inserts

## ***What To Look For:***

Condition of jamb, presence of cracks originating at embedded bars and/or anchorages. Condition of window frame.

## ***Probable Causes/Deficiencies:***

Rust jacking.

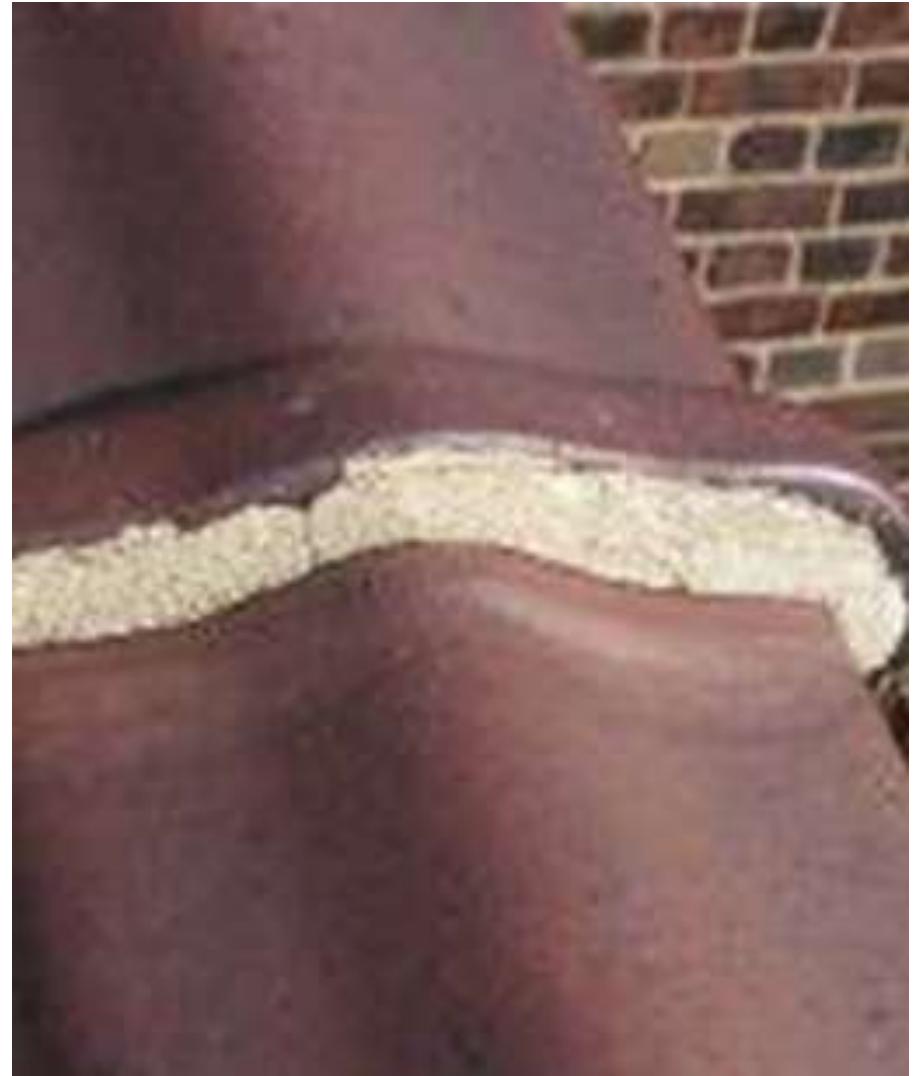
# 4.3.3 Failure of Sealant – Coping Stone Cross Joint

## ***What To Look For:***

Lack of continuity in jointing material.  
Inadequate joint dimension.

## ***Probable Causes/Deficiencies:***

Poor original construction /material.  
Excessive water penetration in adjoining masonry. Aging and deterioration of cohesiveness and elasticity of jointing material. Excessive movement of coping stone.
