# FAÇADE CONDITIONS

An Illustrated Glossary  
of Visual Symptoms

**Edited by Dan Eschenasy, PE**  
Chief Structural Engineer  
NYC Department of Buildings

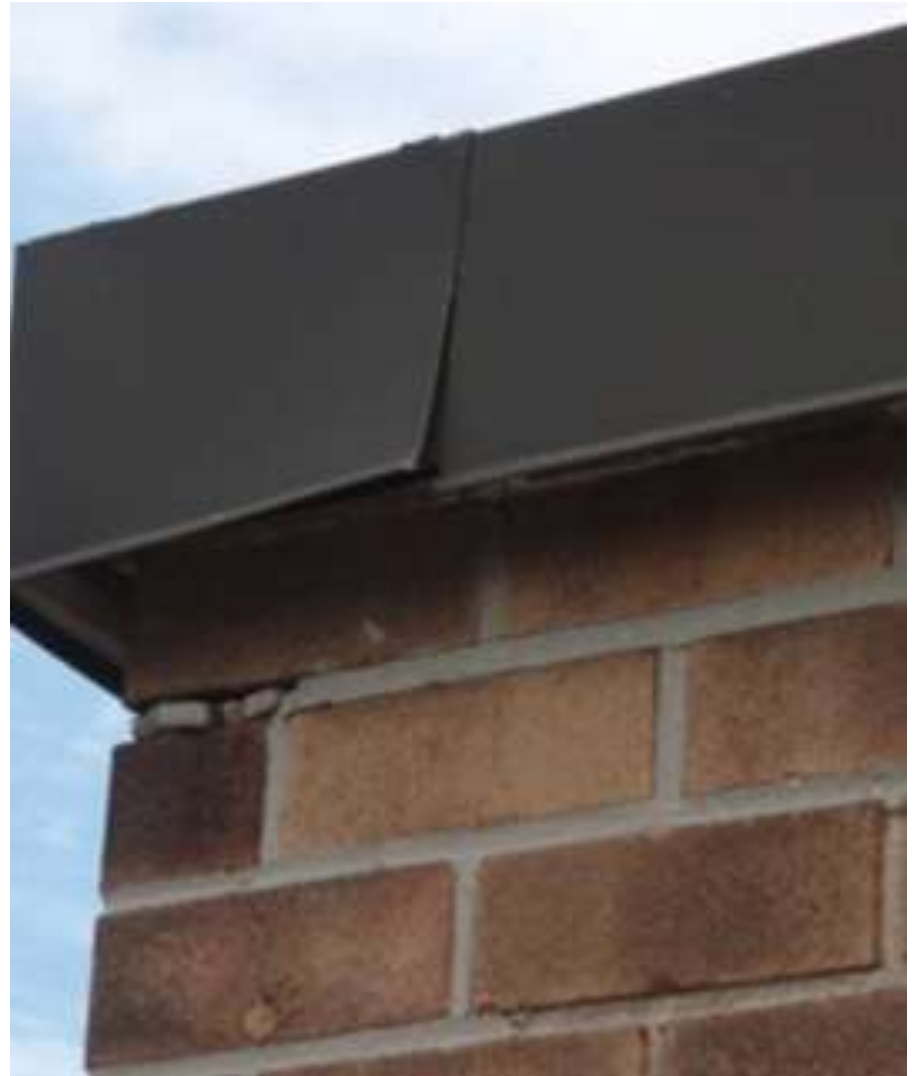
## 4.3.5 Misalignment of Coping Stone

***Probable Causes/Deficiencies:***

Out of plane movement of parapet and masonry below, thermal movement of parapet.

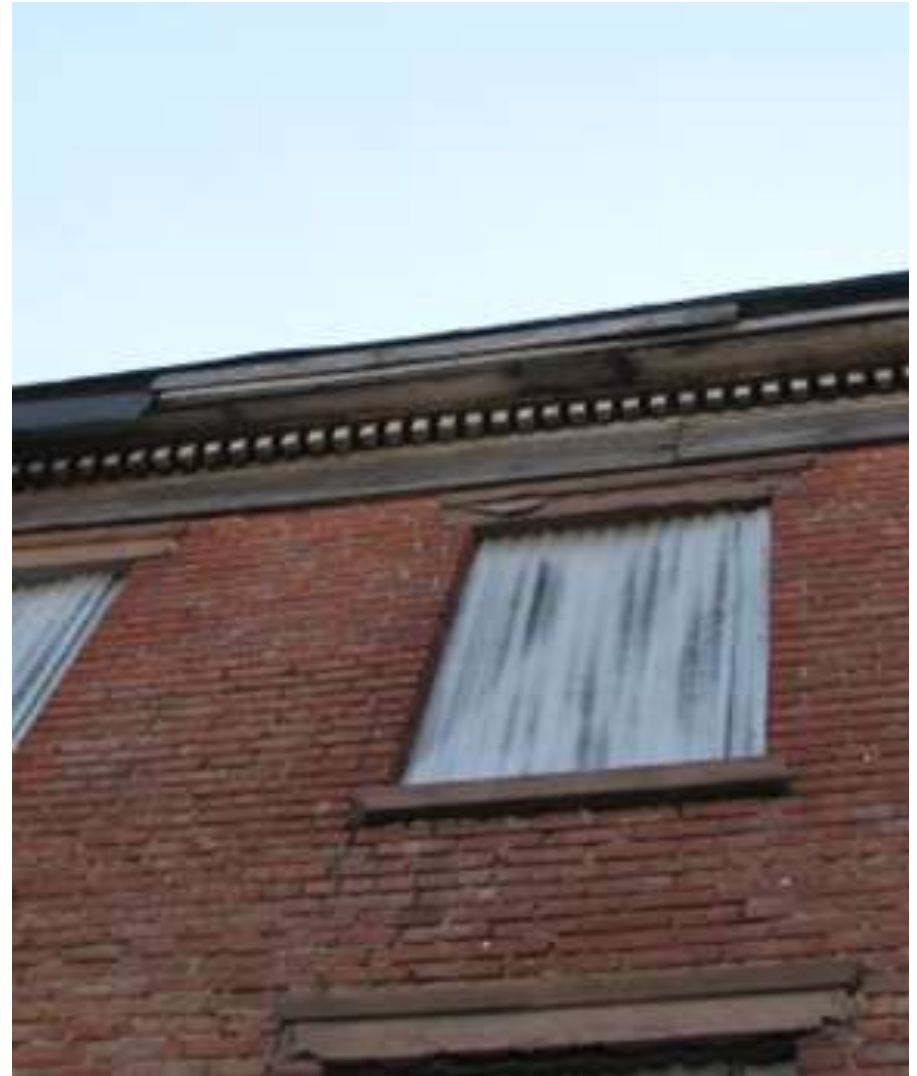
# 4.3.12 Corrosion of Sheet Metal Cornice

## ***What To Look For:***

Deterioration of sheet metal. Rust or white coloration. Holes. Missing sections.

## ***Probable Causes/Deficiencies:***

Insufficient thickness of original tin sheet or tin covering layer. Improper fabrication.

Improper anchorage

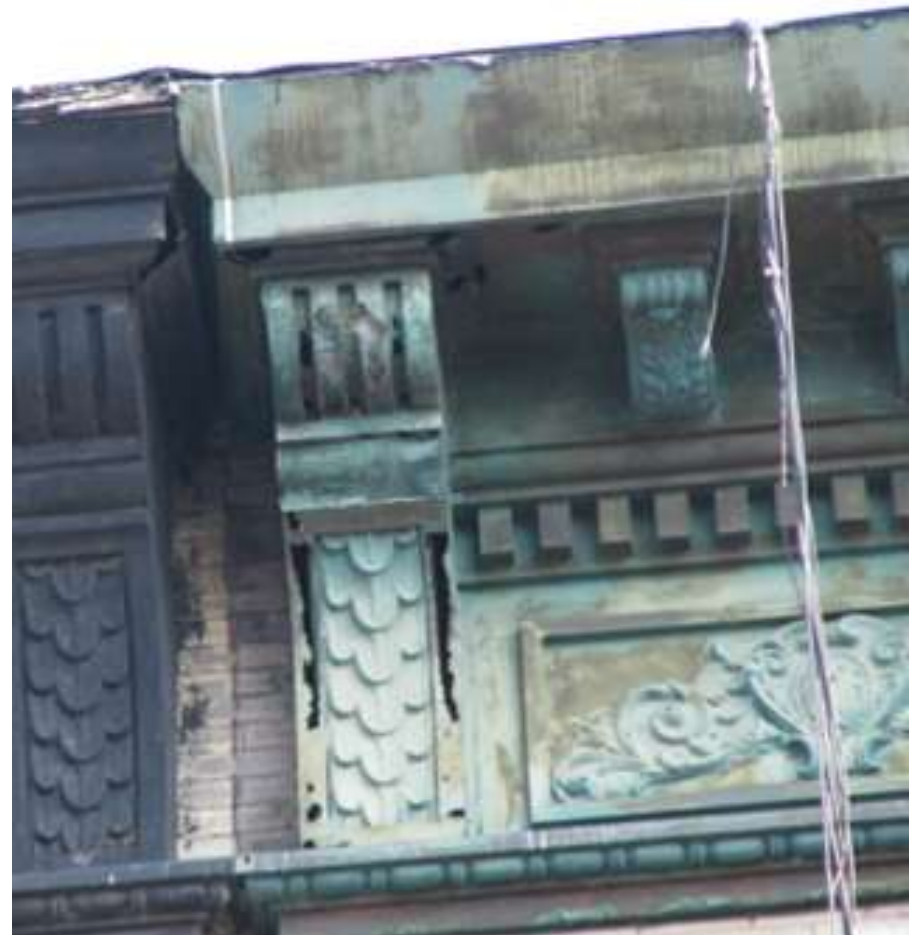
## 4.3.13 Rot of Wood at Cornice

***What To Look For:***

Condition of wood material. Loss of paint protection.

***Probable Causes/Deficiencies:***

Excessive humidity, lack of maintenance.

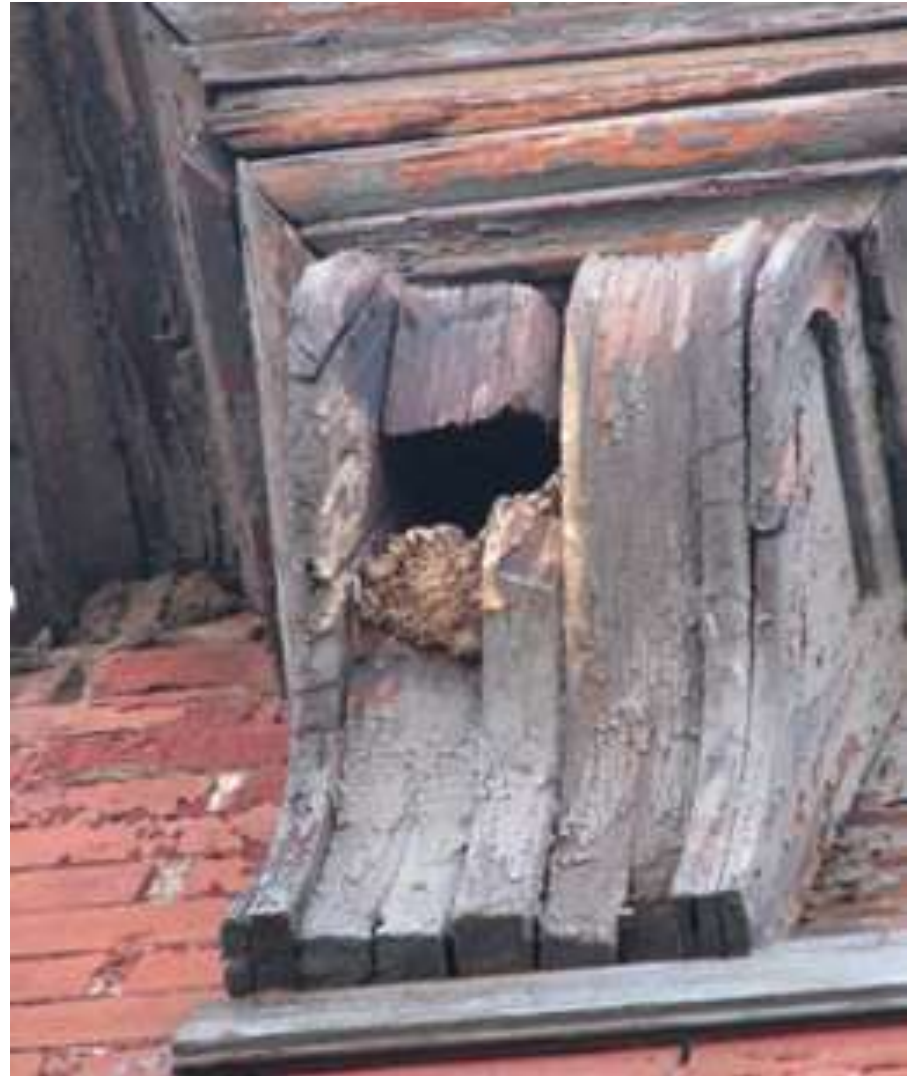
# 4.3.14 Deterioration of Underside Cornice

***What To Look For:***

Cracks/deterioration of decorative elements (stone, concrete, cast stone).

***Probable Causes/Deficiencies:***

Excessive water accumulation followed by icing/ thaw cycles. Stresses due to blocked thermal expansion

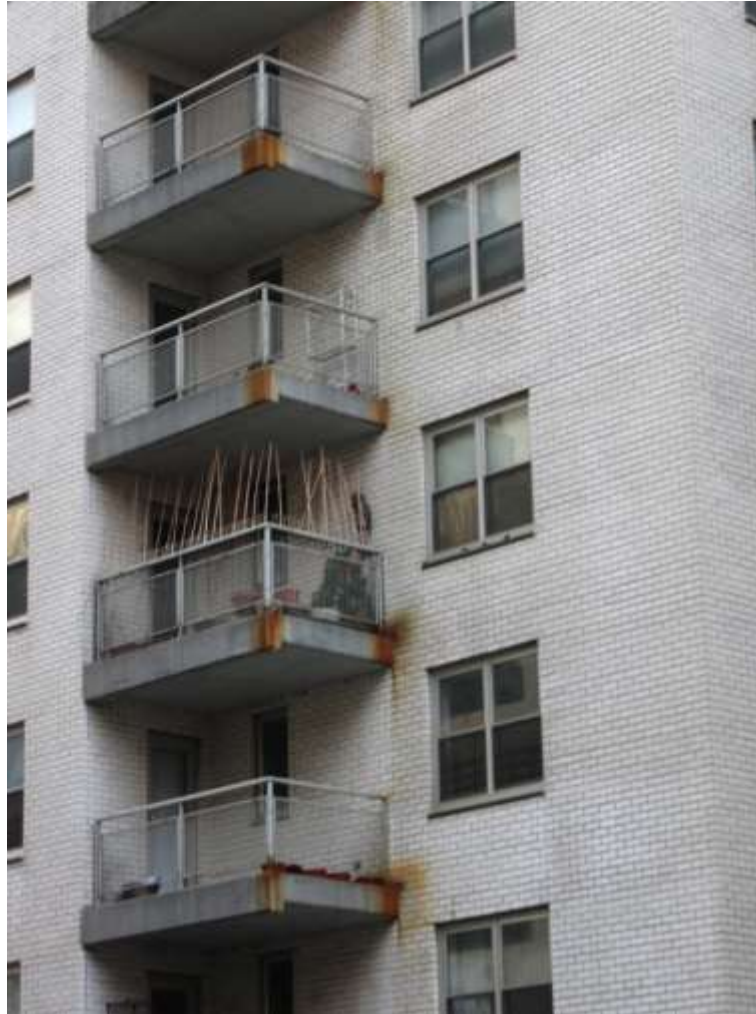
# 4.4.1 Underside Balcony Spall / Crack

## ***What To Look For:***

Condition of underside material (terra-cotta pictured). Spalls. Cracks. Rust stains. Standing water.

## ***Probable Causes/Deficiencies:***

Corrosion of reinforcing or supporting steel. *Rust jacking due to inserts.*  
Lack of drainage. As exposed horizontal surfaces, balcony components can easily deteriorate under repeated water accumulation.

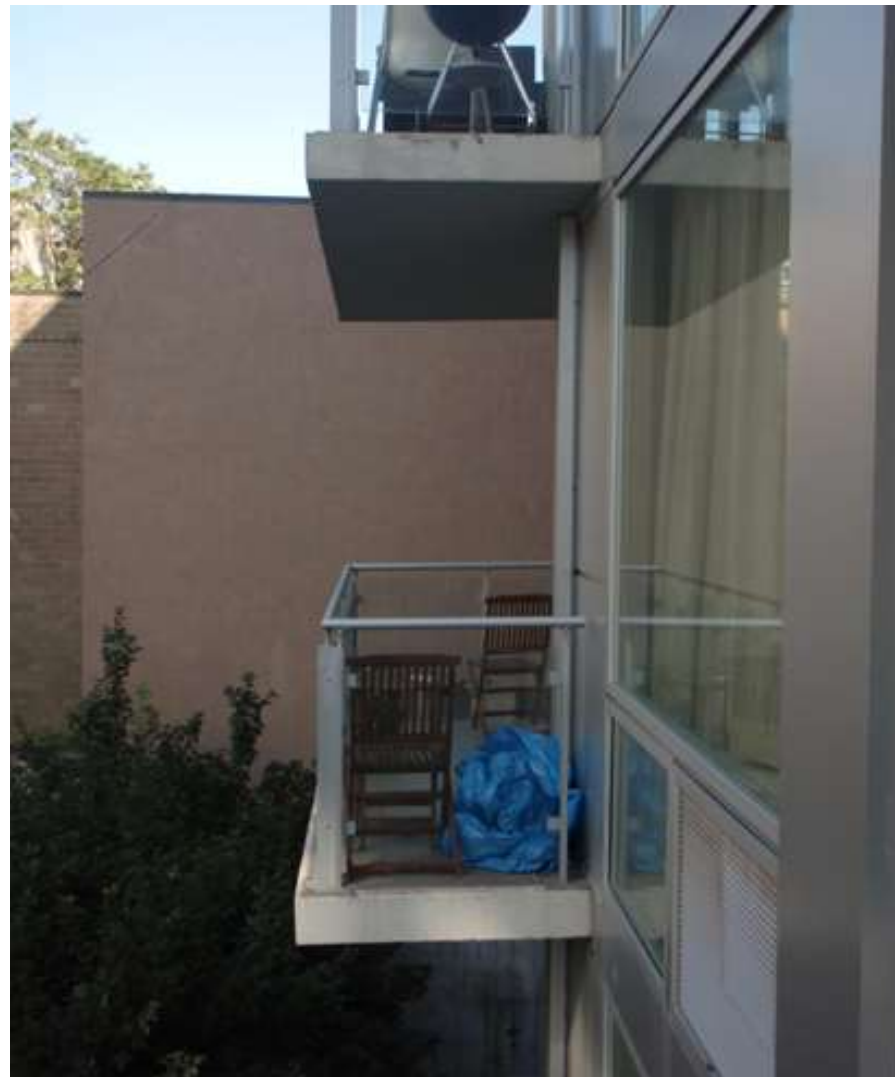
## 4.4.4 Failed Guard Panel

### ***What To Look For:***

Guard, railing components (panels, rails, posts) fractured, missing or loose.  
Cracked/broken glass panel.

### ***Probable Causes/Deficiencies:***

Improper design or construction.  
Deterioration of connections. Displacement of post. Impact. Glass breakage at point attachments.

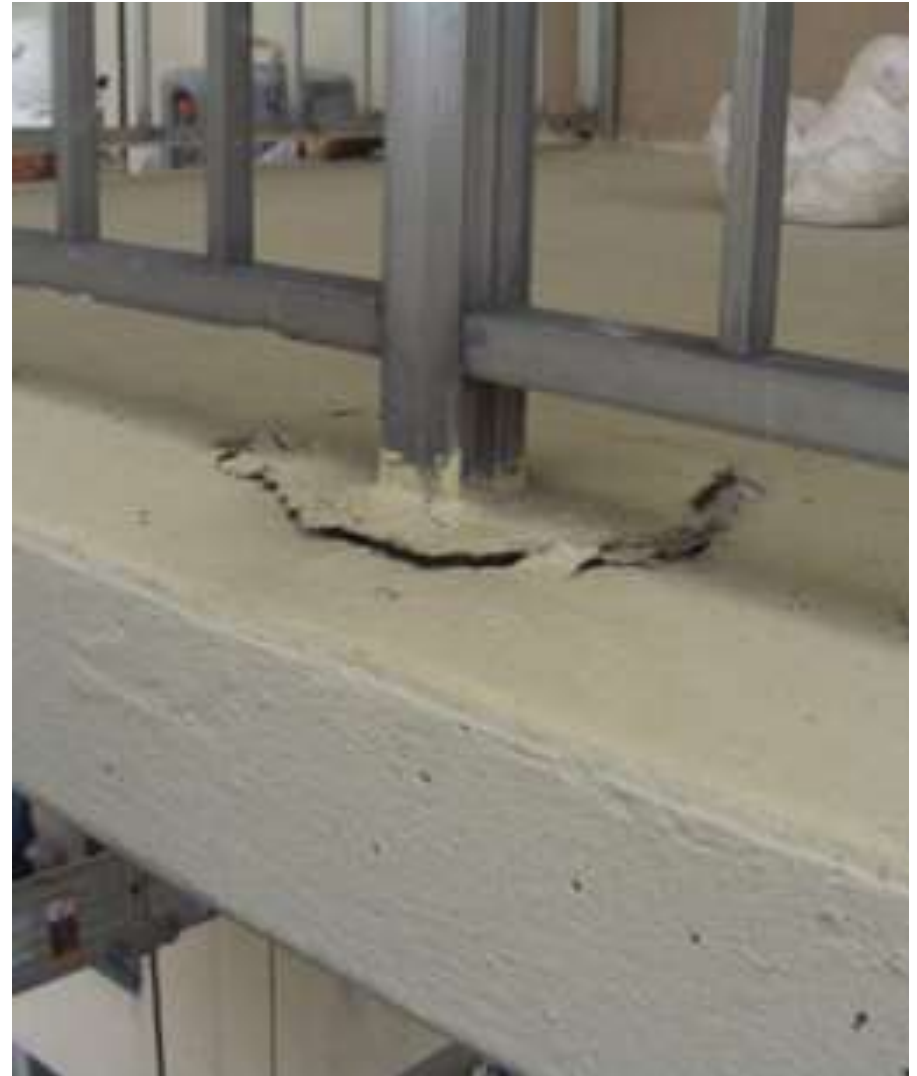
# 4.4.7 Concrete Spall at Anchor Bolts

***What To Look For:***

Condition of base concrete around or close to post anchorage. Missing anchor bolts.  
Condition of underside of anchorage.

***Probable Causes/Deficiencies:***

Anchor originally installed too close to edge of concrete.

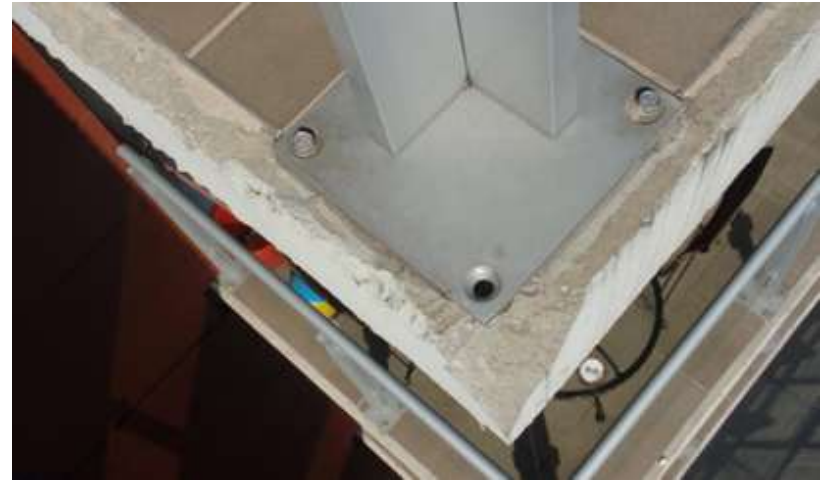
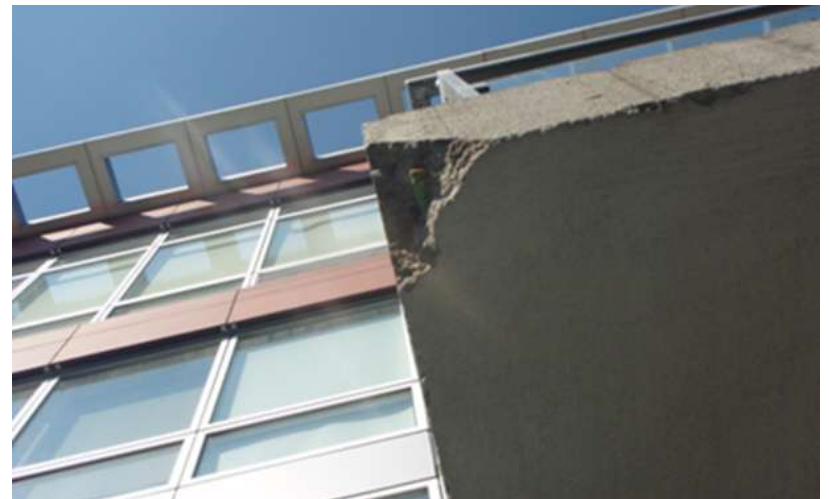
# 4.4.8 Delaminating Concrete or Topping

## ***Probable Causes/Deficiencies:***

Poor quality concrete and/or placement, poor vibrations of concrete leading to the formation of a plane of weakness. Over finishing and/or poor curing practices, freeze thaw action, poor quality of prior repairs. Differential thermal expansion property topping vs. concrete. As exposed horizontal surfaces, balcony components can easily deteriorate under repeated water accumulation.

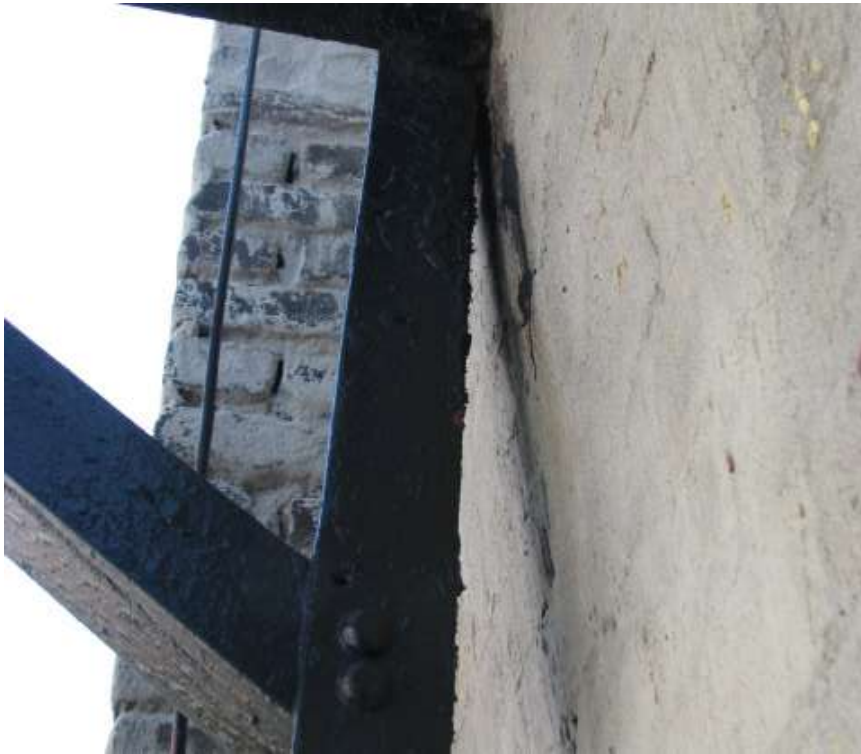
## 4.5.1 OTHER – Fire Escapes

Attachment to wall and condition of fire escape.

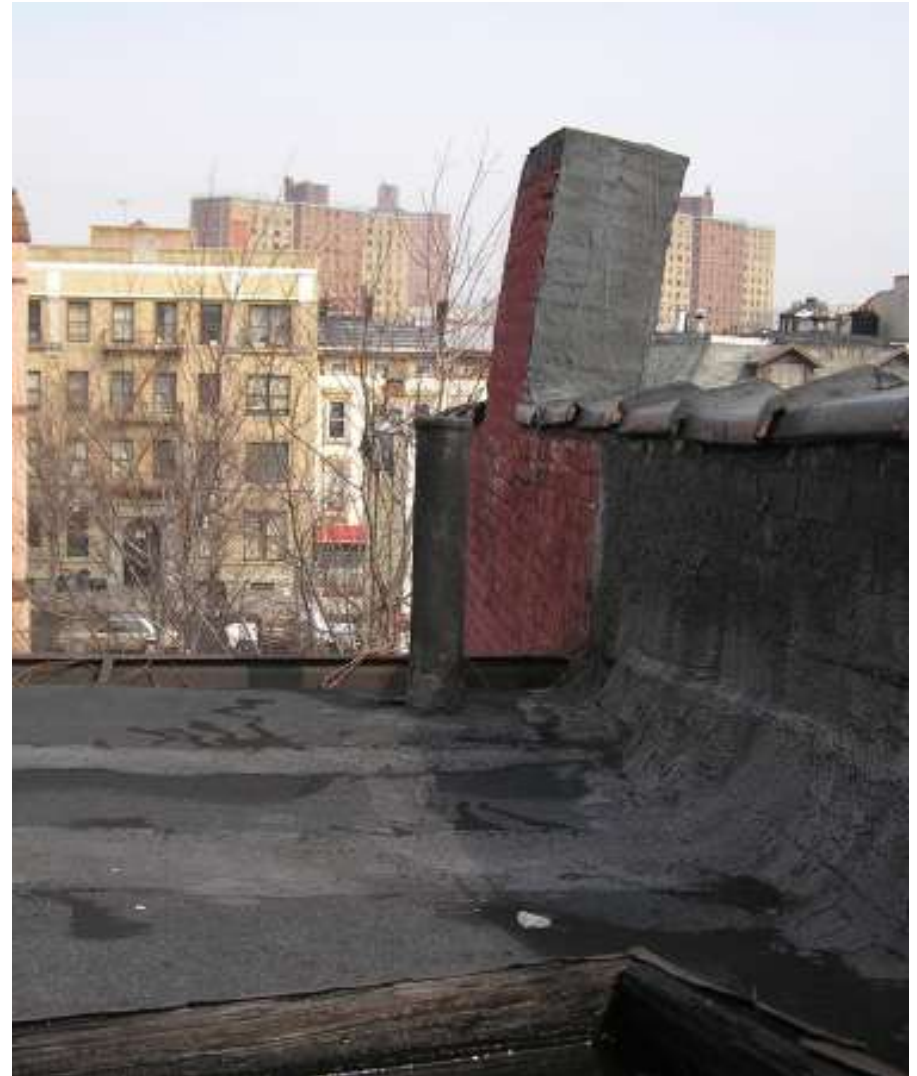
## 4.5.2 OTHER- Chimney Leaning

Verticality of chimney. Condition of mortar joints. Presence of cracks.

Unequal deterioration of chimney mortar joints. Repeated wind acting on chimney.

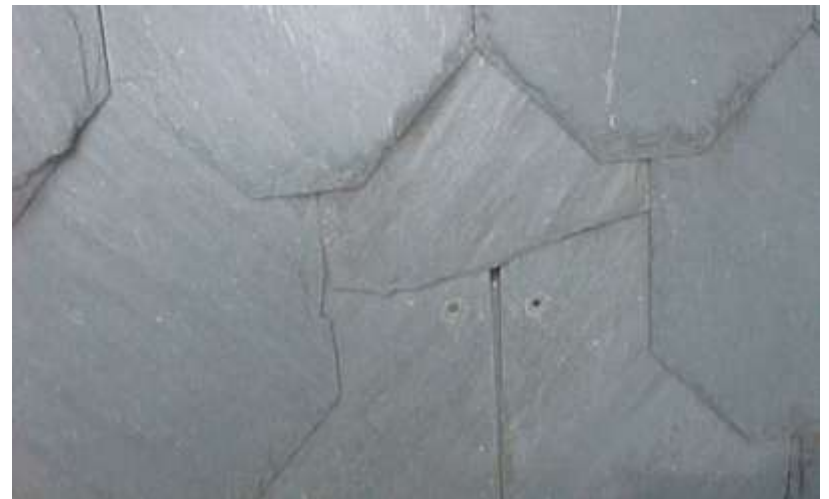
## 4.5.3 OTHER - Slate Roof

Detached or loose slate tiles. Deterioration or lack of nails.

Delamination of slates. Rust of nails.  
Deterioration of supporting wood base.

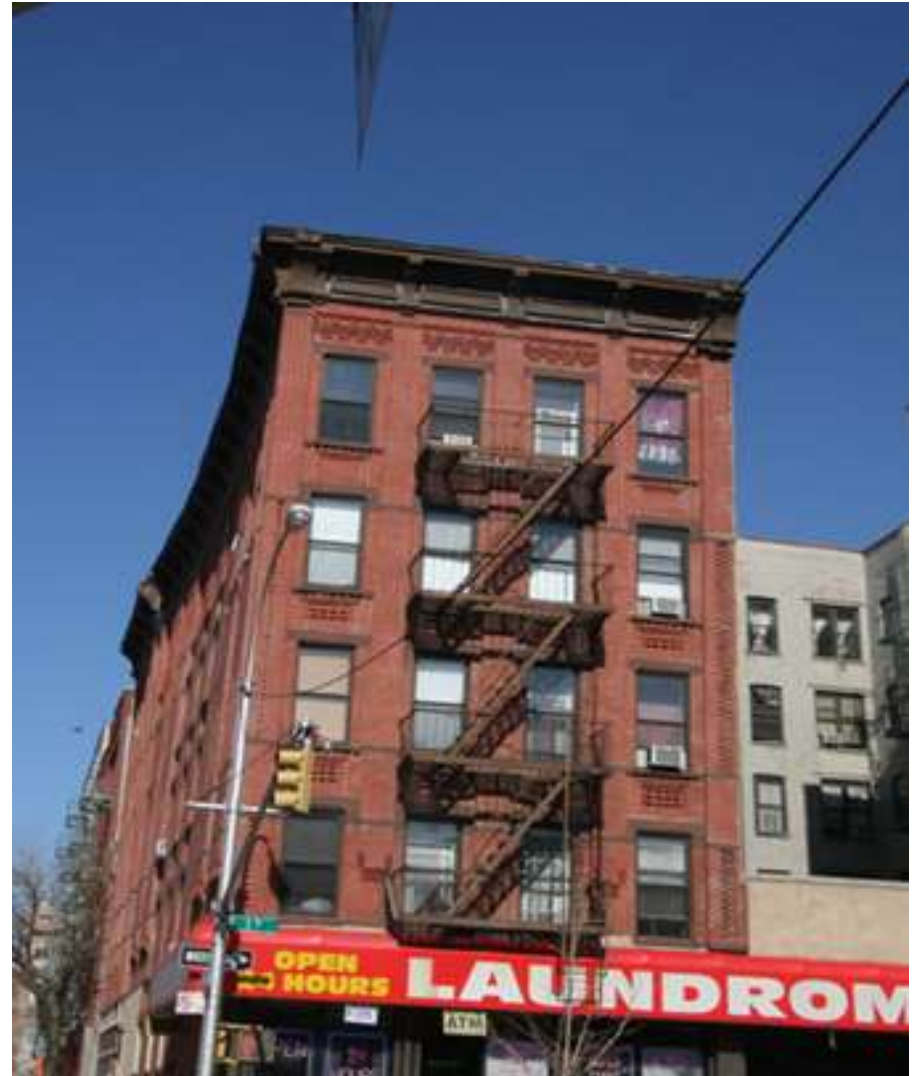
# 5.1.1 Façade Bowing Inwards (or Outwards)

Requires structural engineering analysis.

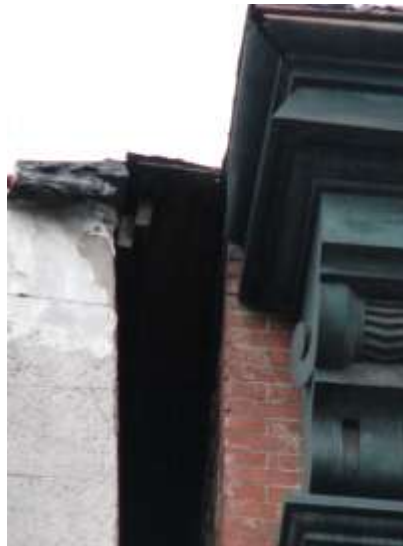
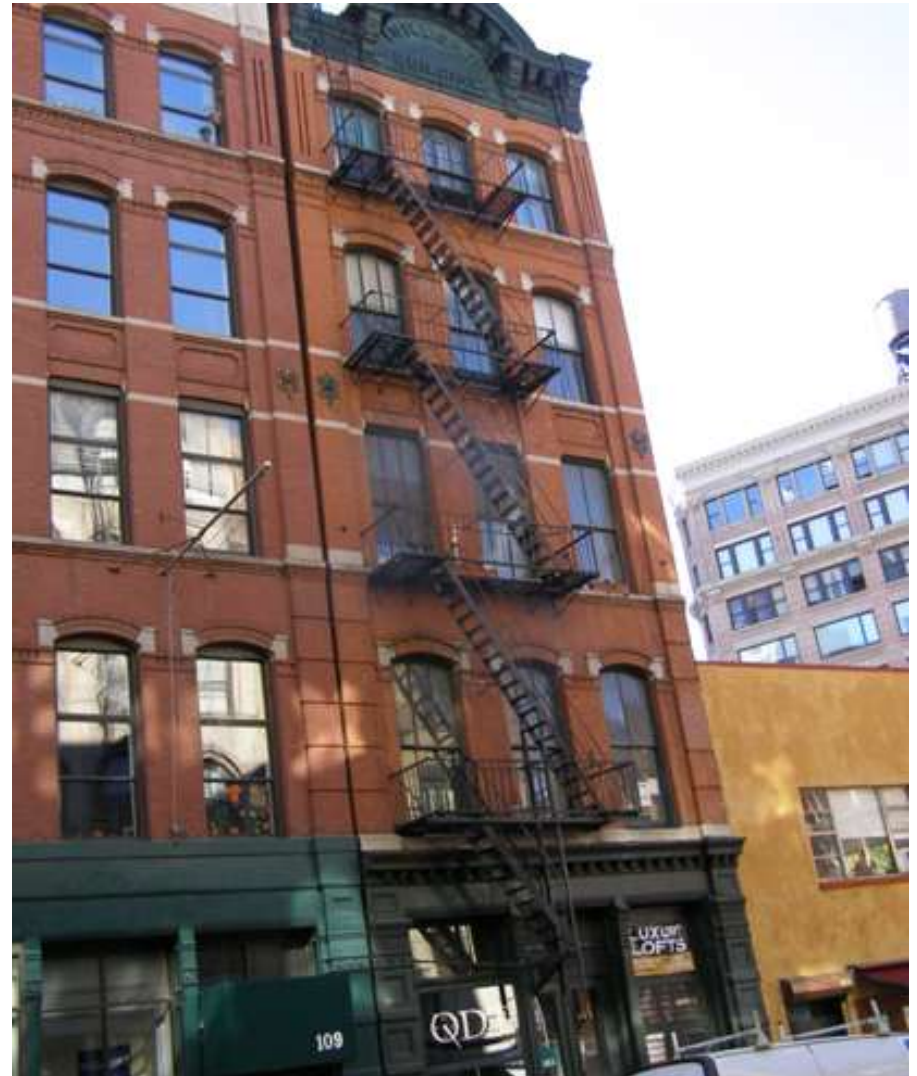
# 5.1.2 Out of Plumb - Bearing Masonry Wall

Requires structural engineering analysis.

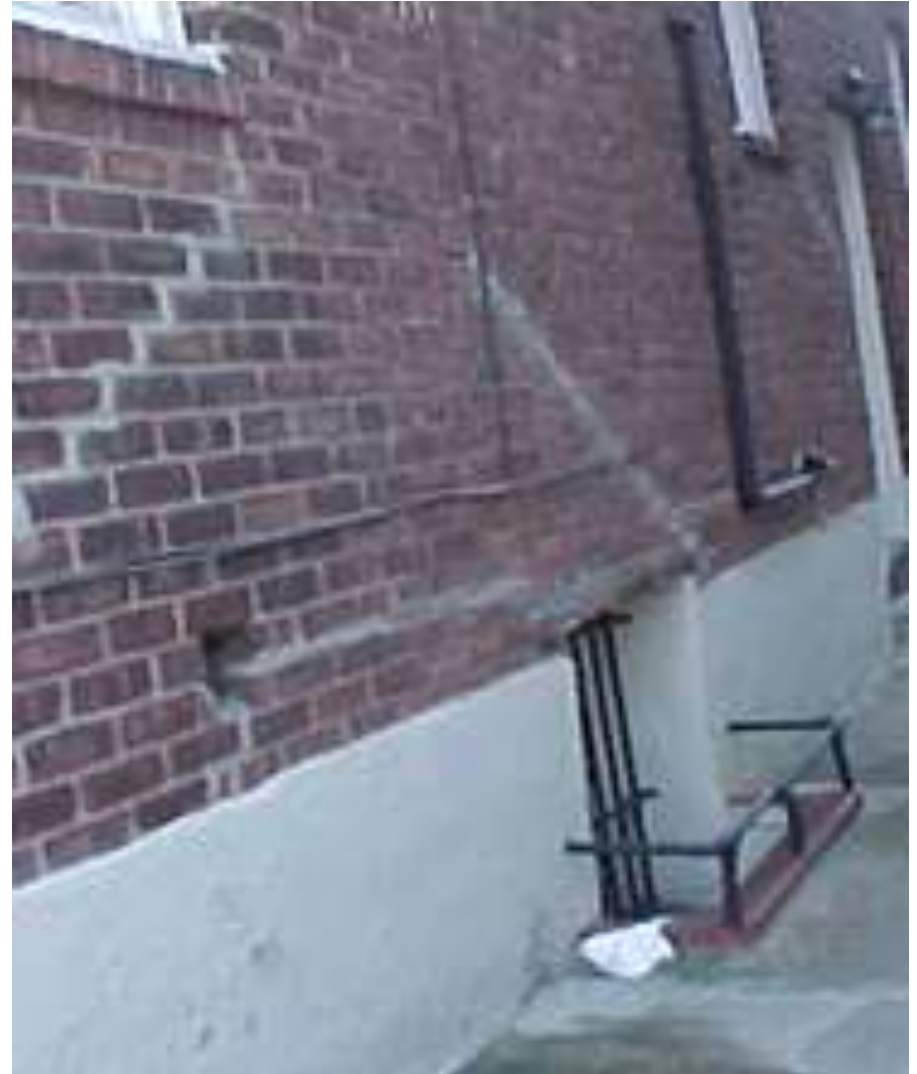
# 5.1.3 Diagonal Cracks at Base of Bearing Masonry Wall

Diagonal cracks, usually stepped, at base of building. Photo displays a repaired crack.

Usually the result of settlement or movement at the foundation level.

Note: Photo displays repaired cracks.

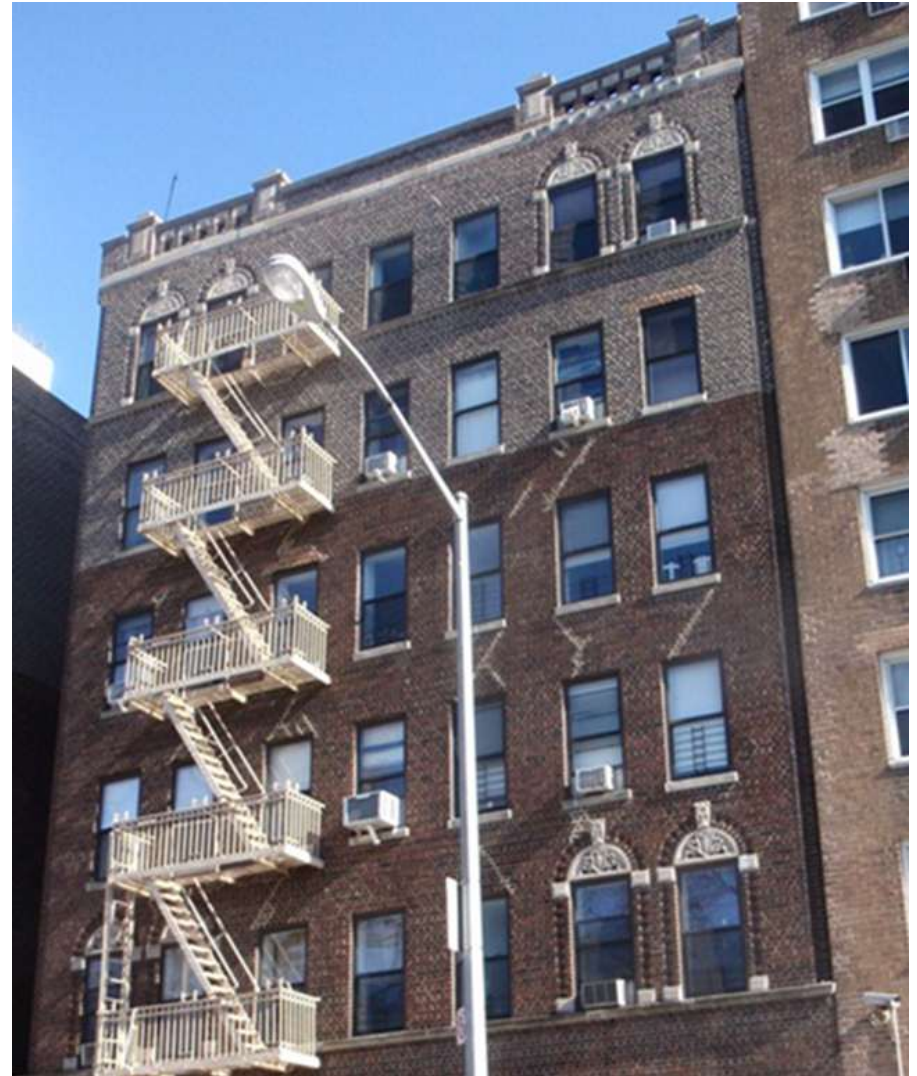
# 5.1.4 Diagonal Cracks at Spandrel

Diagonal, stepped cracks originating on one side of opening only, more common near building corners. Crack traversing spandrel.

Lateral displacement. Heavier loaded area of masonry tends to move outwards (due to larger stresses on mortar or foundation). Condition might have appeared soon after erection. Deflection of lintel. Lean of building.

Condition can occur due to differential settlement of foundation.

Note: Photo displays repaired cracks

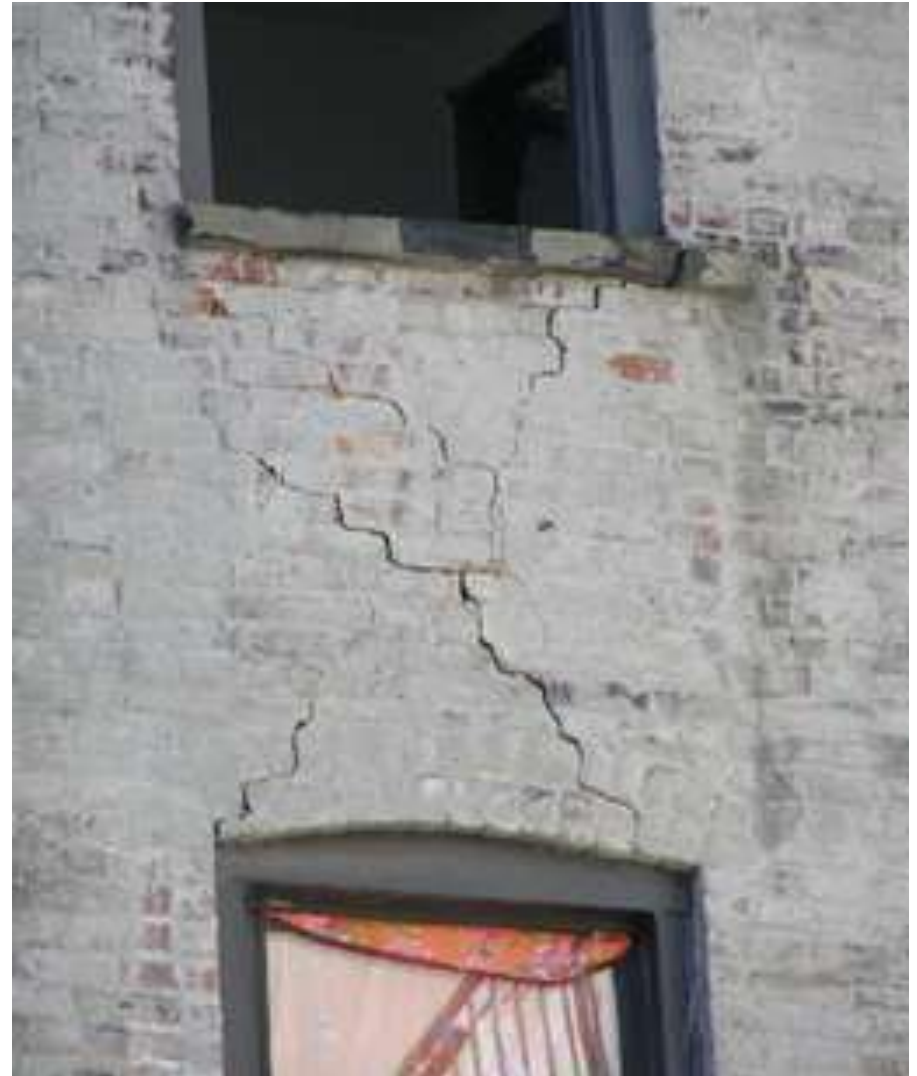
# 5.1.5 Intersecting Diagonal Cracks – Connecting Opening

Intersecting diagonal cracks in spandrels.  
More common near corners.

May require engineering analysis.

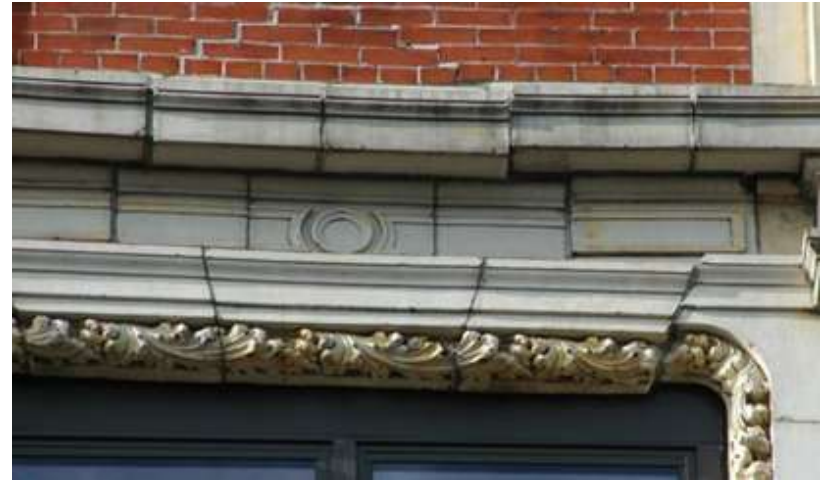
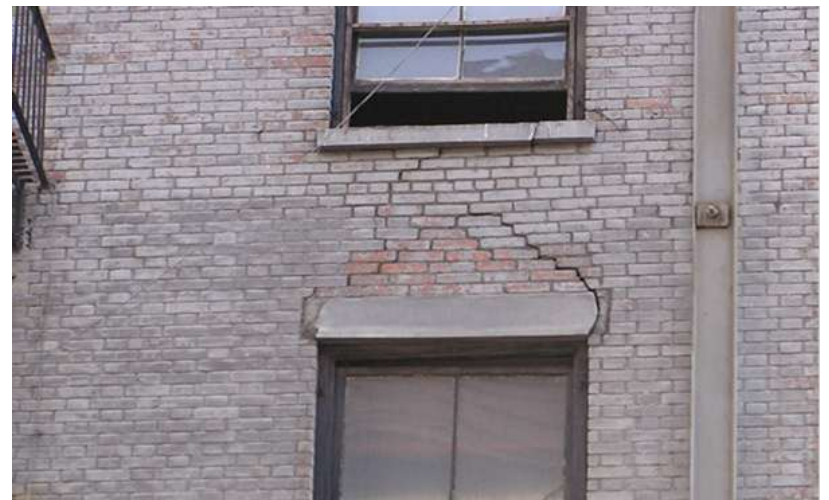
# 5.1.6 Inverted “V” Crack at Lintels

Inverted V shaped stepped cracks. More commonly originating at lintel.

Deflection of lintel. Crack forms along the lines of the *relieving masonry arch*  
Condition might have appeared soon after erection. Differential settlement under load (spandrel/pilaster)

Presence, condition of steel lintel needs to be investigated.

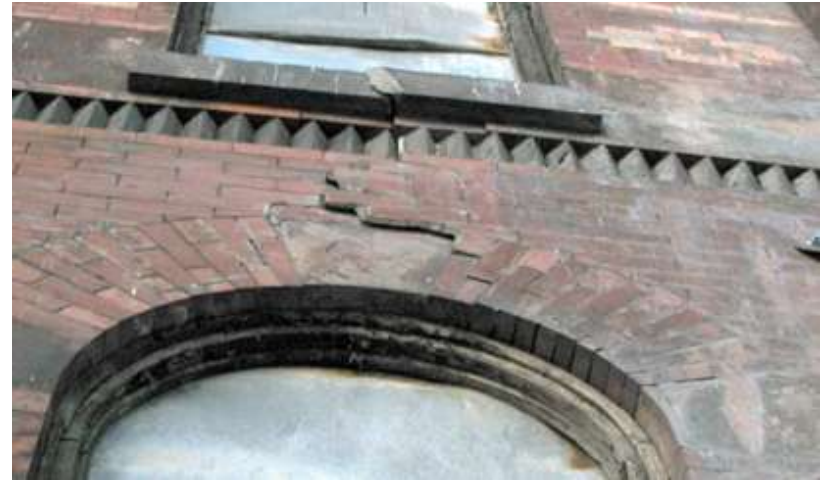
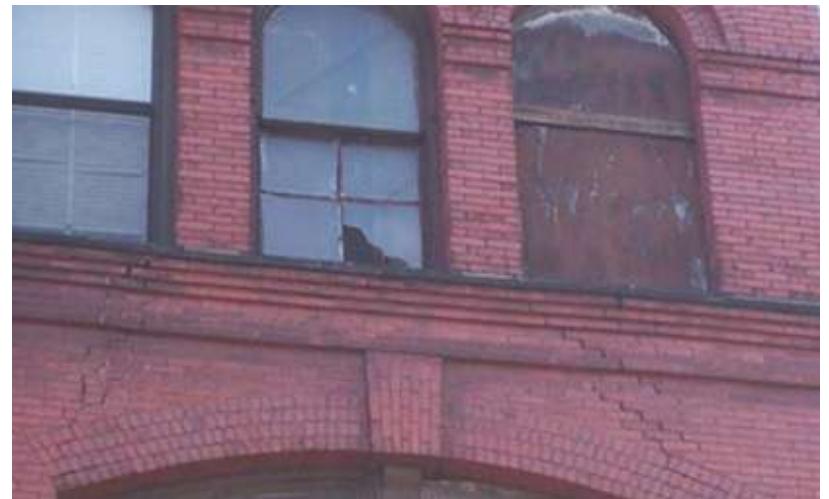
# 5.1.7 Crack at Bearing Masonry Arch Crown

Cracks above arched openings. Displacement of crown stone.

Lateral displacement of bearing base of crown. Heavier loaded area of masonry tends to move downwards (due to larger stresses on mortar or foundation) and outwards ( due to arch effect). Condition might have appeared soon after erection.

Condition can occur due to differential settlement of foundation.

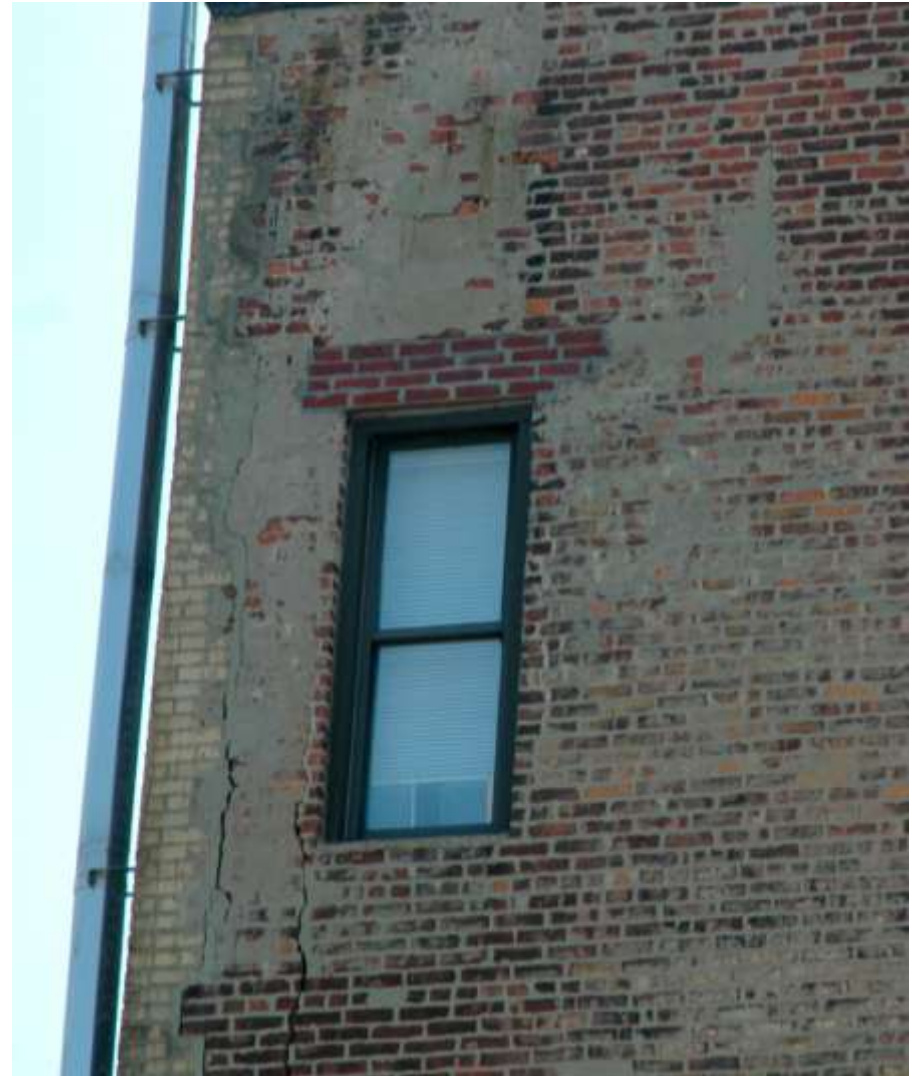
# 5.1.8 Vertical Crack in Bearing Masonry

Crack of both brick and mortar – extending vertically.

Vertical crack in bearing brick masonry is typical for failure in compression. Significant vertical overload (e.g. at end of supported beam , roof equipment) . Crack might correspond to a change (plan) in masonry thickness. Rust of metal inclusions.

When caused by compression loads, masonry requires engineering analysis.

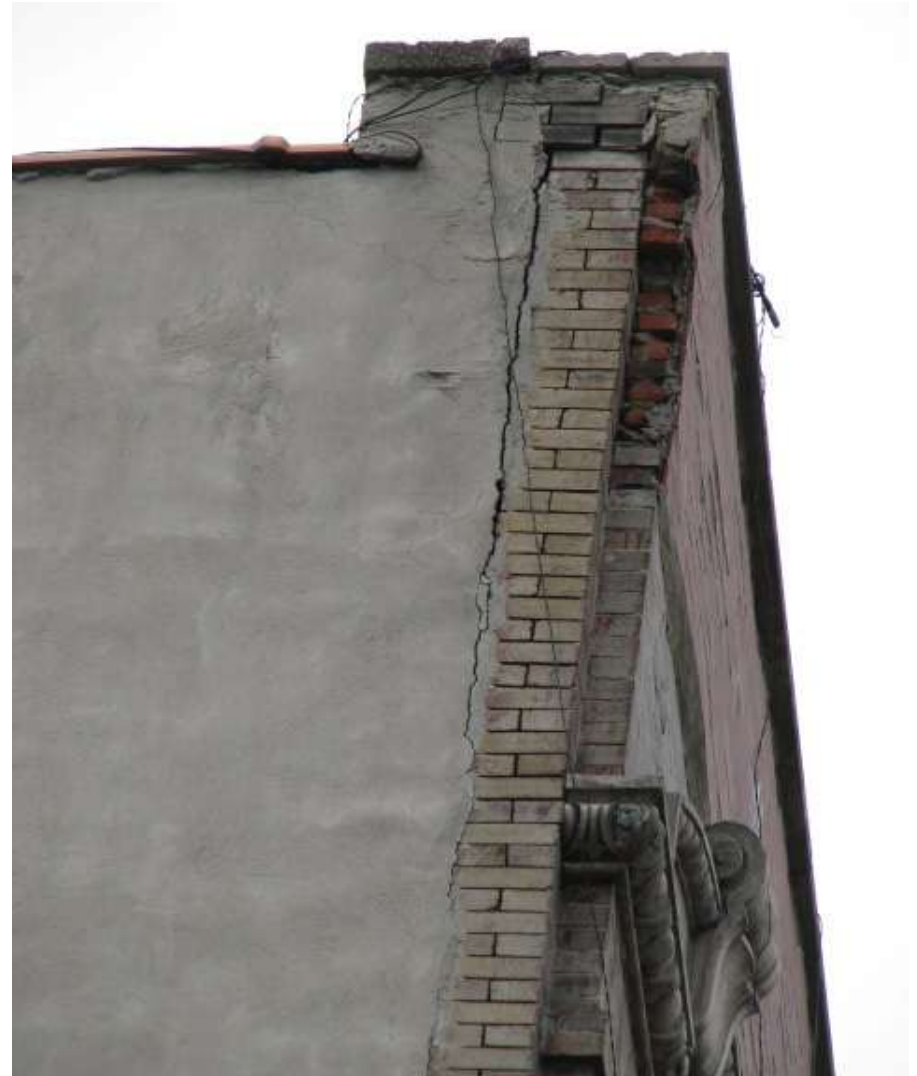
# 5.1.9 Vertical Crack at Building Corner

Vertical cracks in the immediate vicinity of corner. Condition of joint of face and ordinary brick. Condition of masonry tooth. Differentiate crack in masonry vs. construction joint formed between ordinary brick and face brick. Cracks in parging/stucco might only reflect the presence of stresses at joint or actual cracks in masonry.

Cracks might be caused by differential movement due to perpendicular orientation of walls and quality of brick. (face brick vs. ordinary brick set at right angle.) Corner cracks in bearing masonry buildings might represent a weakening or serious damage of the load paths. Insufficient corner toothing or anchoring.

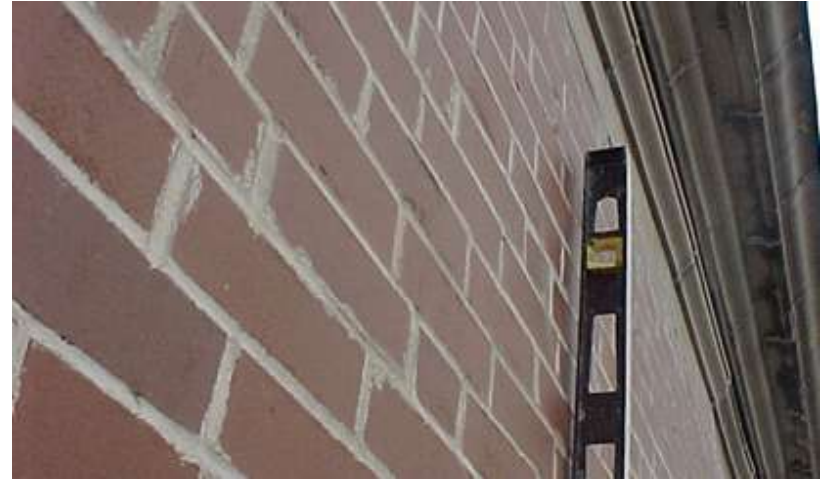
# 5.1.10 Bulging of Bearing Masonry

Bulging in outside wythe might indicate improper/insufficient bonding between wythes. Bulging of the entire masonry might be caused by the expansion of the floor structure.

**Interior cracks on wall perpendicular to bulge**

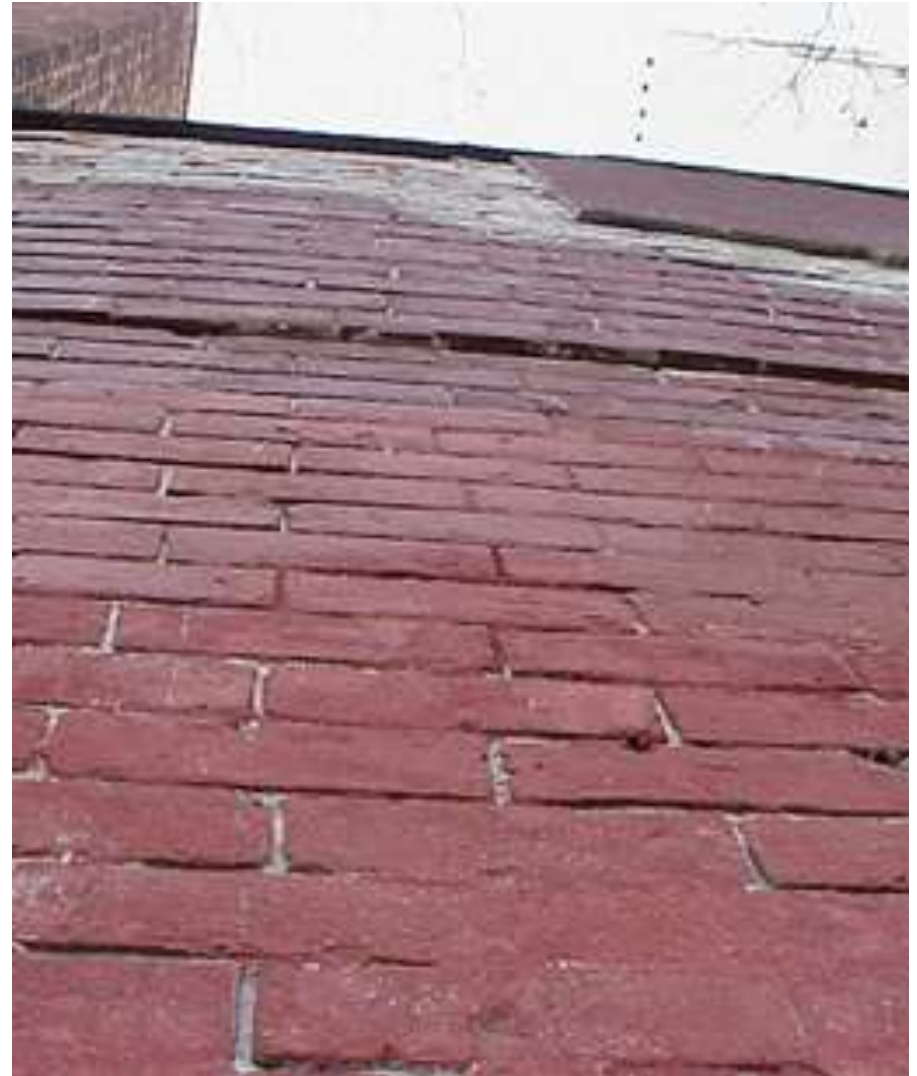
# 5.1.11 Bulge/Displacement of Bearing Masonry at Floor Level

Outward displacement or bulge at base of parapet can be caused by pressure from roof/floor structure, especially trussed roofs. Rust of roof or floor structural frame.

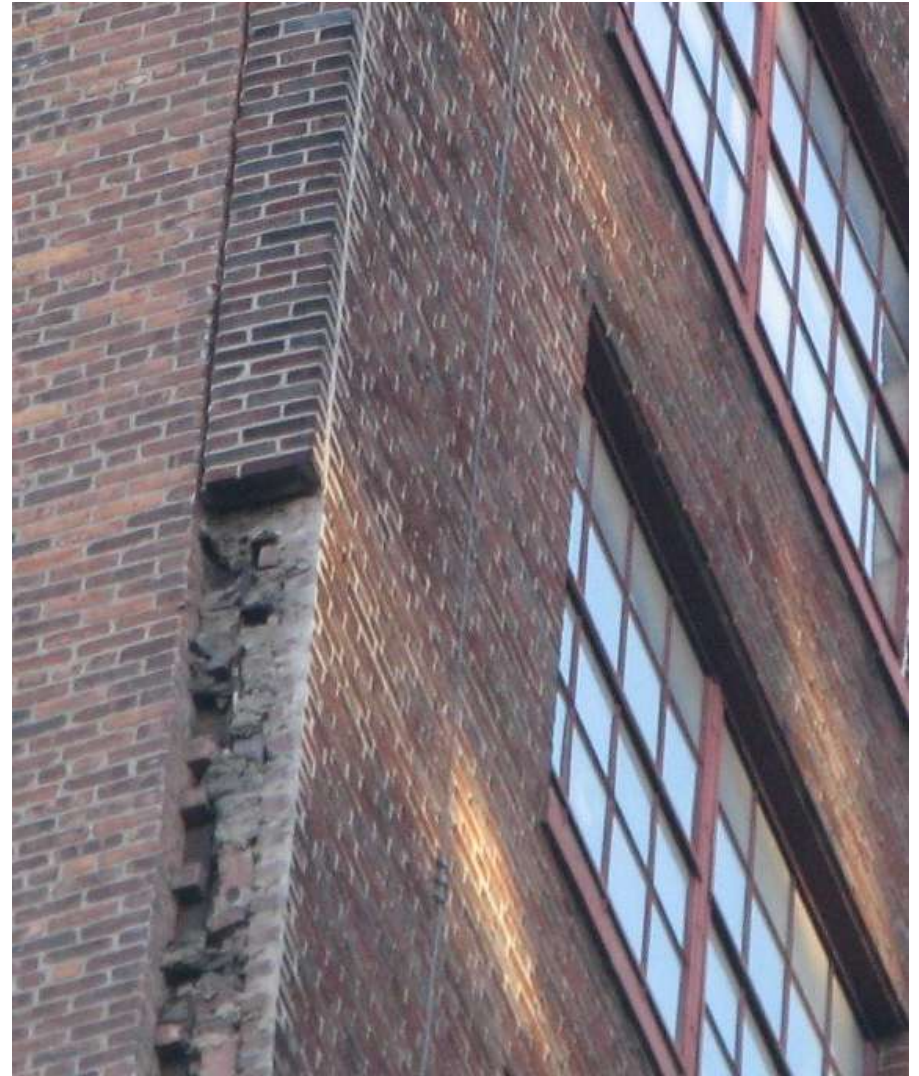
# Collapse of Brick at Improper Corner Repair

Repair included cutting vertical joints on both sides of the corner. Masonry in transitional facades was not anchored to columns. Losing attachment as a result of the repair, some bricks fell.
