# FAÇADE CONDITIONS

An Illustrated Glossary  
of Visual Symptoms

**Edited by Dan Eschenasy, PE**  
Chief Structural Engineer  
NYC Department of Buildings

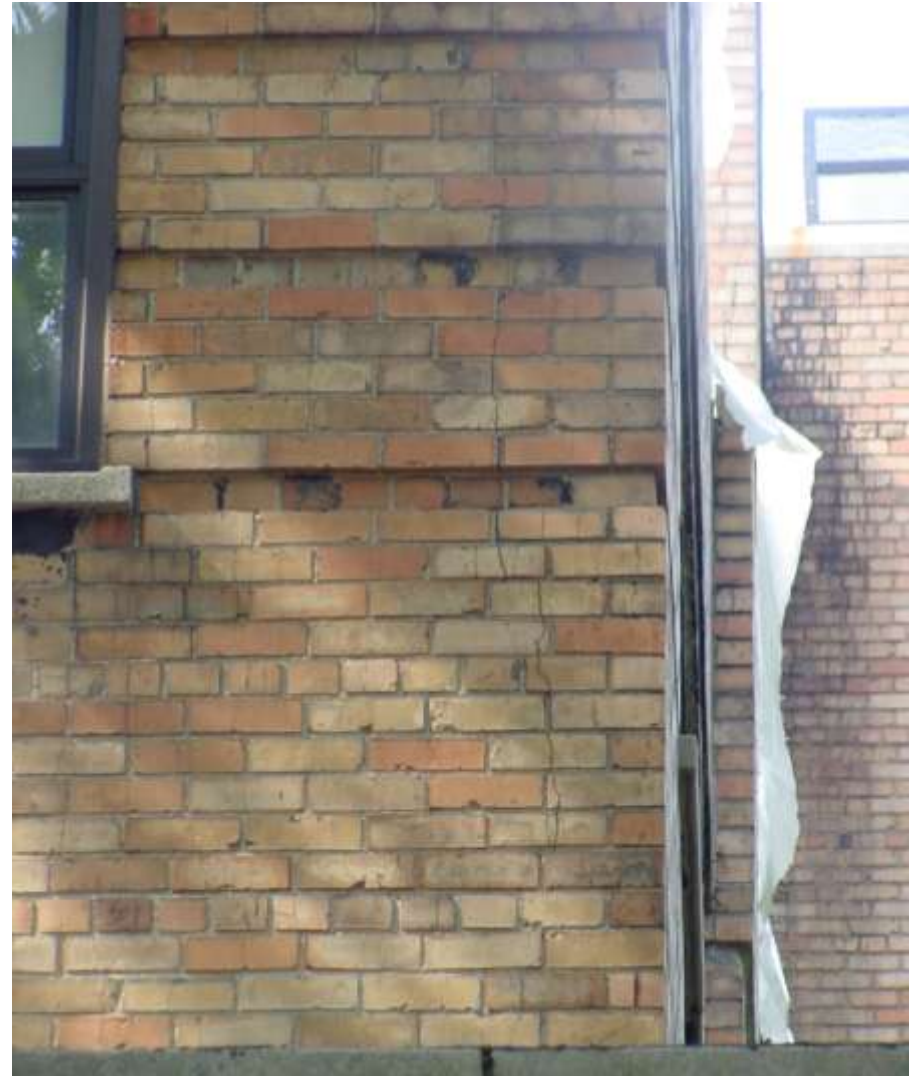
# 5.2.1 Thin (Hairline) Crack in Transitional Façade

Direction and location of crack, especially position of crack relative to steel frame elements.

Movement of clay brick restrained by the structural (steel) frame. Long term and irreversible moisture expansion of fired clay brick. Thermal expansion due to daily or seasonal temperature variations. Corrosion of enclosed steel. Creep of concrete structural frame.

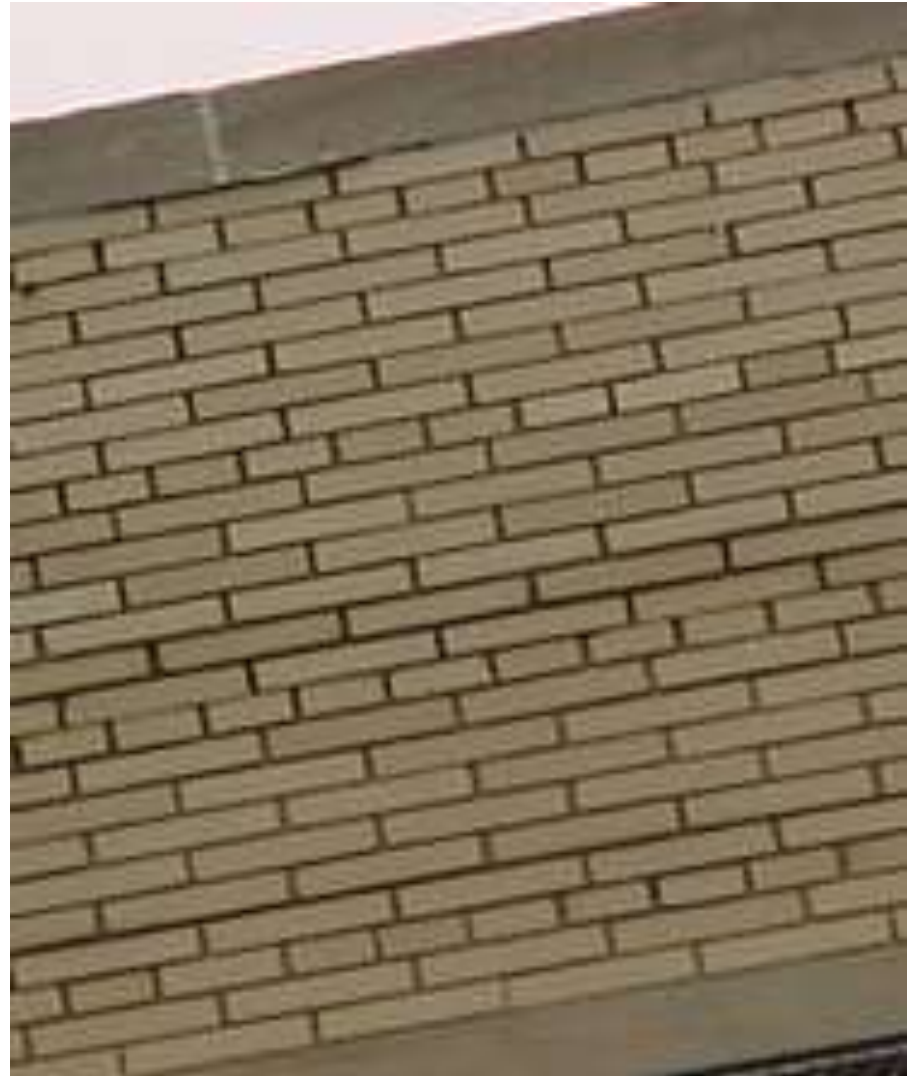
## 5.2.2 Bulge At Parapet of Transitional Facade

Corrosion of structural steel. Slippage of parapet over flashing. Rain water penetration and accumulation at base of parapet.

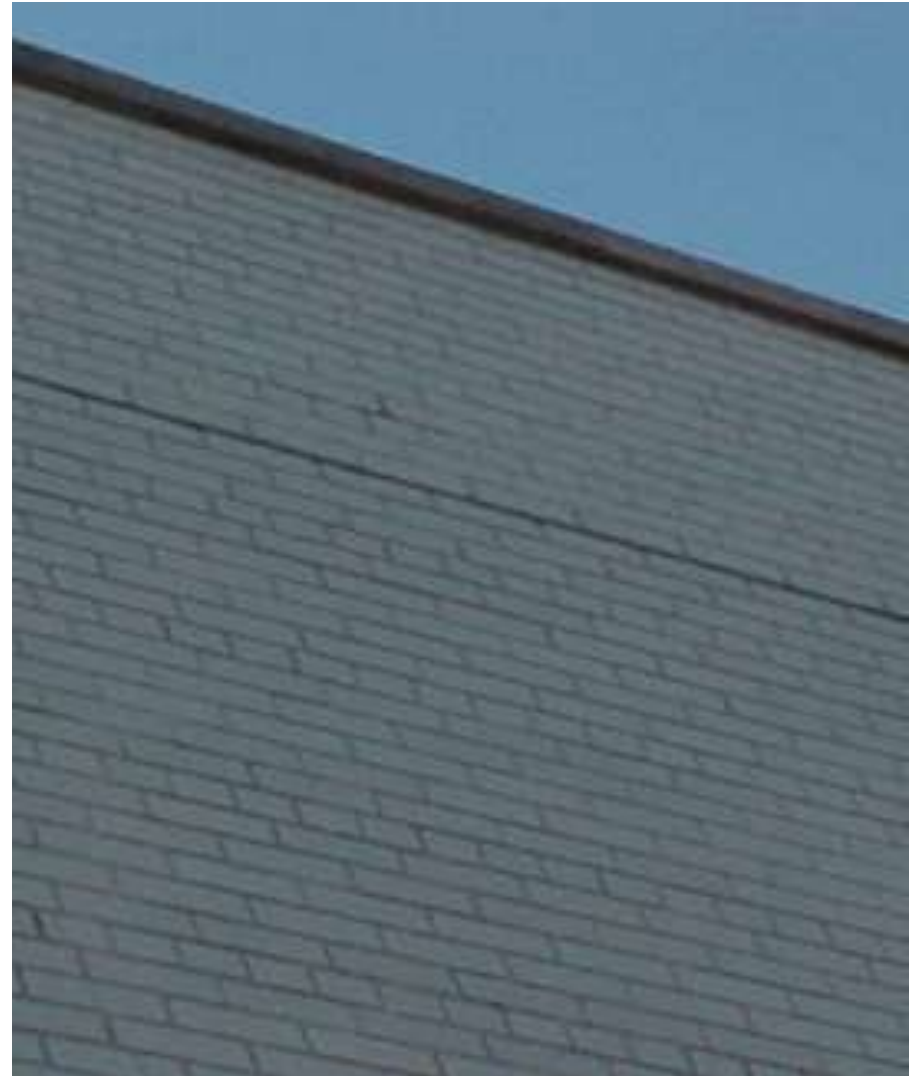
## 5.2.3 Crack At Parapet Along Spandrel Beam

Position of crack relative to the structural supporting elements, verticality of parapet. Alignment of parapet. Separation of parapet from masonry below. Condition of back-up masonry.

***Probable Causes/Deficiencies:*** Corrosion of supporting steel, thermal movement of parapet, creep and deflection of parapet under wind loads, possible water penetration due to failed roof flashings.

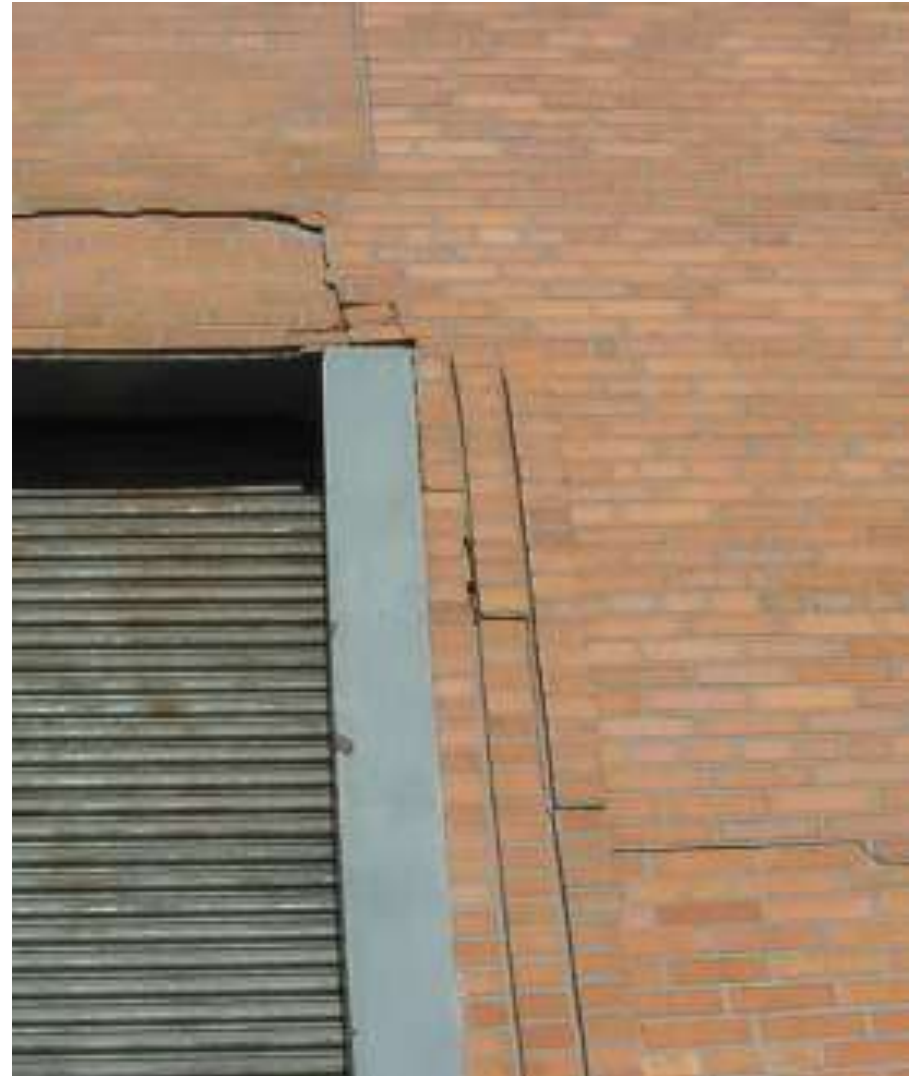
## 5.2.4 Crack Around Opening In Transitional Facade

Cracks of various sizes and directions stemming from openings in masonry.

Corrosion of supporting steel. Displacement or excessive deflection of supporting steel (that might have been affected by corrosion).

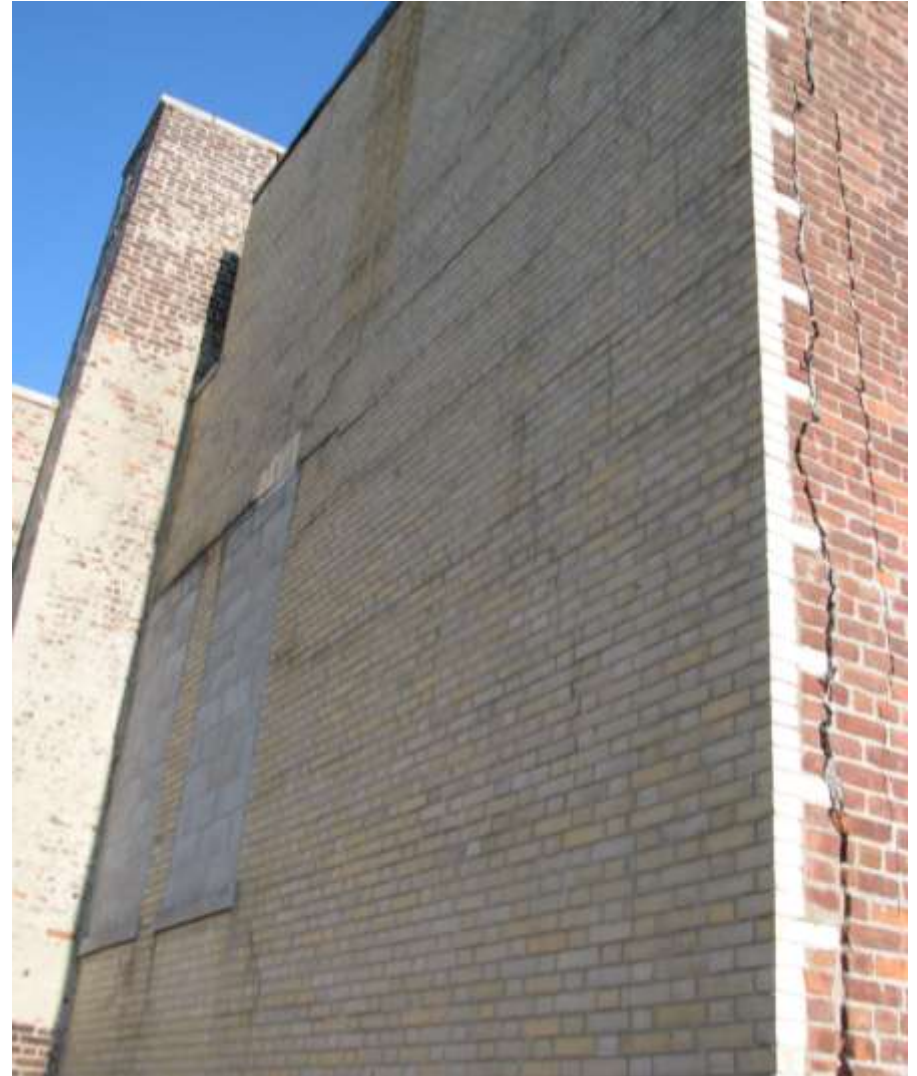
# 5.2.6 Multiple Vertical Cracks Along Corner of Transitional Façade

Several vertical cracks in the vicinity of corner (same or both sides of the corner). Separation of masonry along cracks.

Significant rate of corrosion coupled with thin brick cover of steel. The typical problems of transitional facades are aggravated at bricks around columns when the brick runs uninterrupted from bottom to top of building.

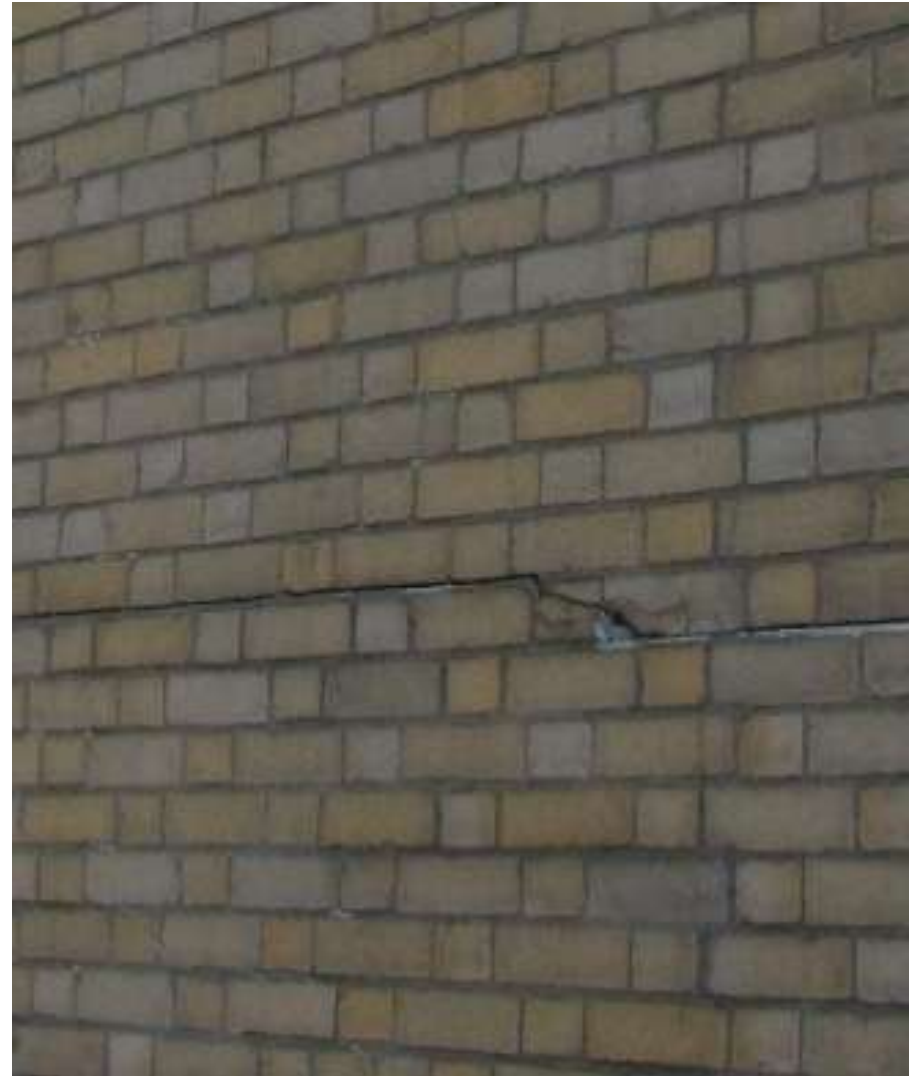
# 5.2.7 Bulge and Crack at Face Masonry

Presence of cracks.

Corrosion of steel spandrels. Shearing of brick headers at steel support. Freezing of water trapped (ice buildup) in the crack space.

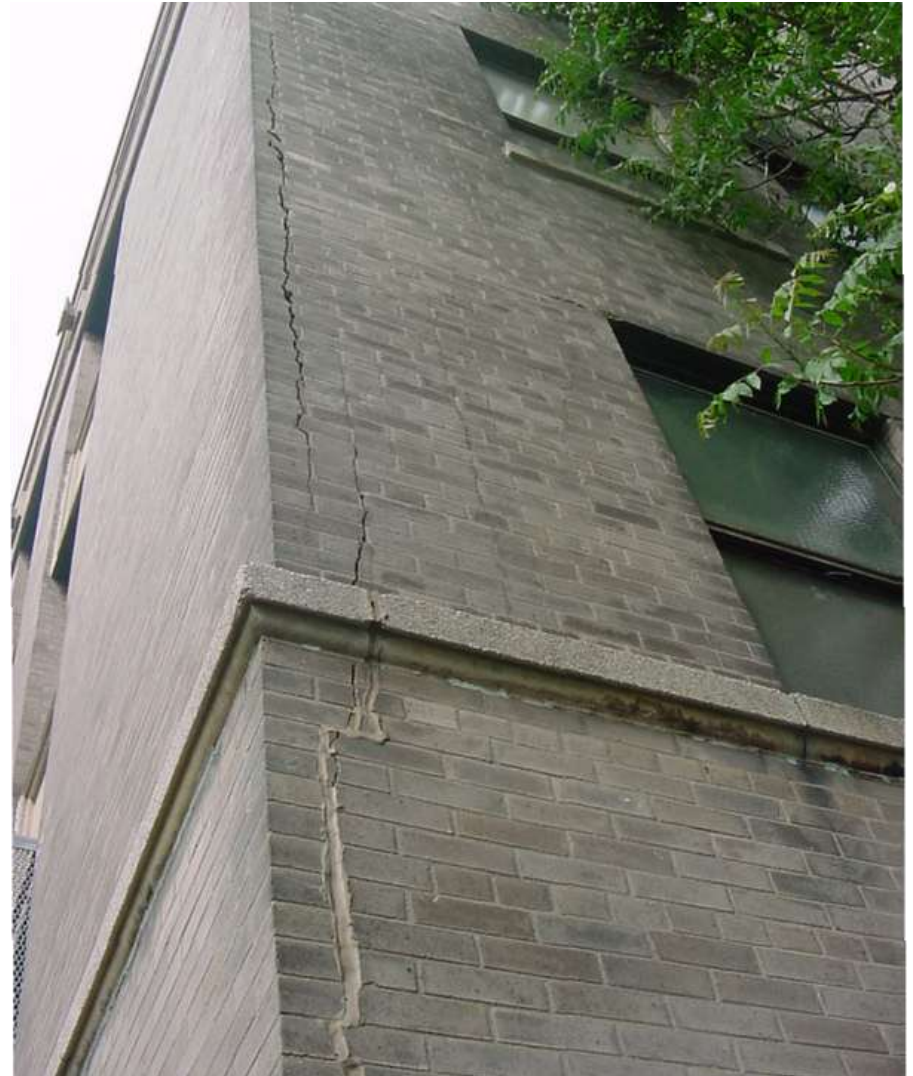
## 5.2.8 Improper Repair of Corner Crack Transitional Facade

Repair of cracks by injecting or applying compounds may only temporarily reduce the rate of corrosion. The thermal movement of masonry will open cracks further up (at same or different locations) and allow direct penetration of water. Rust jacking will continue. Also this repair does not address the probable separation of masonry from adjoining support.

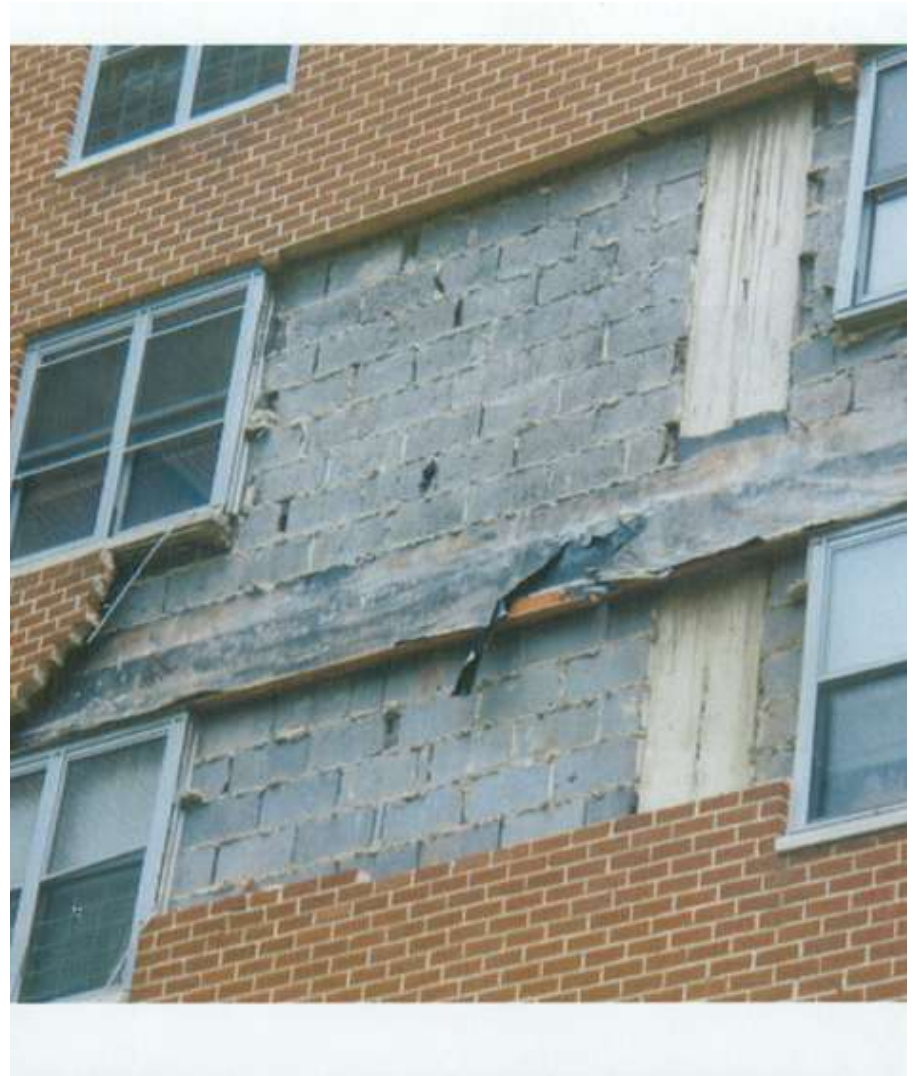
# Collapsed Cavity Wall Veneer

Lack of proper and sufficient ties allowed collapse of face brick.

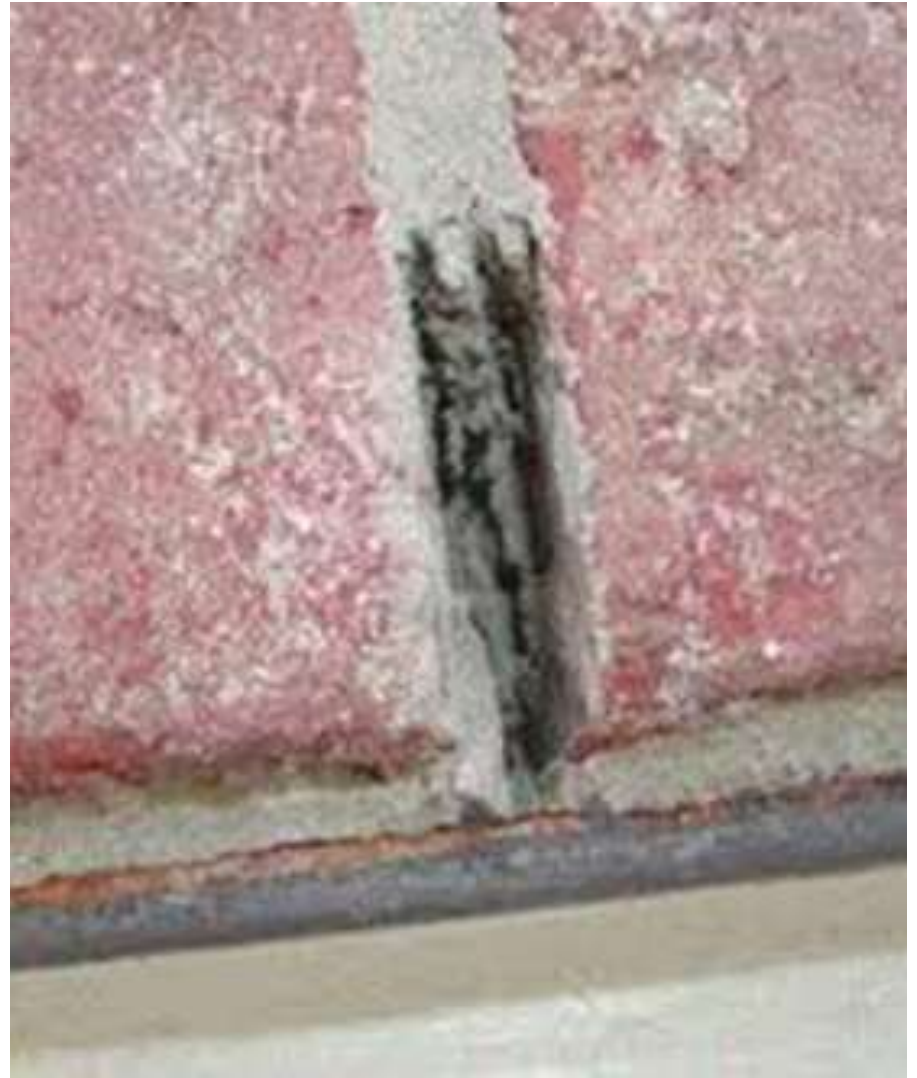
## 5.3.2 Rolling Block in Brick Veneer

Insufficient bearing of brick on shelf angle; shelf angle rotation (due to excessive shims) transfers load to lower facade veneer (contrary to design intent) ; construction tolerance issues; insufficient or rusted wall ties. Loss of wall ties anchorage.

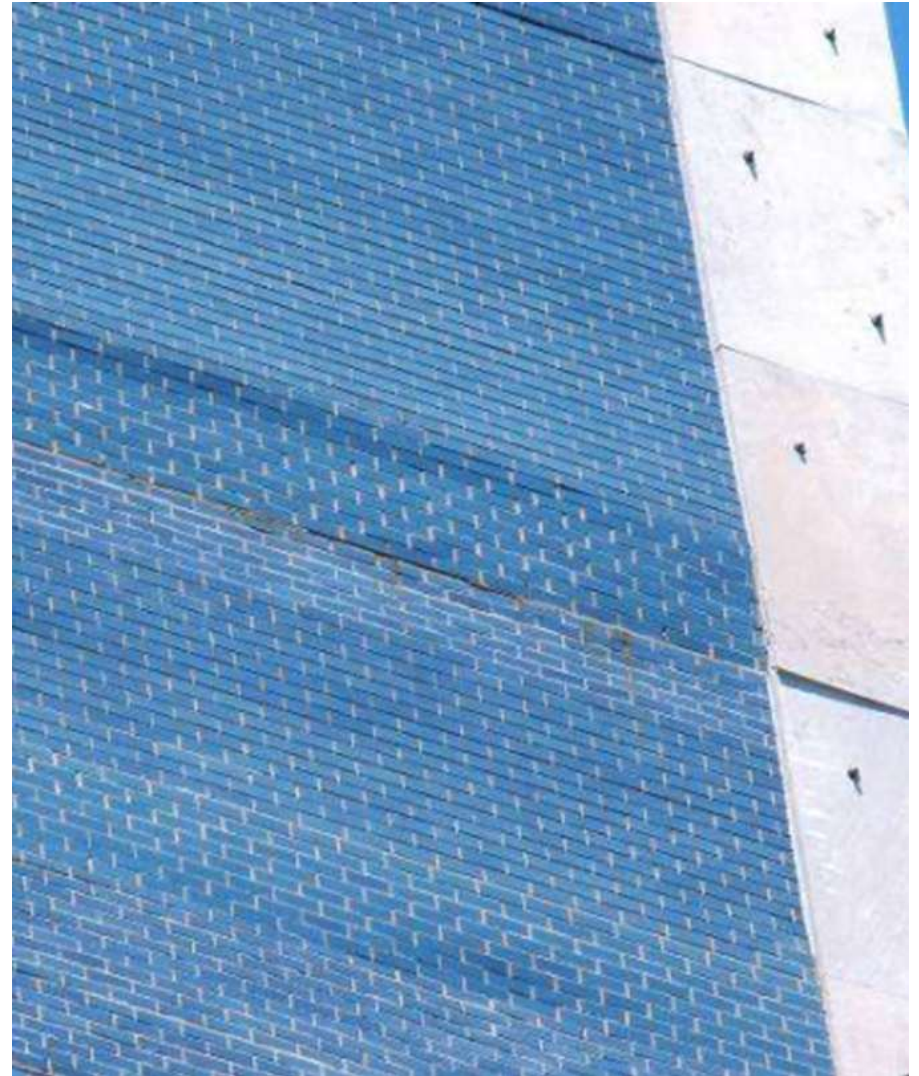
## 5.3.3 Bulged, Buckled Veneer at Joint

Outward displacement of face brick. Bulging. Horizontal cracking and location of cracks relative to the shelf angle. Lack of soft material in joint. Veneer displaced off shelf angle.

Improper installation of joint. Un-accommodated thermal movement; poor workmanship (material); poor workmanship (construction tolerances); loose G-locks; Lack of installation of soft joints; concrete frame shortening resulting in loose G-locks (shelf-angle raised up).

View soft-joint position for insufficient dimension; view wall ties.

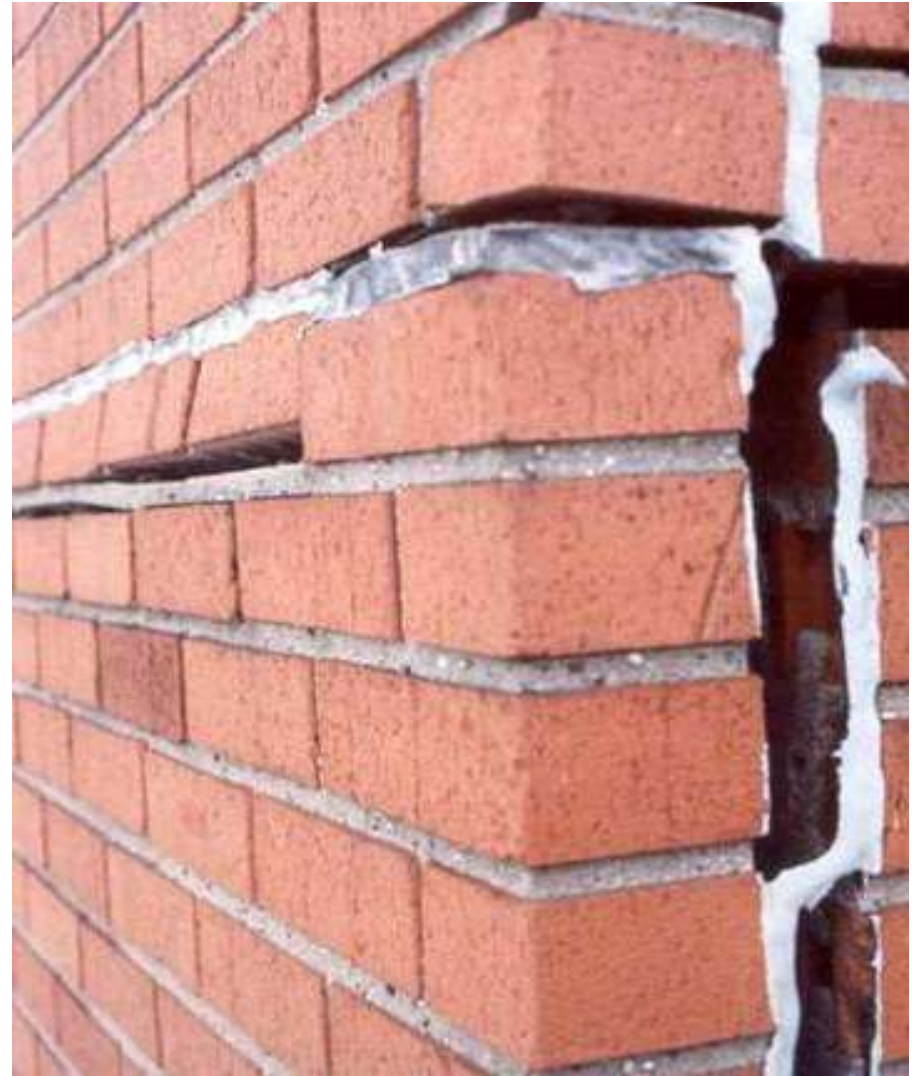
## 5.3.4 Displacement and Crack of Veneer

Cracks along shelf angles; out of plane displacement of bricks; loose bricks at shelf angles and parapets.

Thermal loading/movement is not accommodated due to insufficient or improperly placed expansion joints. At clogged veneers pressure from water accumulation and subsequent freezing. Rotation of shelf angle.

Placement of vertical and horizontal control joints and expansion joints.

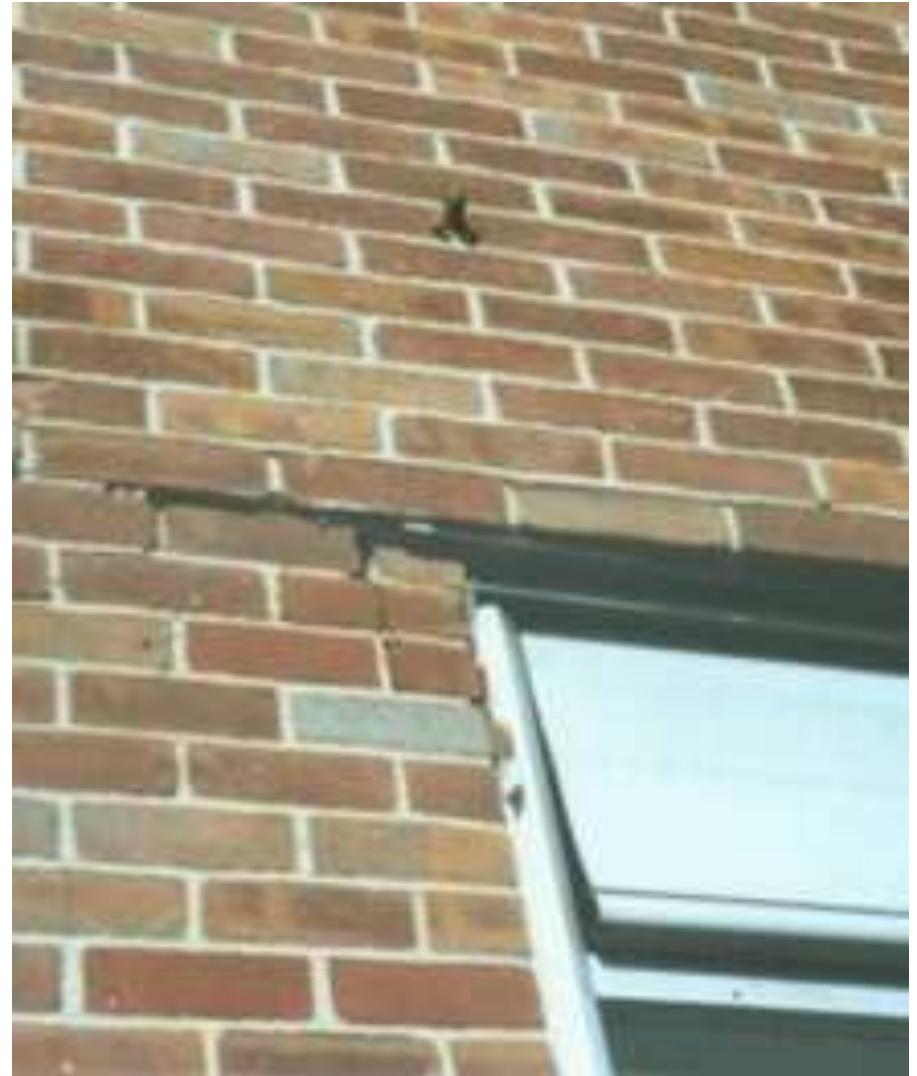
# 5.3.5 Mortar Joint Crack at Shelf Support of Brick Veneer

Cracks in mortar joints along shelf angles, spalling of brick around these joints; bowing of veneer.

Rust jacking due to unprotected steel shelf. Lack of soft joint (Vertical load is transferred to the lower façade veneer instead of being transferred to the shelf angle). Incorrect installation of brick veneer or flashing at shelf angles. Hardened material in lieu of soft joint.

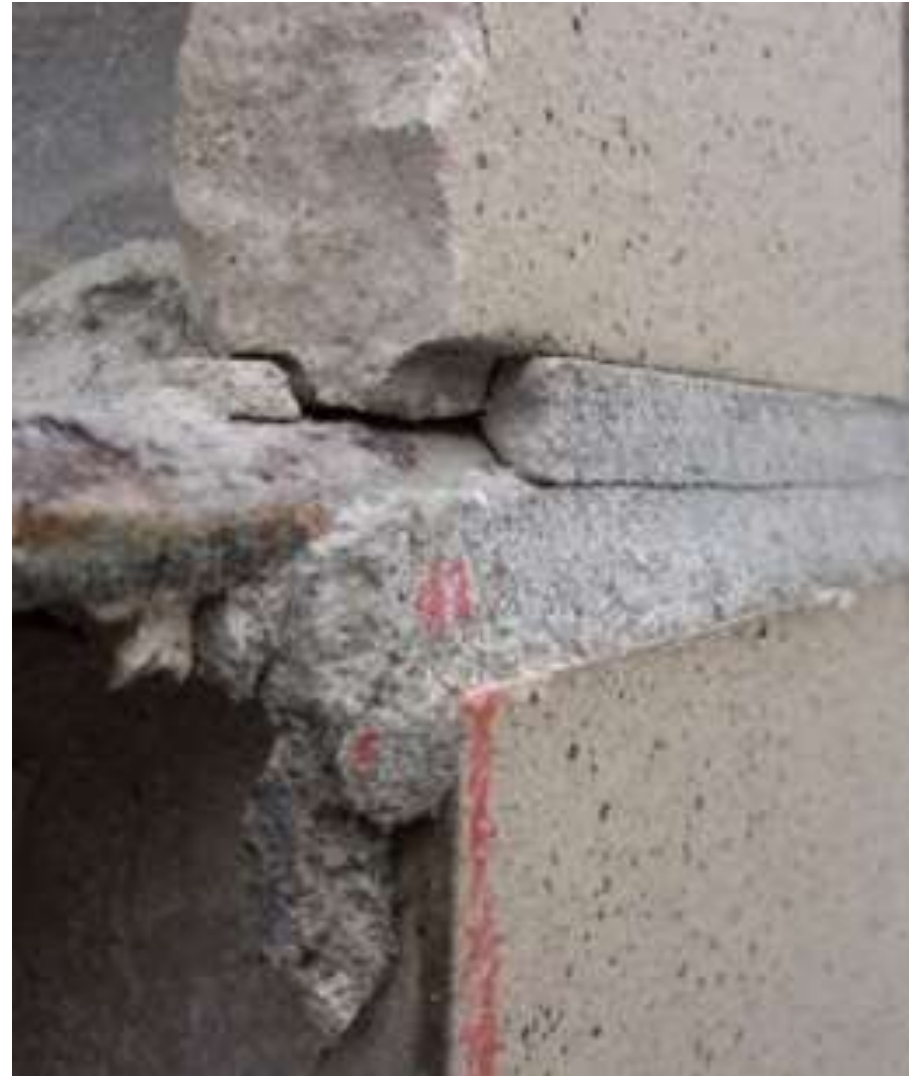
## 5.3.6 Incipient Brick Spalling at Shelf Support of Veneer

Spall of brick located at shelf angle joint.  
Cracked mortar at joint above spall,  
incipient bowing.

Additional spalling of brick course below shelf should be anticipated; load transfer to veneer below may result in bowing, buckling of veneer; confirm placement/extent of soft joint in veneer.

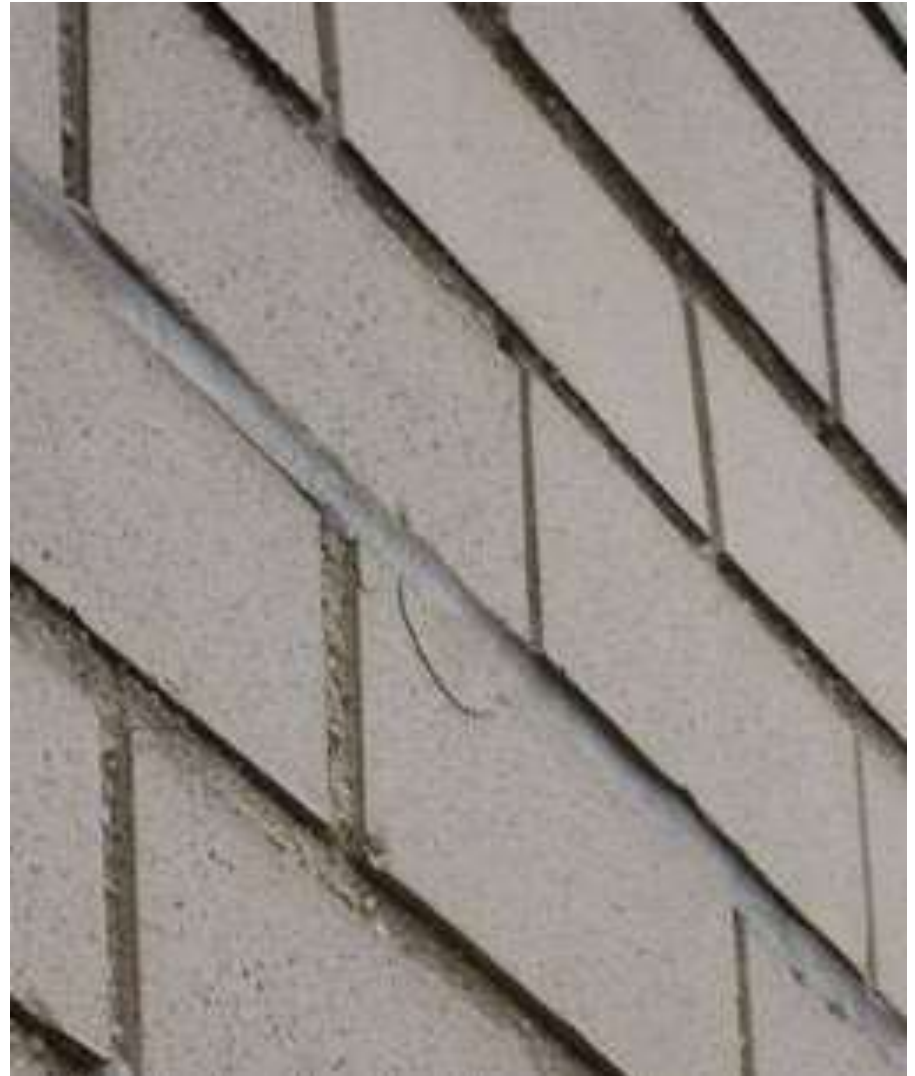
## 5.3.7 Undulating Brick Veneer – Horizontal Bowing

Thermal and ceramic expansion in the horizontal direction is restrained; (e.g. restrained at building corners from an expressed reinforced concrete frame).

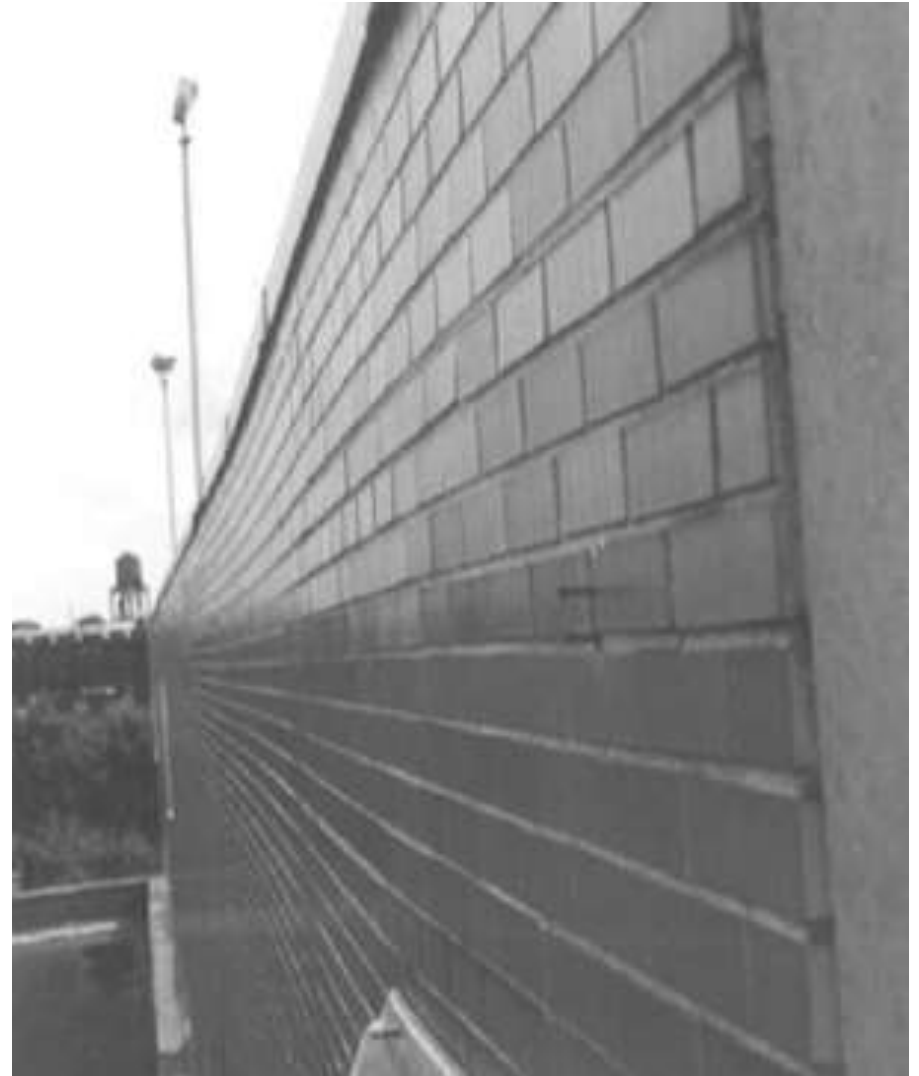
## 5.3.8 Vertical Cracks in Veneer at Corner

Size and direction of cracks.

Horizontal expansion in the plane of the veneer is not accommodated at the vertical control/expansion joints. Joint dimension is insufficient. Lack or improper placement of joints.

The thermal expansion develops forces that crack the brick veneer.

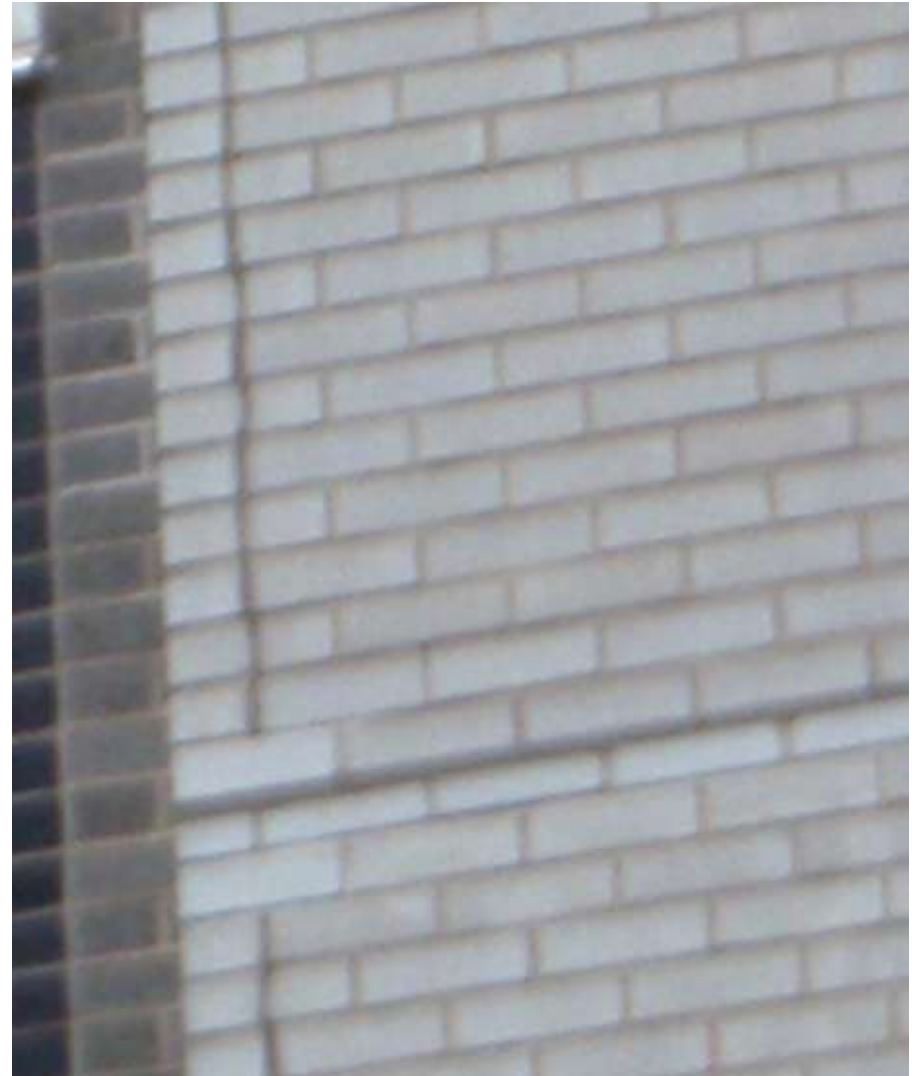
## 5.3.9 Bowing Brick Veneer

Insufficient drainage of water (clogged weep holes) or rust jacking pushing veneer off the shelf angle. Insufficient or rusted wall ties.

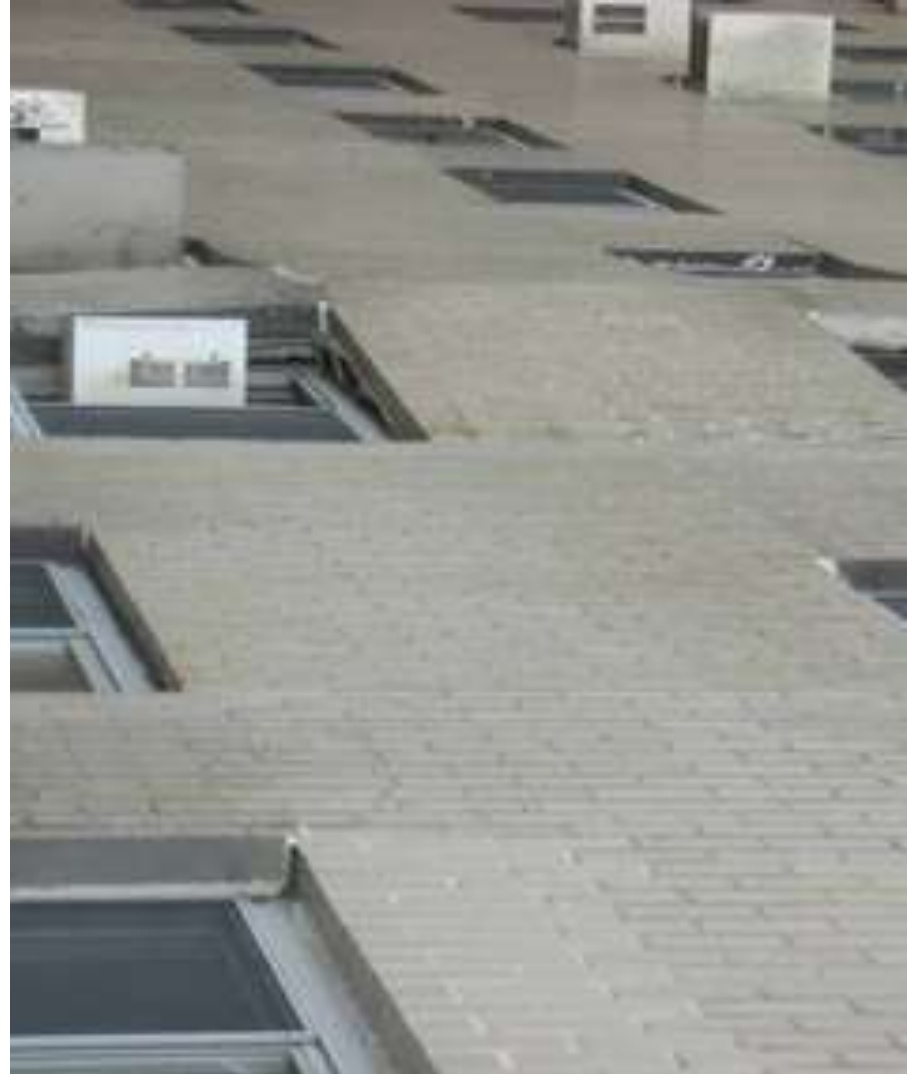
# 5.3.10 Rusting Lintel/Shelf Angle at Brick Veneer

Rust coloration on the adjoining area,  
Change in shelf angle thickness. Presence of flashing

Deterioration or lack of corrosion protection of steel shelf angle. Improper flashing. Larger volume of corrosion residues exerts pressure on veneer in vertical and horizontal direction.

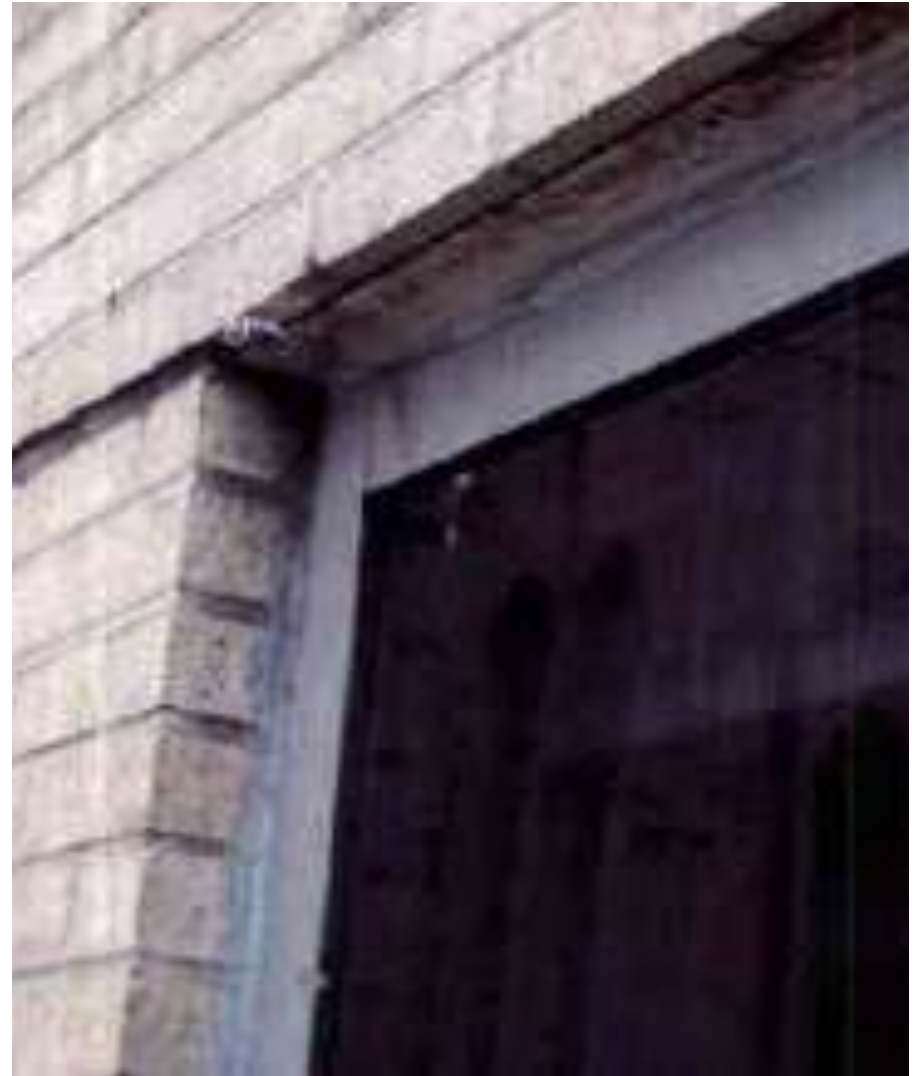
# 5.3.11 Deterioration of Filler Material At Joint in Veneer

Missing or squelched joint filler.

Improper filler material. Insufficient joint width. Aging of filler material.

Lack of filler allows increased rain water penetration, vertical joint may become ineffective.

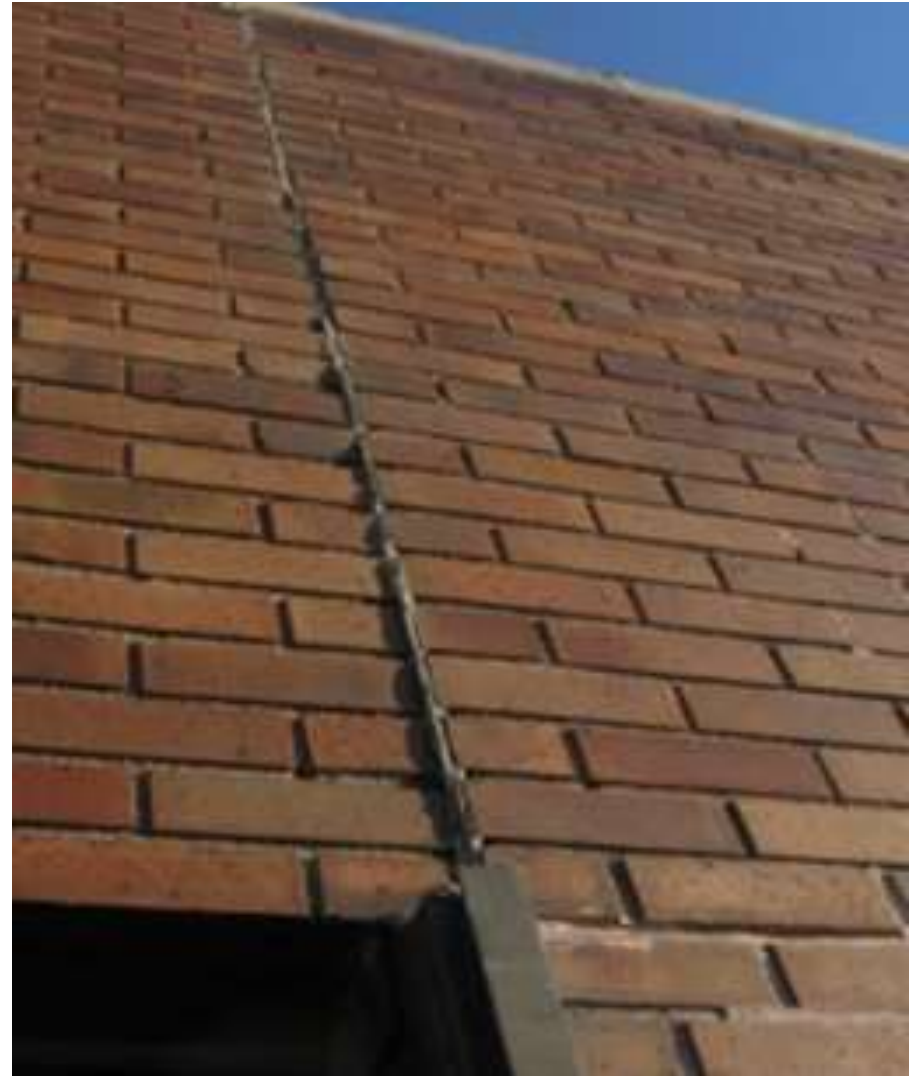
# 5.3.12 Stepped Crack in Brick Veneer

Stepped crack into mortar joints or into brick and mortar joints, downward bowing of shelf support. Verticality of wall elements.

Weakening of shelf support due to corrosion or due to movement of G-locks. Movement of veneer over shelf. Lack of joints. Movement of supporting frame.

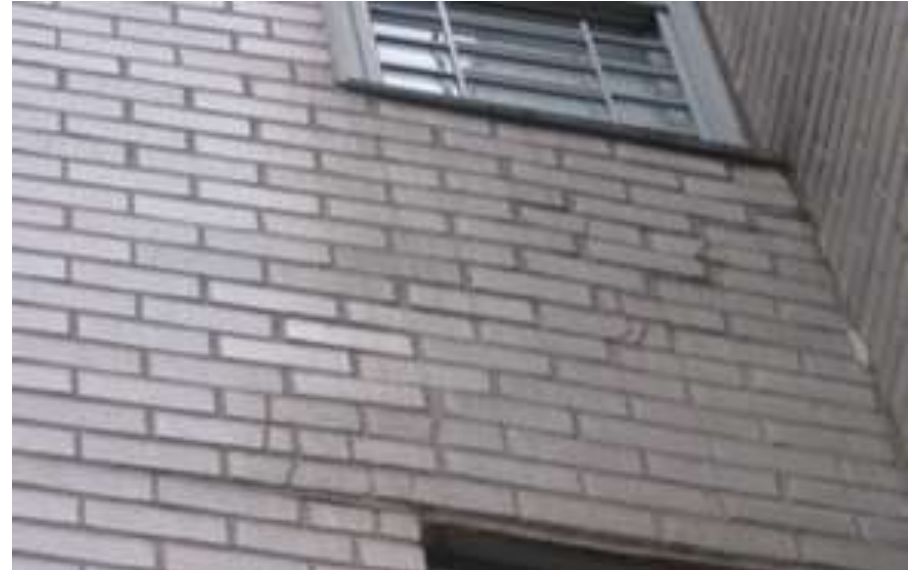
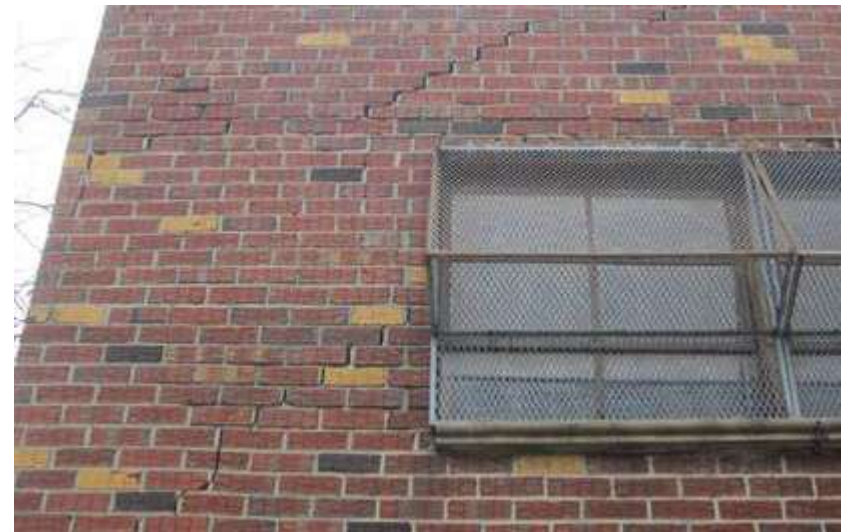
# 5.3.13 Brick Veneer Displaced off Supporting Shelf

Step in the vertical plane, rust coloration of brick, clogged weep holes, spalling of brick below shelf.

Insufficient drainage of water (clogged weep holes) allows water or ice buildup behind veneer and result in the veneer being pushed out. Also rust jacking can push veneer off the shelf angle. Insufficient or rusted wall ties.

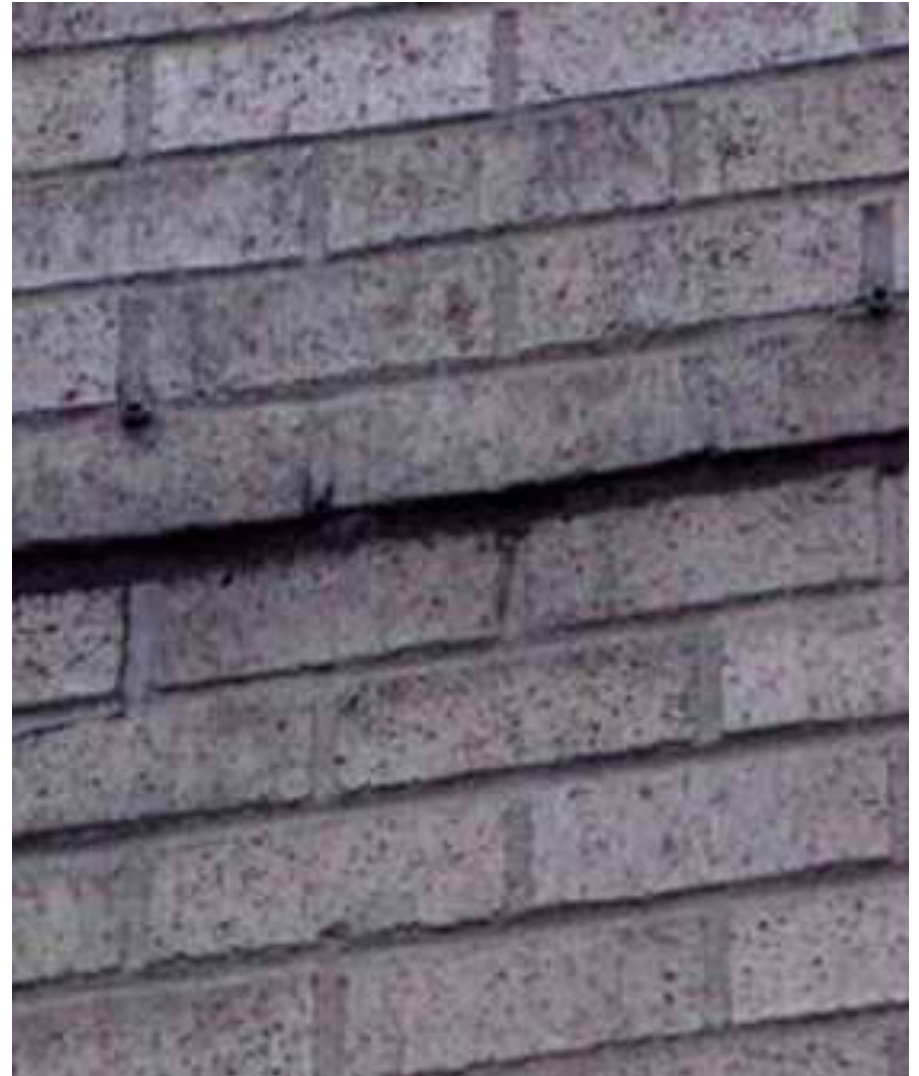
# 5.3.14 Vertical Cracks (distributed) in Brick Veneer

Vertical cracks, size and number of cracks, presence and condition of soft joints.

Brick undergoing ceramic or thermal expansion becomes compressed between shelf angles top and bottom, large distance between horizontal joints.
