# FAÇADE CONDITIONS

An Illustrated Glossary  
of Visual Symptoms

**Edited by Dan Eschenasy, PE**  
Chief Structural Engineer  
NYC Department of Buildings

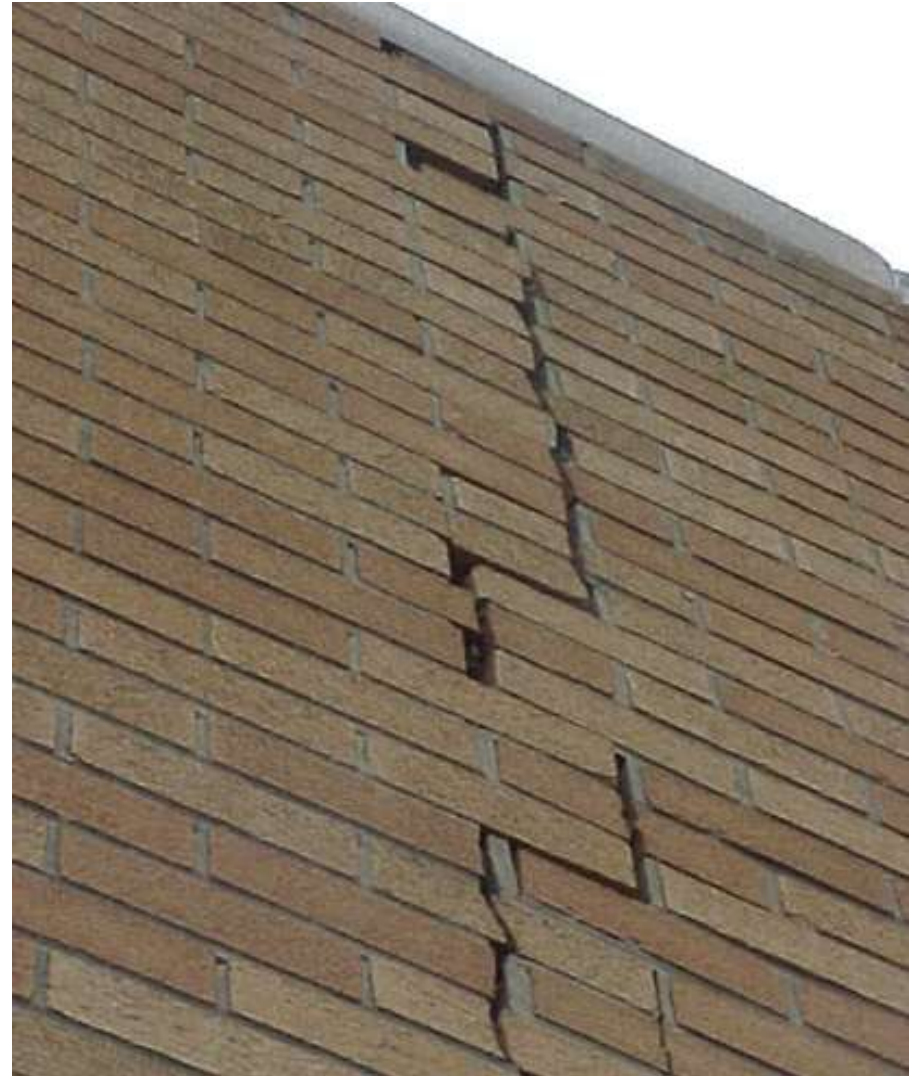
## 5.3.16 Improper Repair of Veneer at Corner

Vertical cracks formed following the replacement of the bricks at corner. The repair did not allow for the ceramic expansion of the newly installed brick.

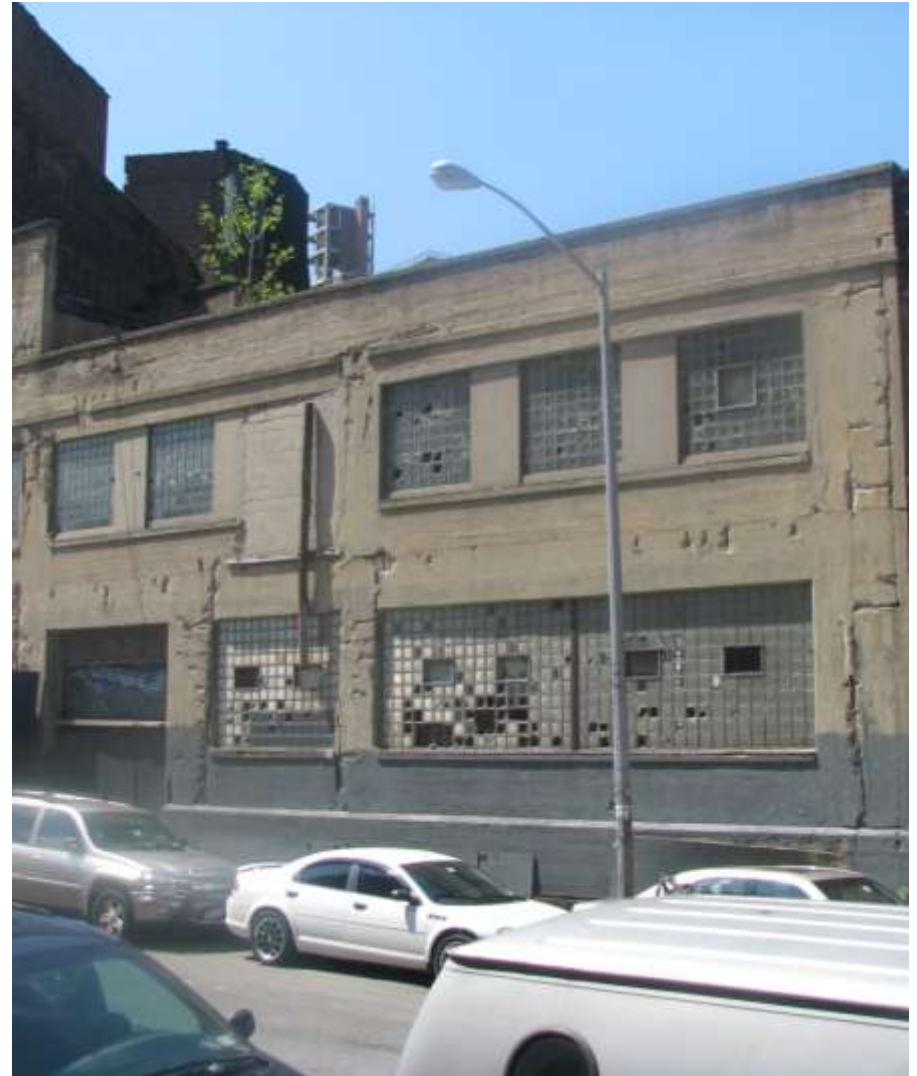
## 5.4.2 Slippage Precast Concrete Panel

Failure of the stone anchoring system; Rust build-up on the shelf angle; Use of non-galvanized anchoring system.

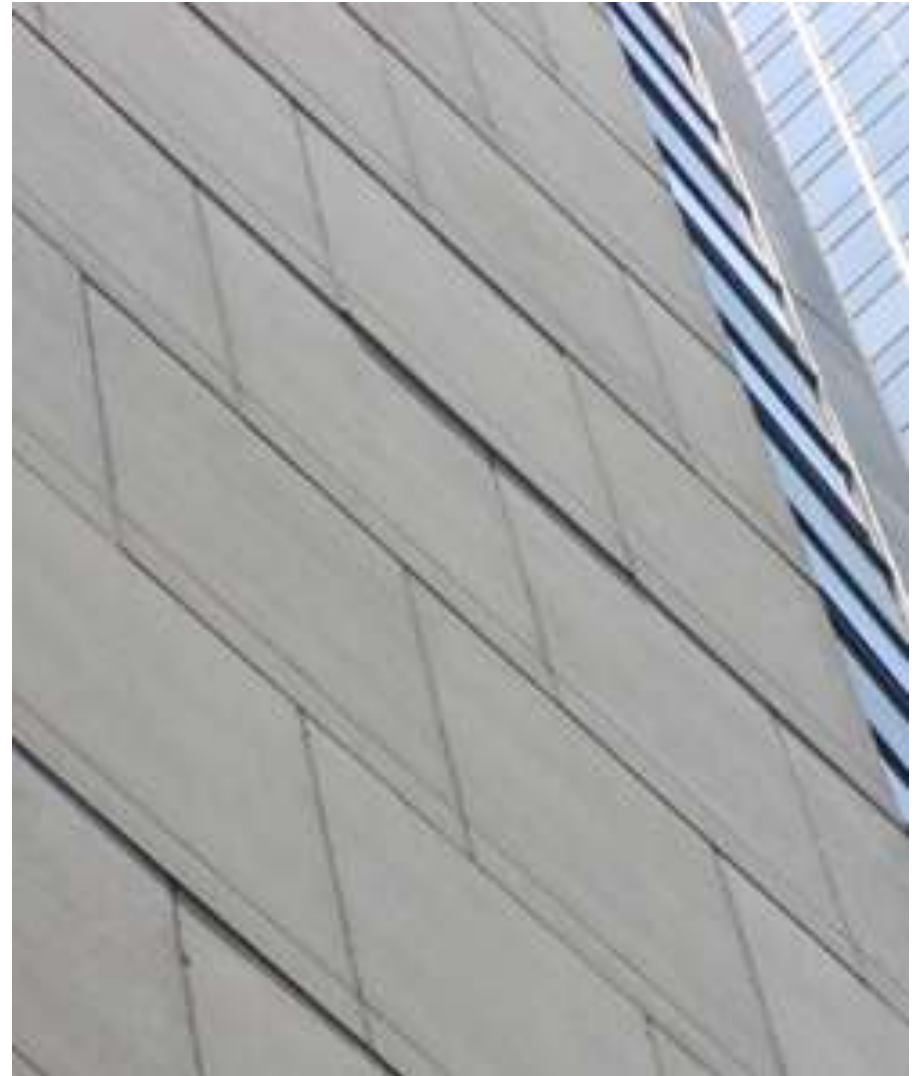
## 5.4.3 Crack in Concrete Panel

Crack in individual precast panels. *Crack opening and separation of panel.*

Mishandling during installation. Failure of attachment.

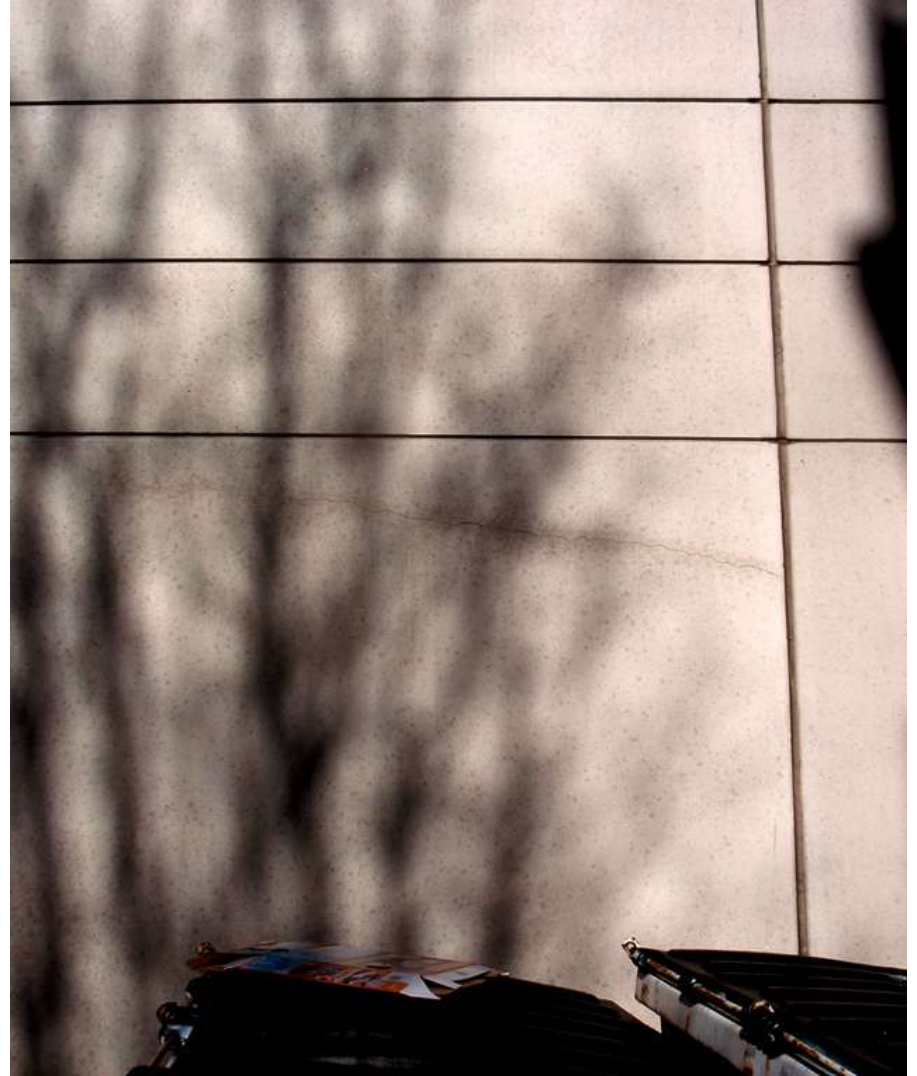
# 5.4.4 Surface Spalling of Precast Concrete Panel

Surface spalling; Stone displacement;  
Evidence of an applied coating.

Use of non-breathable coating.

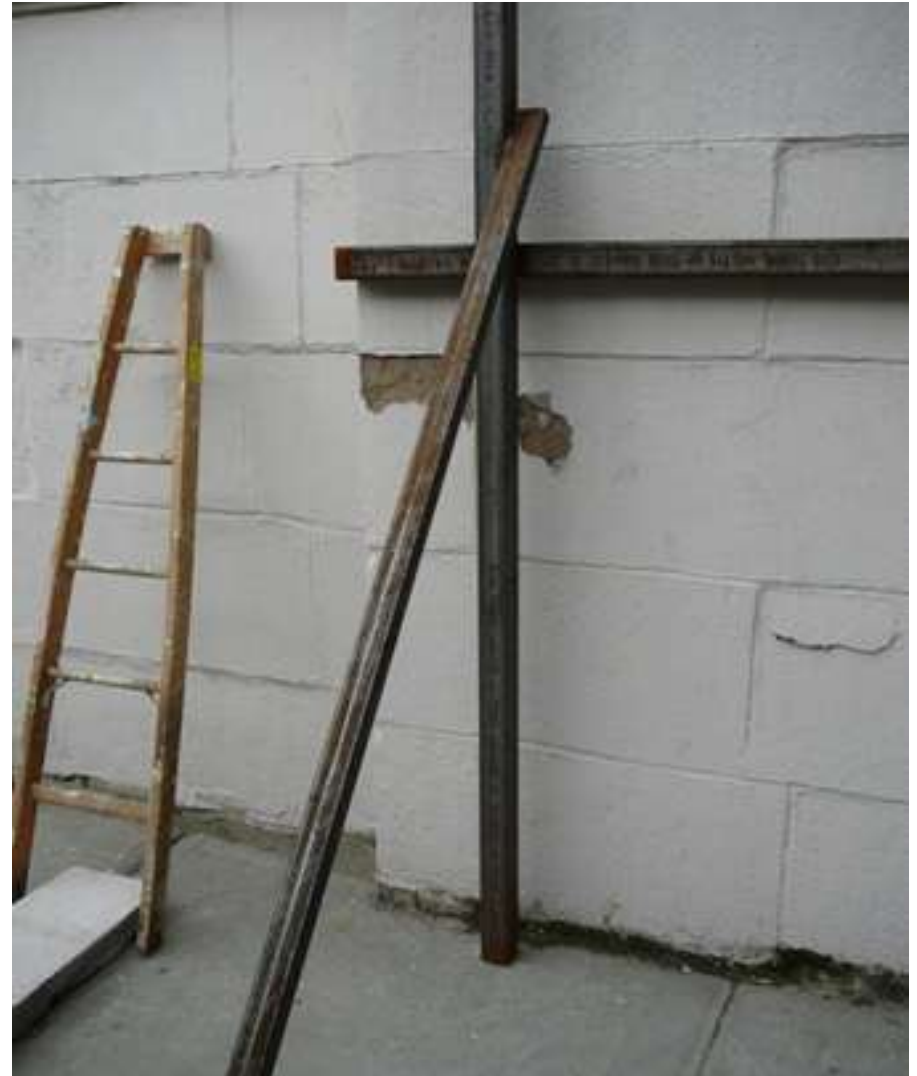
# 5.4.5 Crack at Joints of Precast Panels

Bulging of stone not related to shelf angle location; Cracking associated with bulging.

Insufficient number of stone anchors provided. Defective Precast Concrete Panel Attachment.

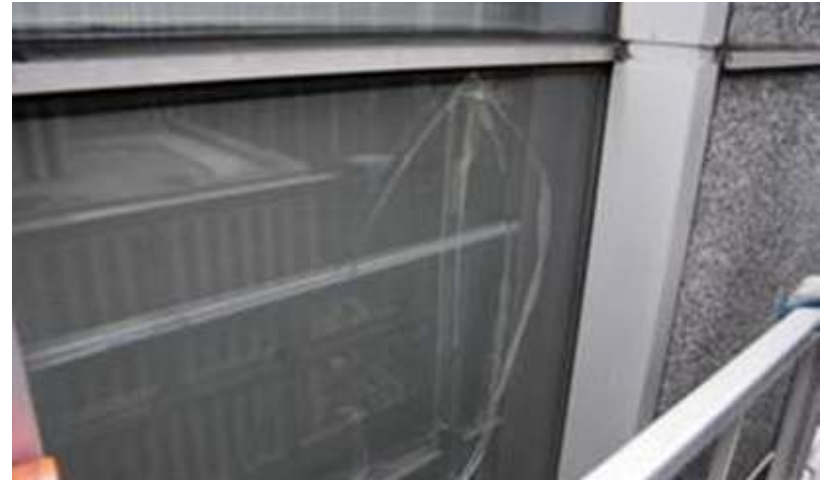
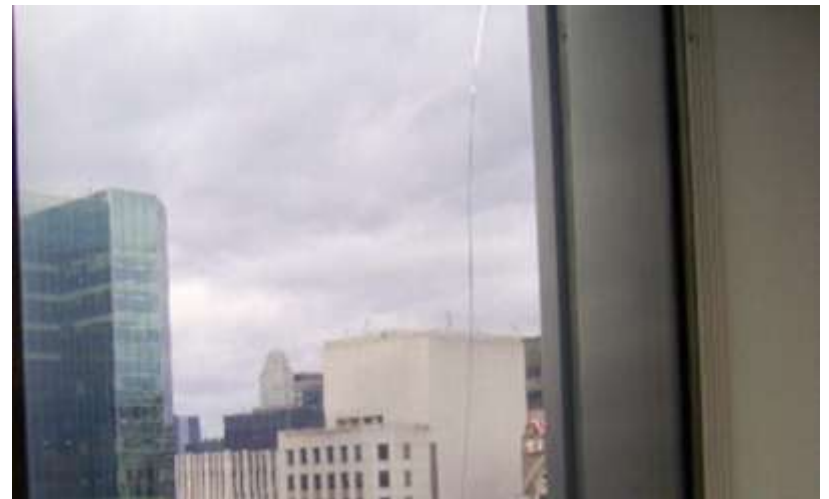
# 6.1.2 Glass Defects

Stains, deposits scratches and other imperfections on the surface of the glass panels and their coating. Discoloration.

Mishandling during erection. Manufacturing defects that were not detected at the plant.

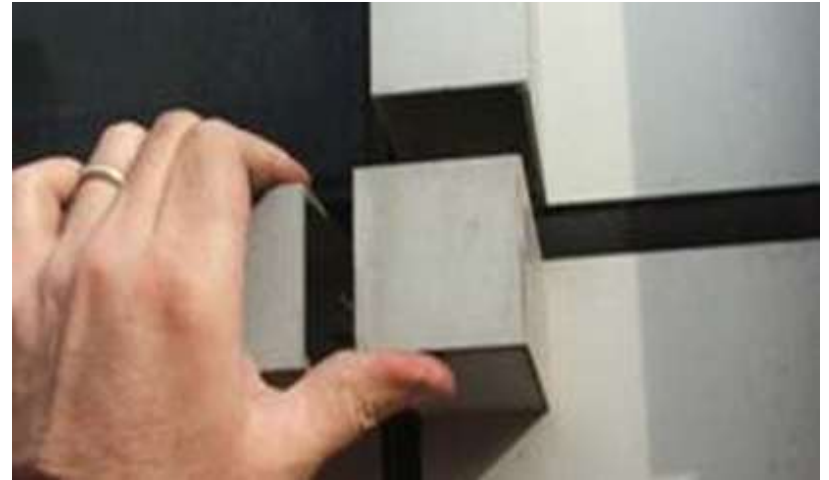
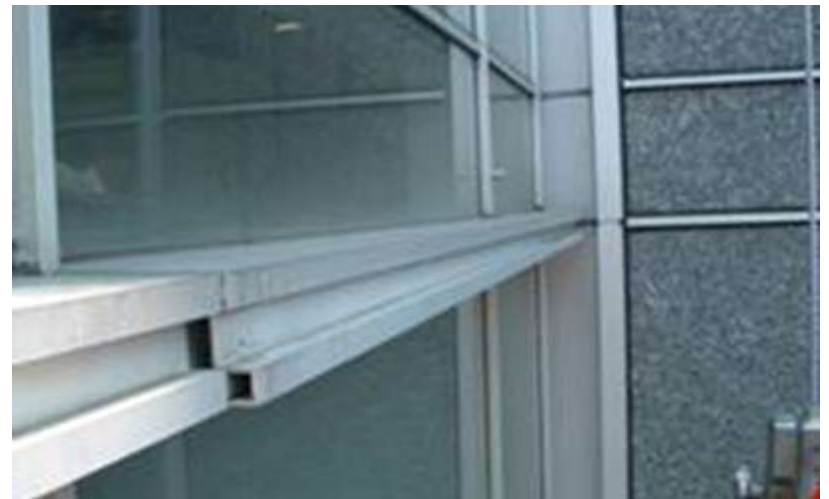
# 6.1.4 Missing Decorative Trim of Curtain Wall

Exposed underlying construction, condition of architectural hardware.

Design failure – excessive deflection, movement of metal element, and metal fatigue due to repeat wind load. Excessive story drift. Fastener fatigue failure.

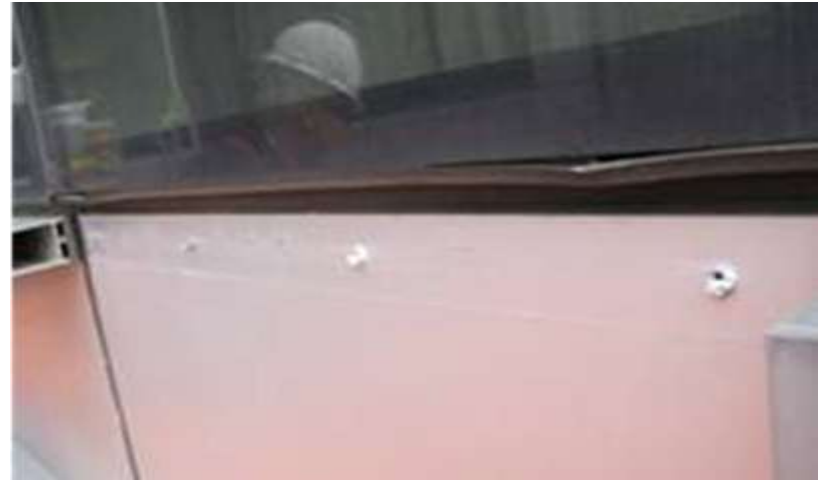
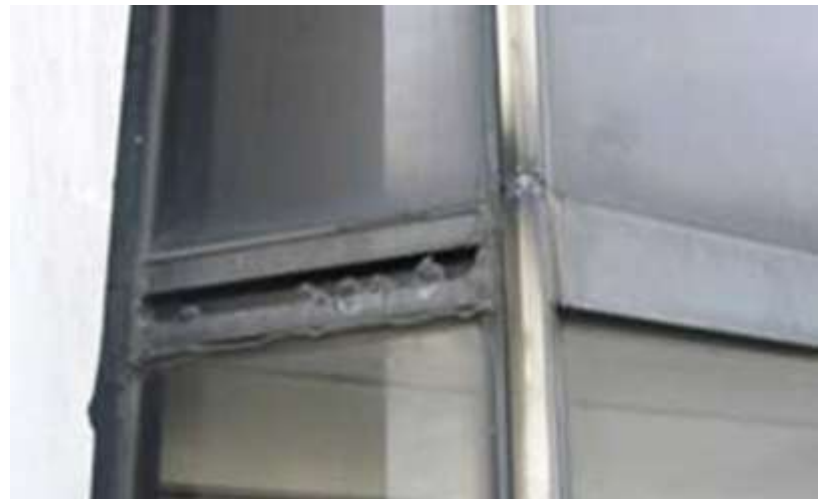
# 6.1.5 Loose Snap-on Trim

Original design failure, metal fatigue, fastener fatigue/failure.

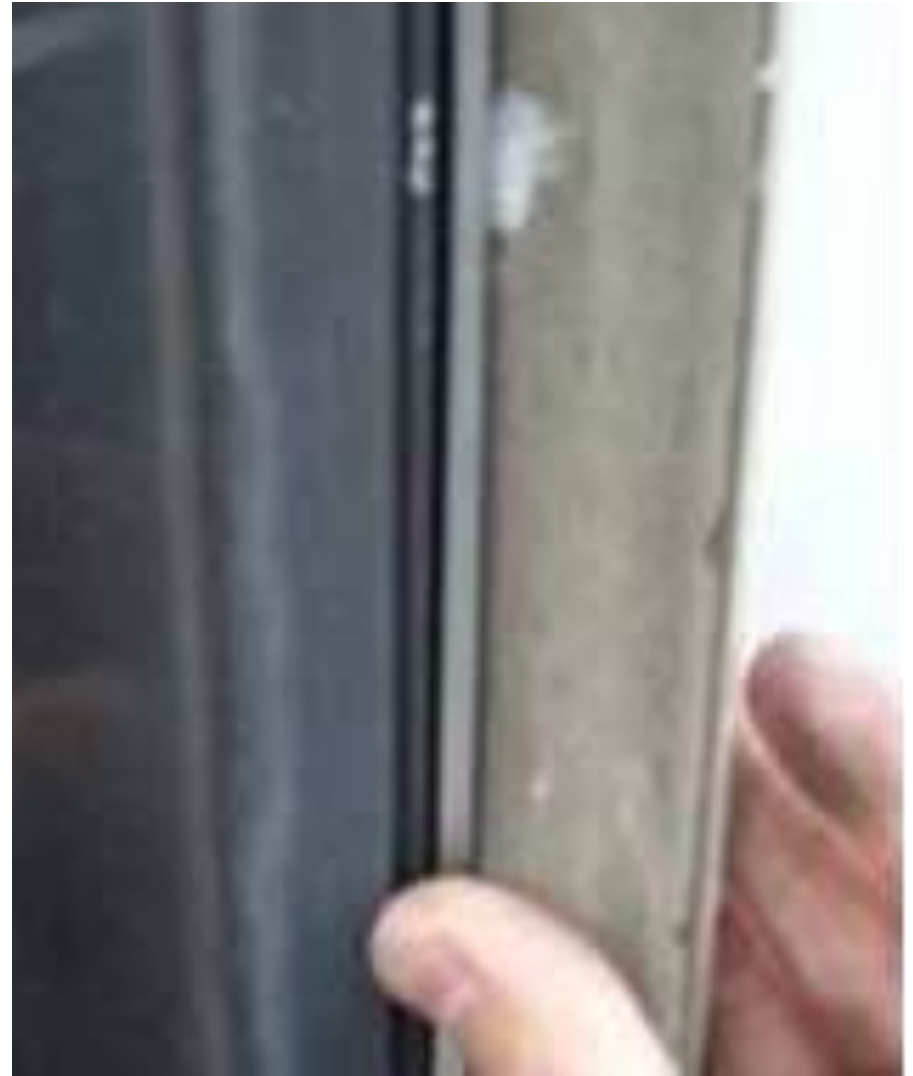
# 6.1.6 Mullion Deformed

Thermal expansion blocked. Mechanical impact.

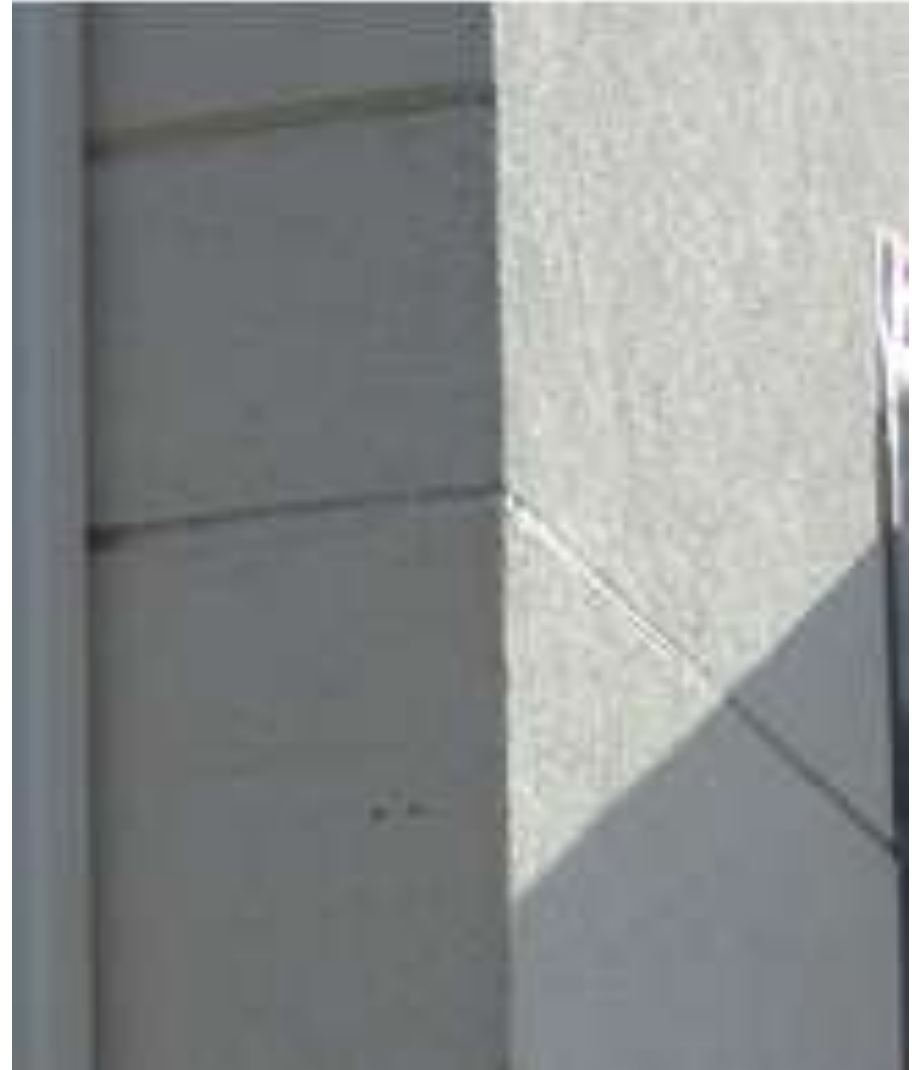
# 6.2.1 Sealant Joint Failure - EIFS

Active water leaks; Discoloration;  
Sealant recessed in joint. Wet,  
gummy or bulging sealant.

Water accumulating along interface of  
sealant and EPS substrate. Improper use of  
foam backer rod. Finish coat within joint.

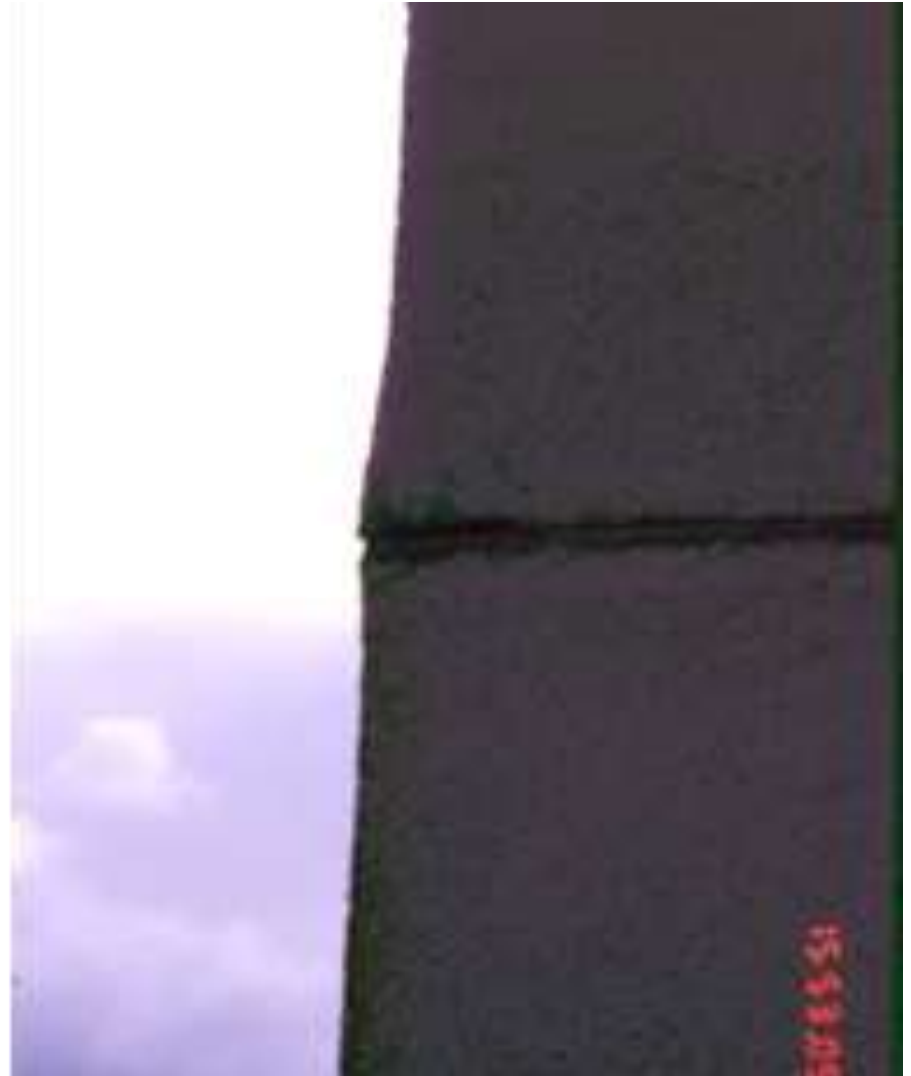
## 6.2.2 Mitered Outside Corners of EPS Board - EIFS

Active water leaks: Exposed reinforcing mesh at corner; Bulging at corner.

EPS (aged) boards are not interlocked at corners.

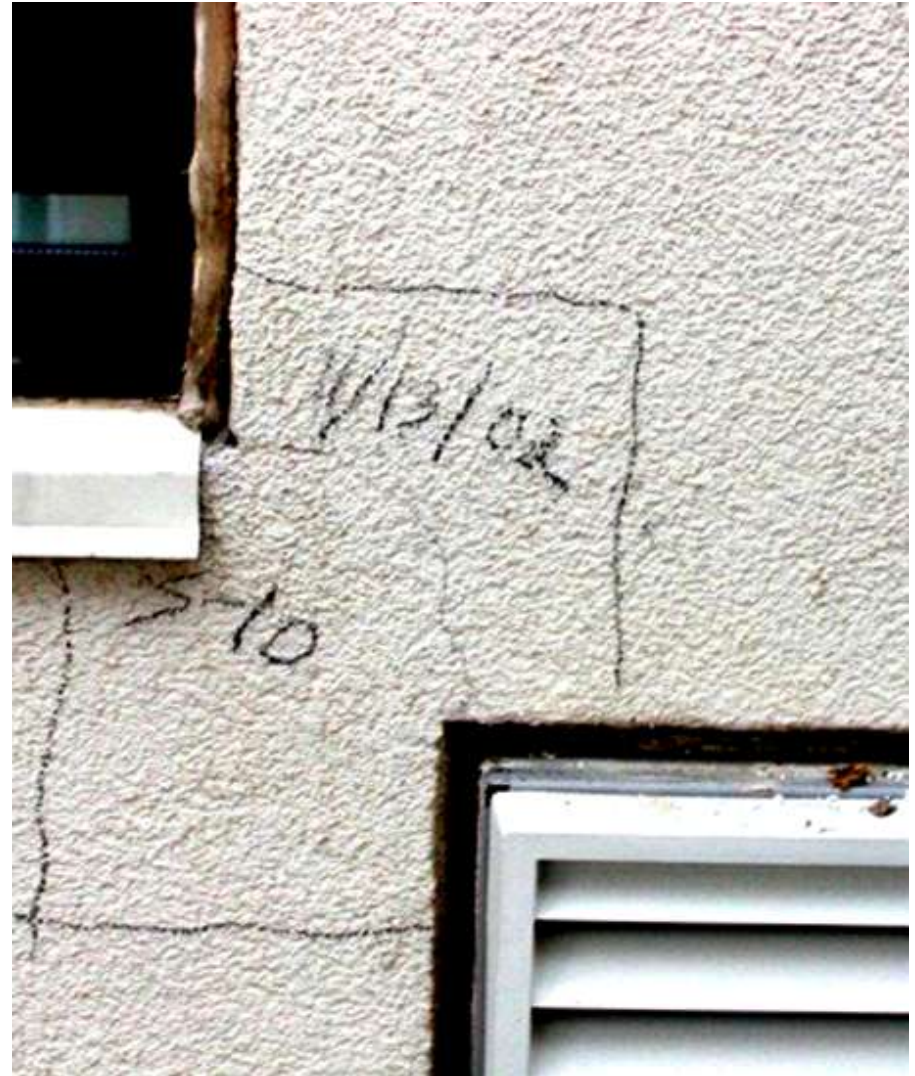
## 6.2.3 Cracking at Penetration Corners at EIFS

Active water leaks; Cracks in finish coat at or near corners of penetration.

Improper back-wrapping of reinforcing mesh; lack of diagonal reinforcing at corners; EPS board is not “L”-shaped at corners.

Test exterior sheathing behind EPS board using long pins of moisture meter to confirm water penetration.

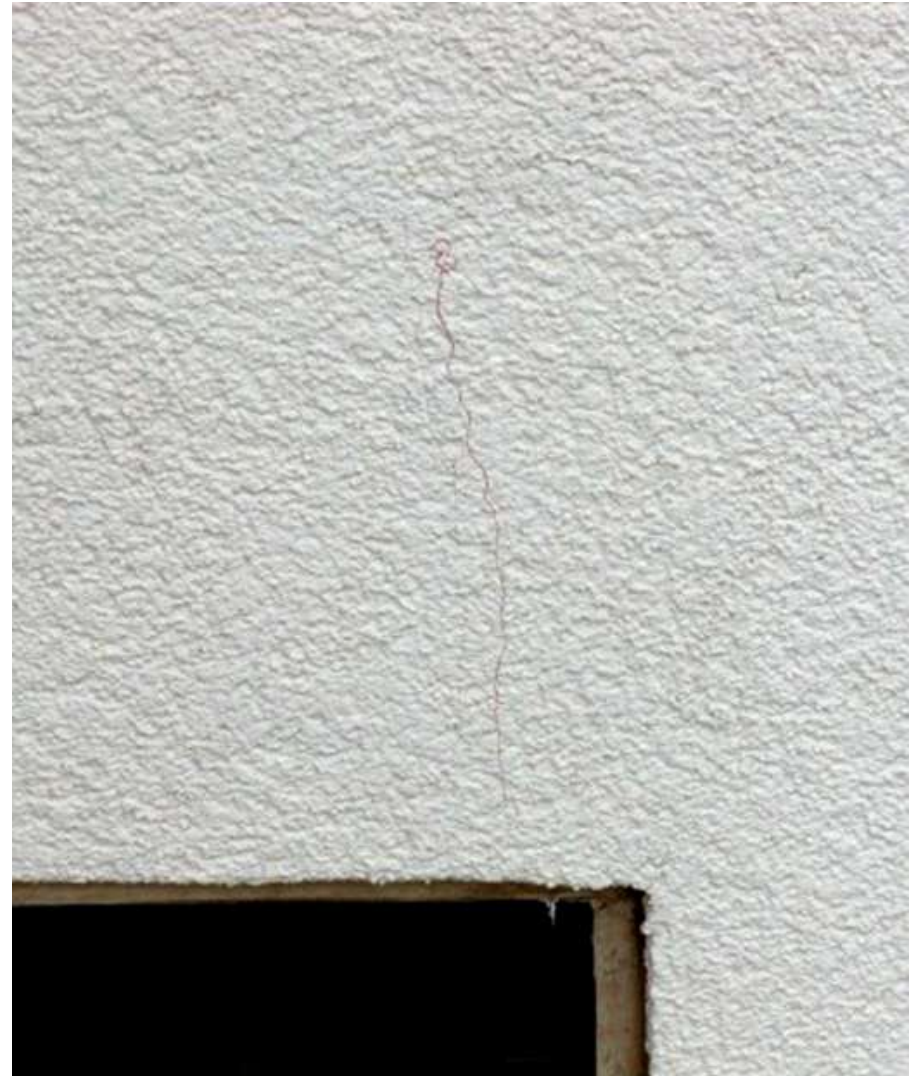
## 6.2.4 Cracking Adjacent to EIFS Penetration

Active water leaks; cracks in finish coat at or near corners of penetration.

Improper back-wrapping of reinforcing mesh; no flashing installed behind EPS board.

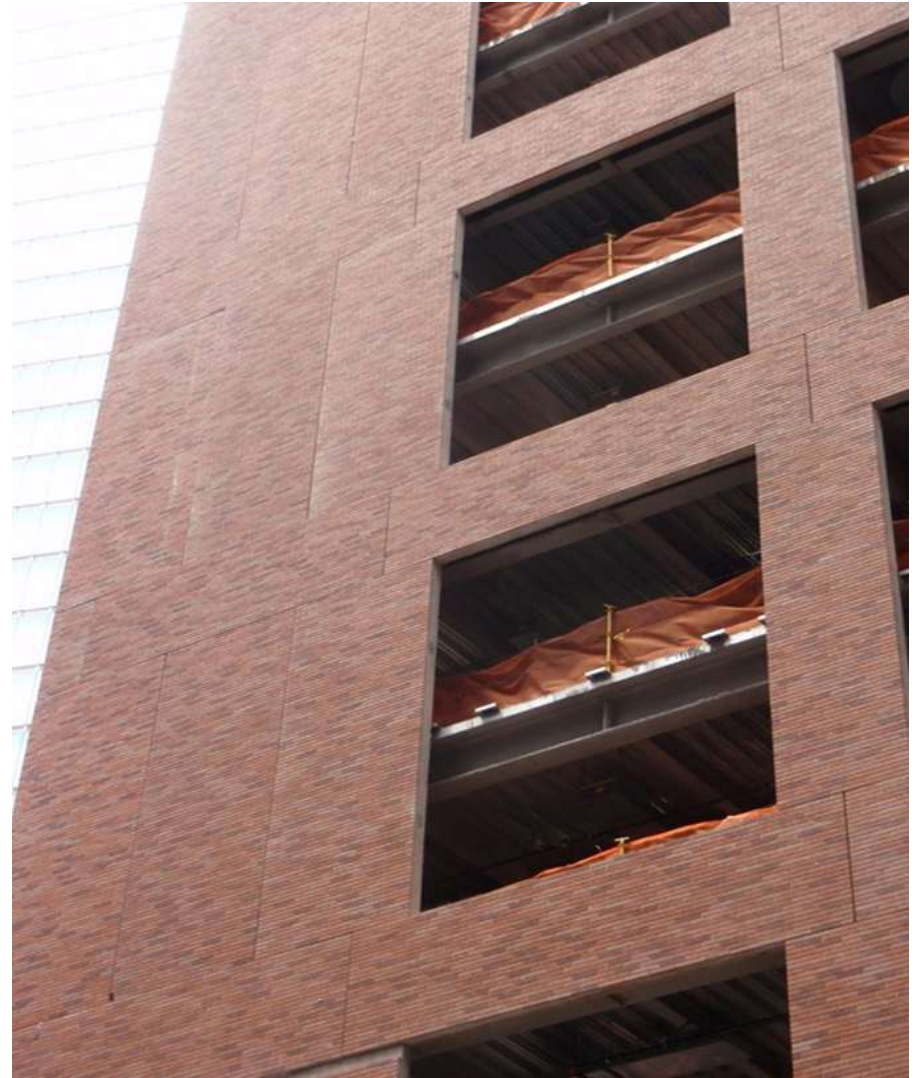
## 6.3 Thin Brick Panel

Relatively new systems, the panels are delivered at the site as a sandwich containing an exterior thin brick veneer, a rainwater screen and management system and insulation.

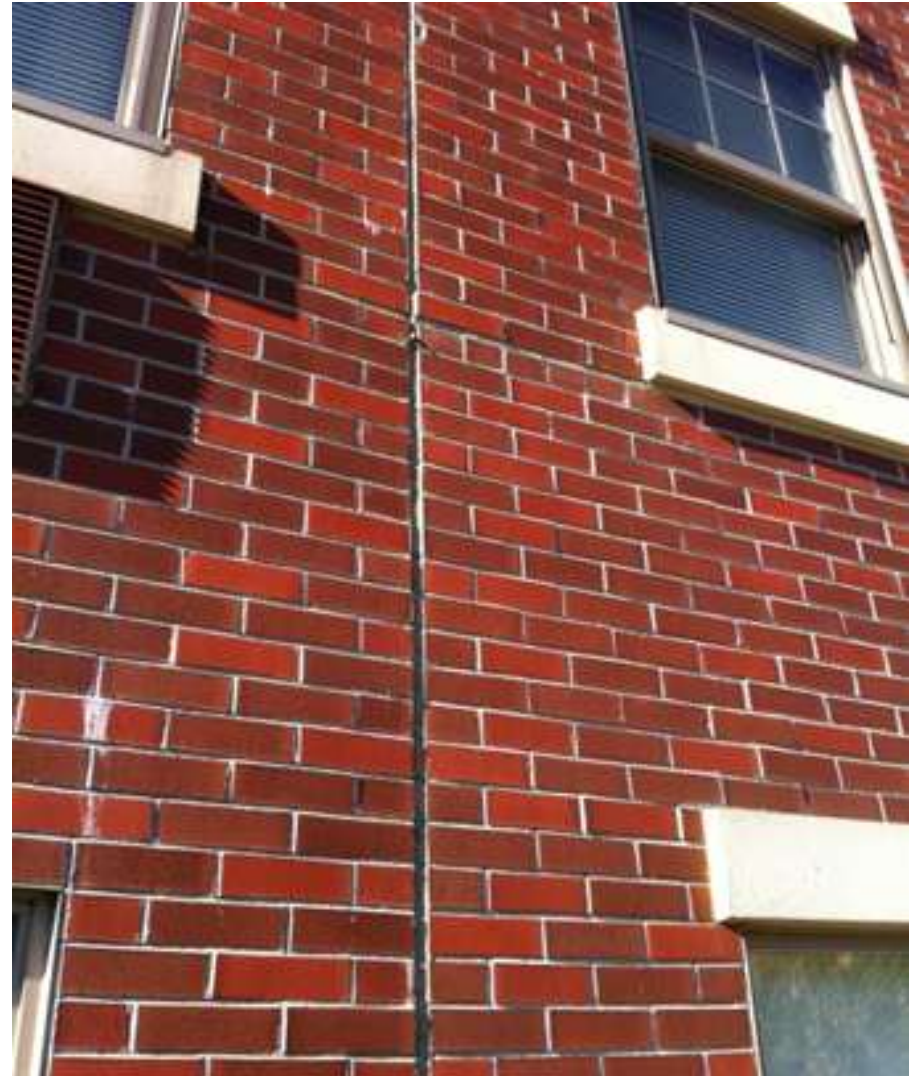
# 6.3.1 Sealant Joint Failure

Active water leaks. Sealant recessed in joint.

Water accumulating along interface of sealant and substrate. Improper use of foam backer rod.

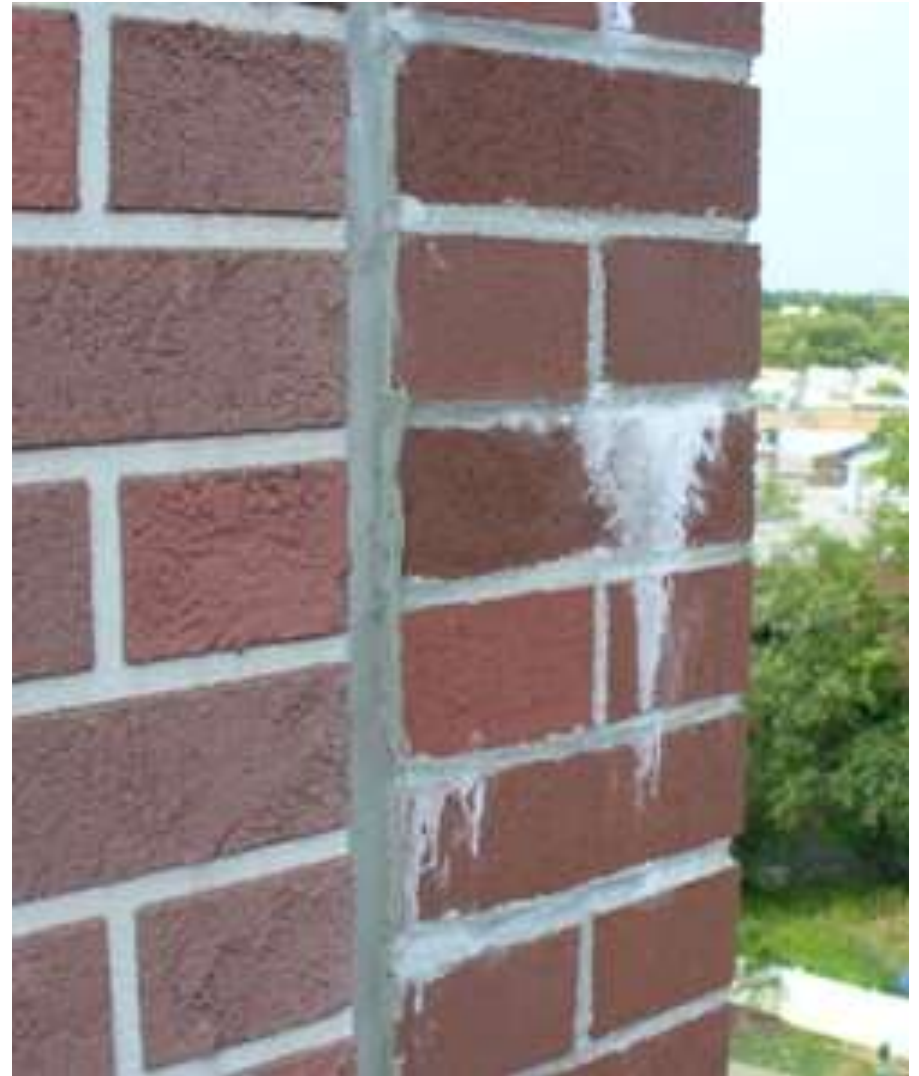
## 6.3.2 Efflorescence -Thin Brick Panel

Water penetration in the brick panel; adhesive/mortar holding brick onto panel could be dissolving, eventually causing the brick to de-bond.

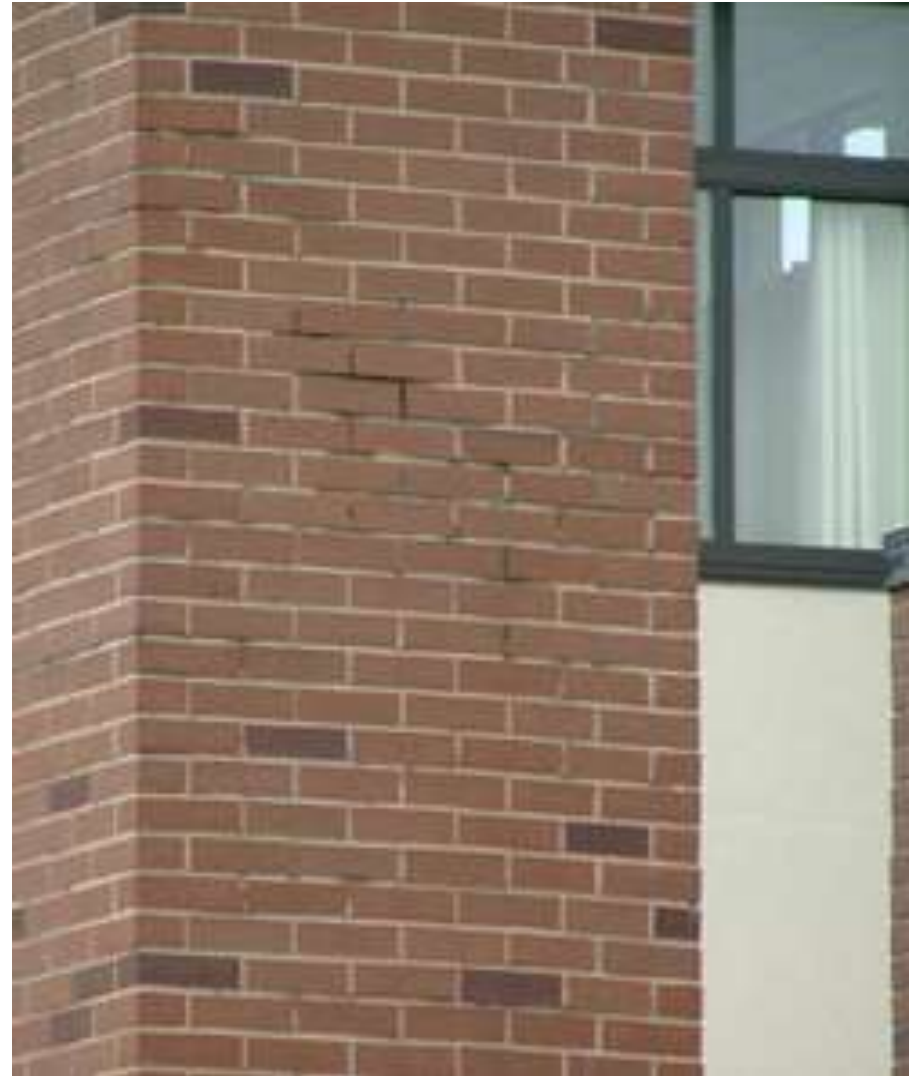
## 6.3.3 De-bonding of Individual Thin Brick

Bond between thin brick and its back-up has been compromised by water or thermal movement.

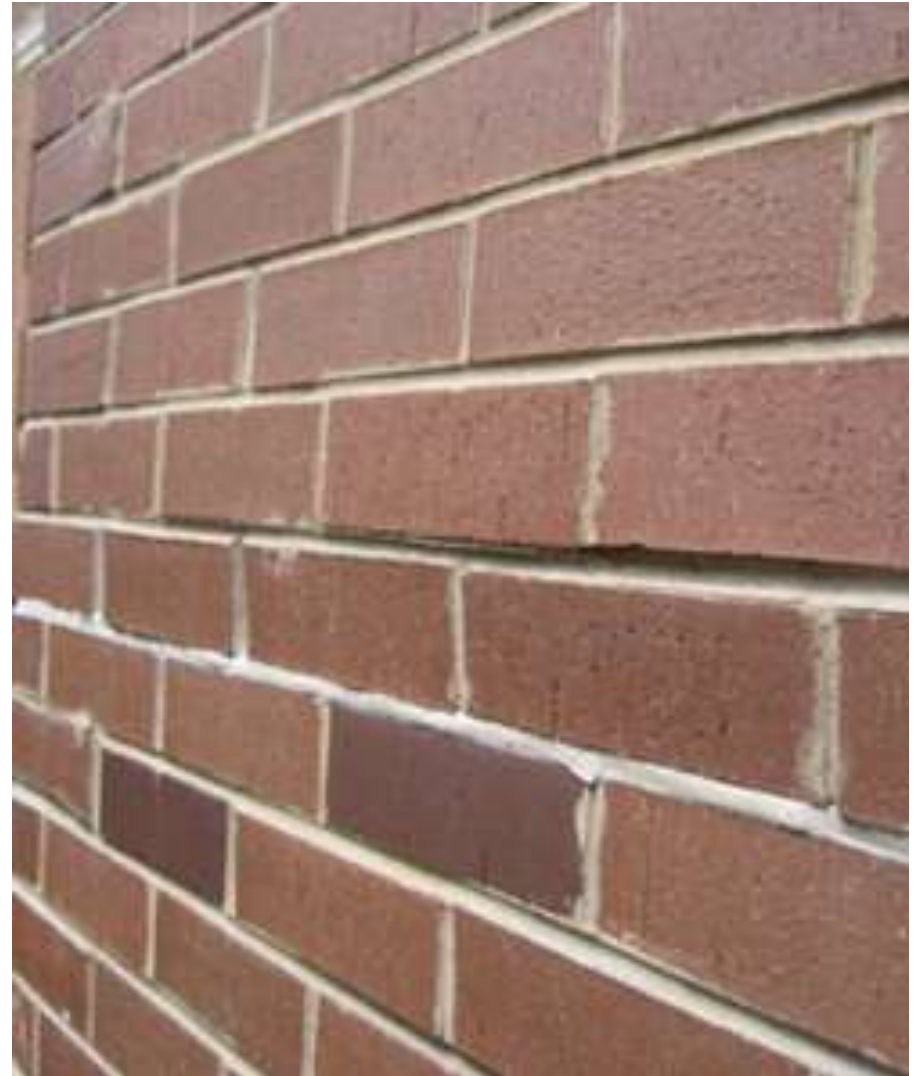
## 6.3.4 Bulging Brick - Thin Brick Panel

Thin brick is not adhered to back-up. Sealant joint spacing is insufficient.
